FINAL REPORT OF INVESTIGATION A&I E18417

Red Signal Overrun

FINAL REPORT OF INVESTIGATION A&I E18417**SMS 20180924#74547**

Farragut North (A02), A02-32 Signal - Switch 7

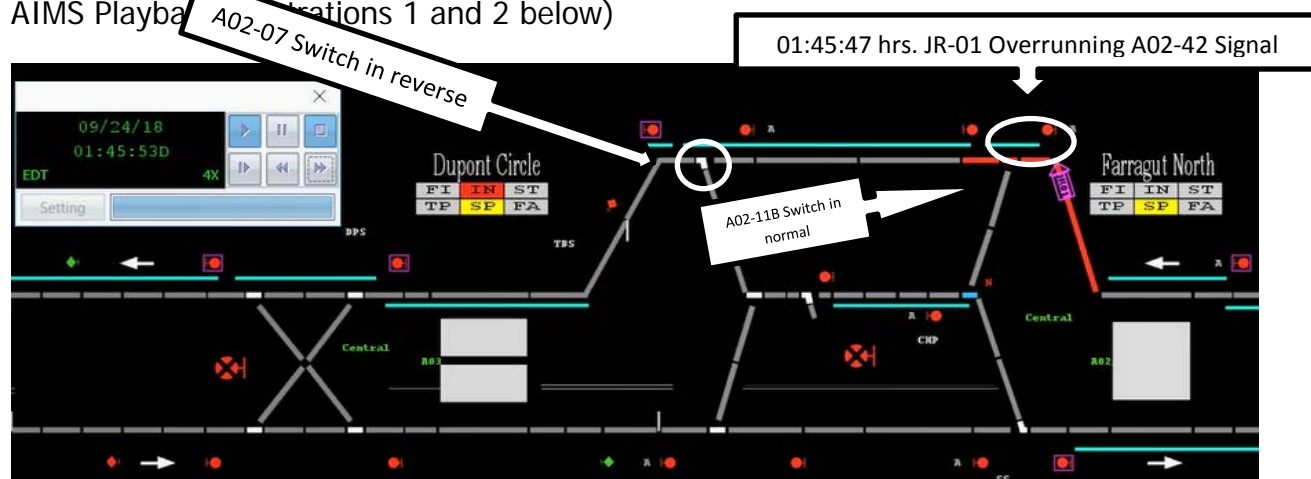
Illustration 1

At 01:45 hrs. per the Advanced Information Management System (AIMS) Playback, the display showed JR01 in approach of A02-42 Signal displaying a red aspect and subsequently proceeding past signal displaying a red aspect; however, A02-11B Switch, associated with A02-42 Signal was in the normal position resulting in no adverse event i.e. Trained switch. Additionally, AIMS further displayed A02-07 Switch laying in the reverse position as JR-01 shunted beyond A02-42 Signal and subsequently triggered a red signal alarm in addition to operating past A02-32 displaying a red signal aspect. (See AIMS Playback Screenshots 1 and 2 below)

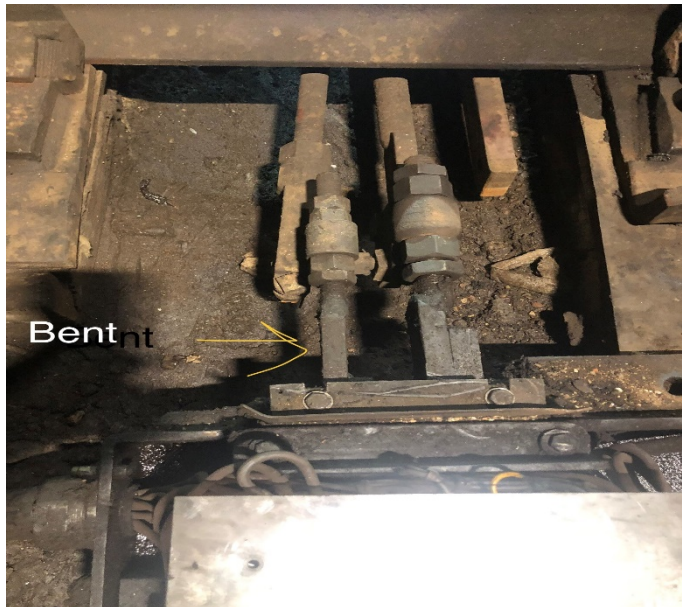
30	EVE 09/24/2018 22:30 B99 Crew went down to see about switch 7. Crew was working with safety on this matter call # SAFE #204. During inspection we came to a conclusion that the point detector rod, lock rod, and basket rod were all bent and also switch 7 also needs a new cover. Crew also cranked 7 in REV and after completing throw there was a 1/4" gap between the point and stock rail. We also seen grease shaving on the inside of NOR point opening and after all the inspection crew re-clamped switch 7 back in NOR & switch is out of service
----	---

Photo 1 – Shows bent rod

8358746	SWITCH #7 OUT OF CORRESPONDENCE IN NORMAL. CLAMPED BY ATC UNIT 2028 IN NORMAL.	SR			INPROG		RELATED							
Failure Reporting														
Cause	Remedy			Supervisor			Remark Date							
3453	TRAILED SWITCH	2825	REPAIRED				09/27/2018							
Remarks:	REPLACED PARTS, THROW ROD AND OPERATING BAR. AM Shift (9/27/18): Went road way with track personnel for inspection & obstruction switches 5 (A, B) & 7. All switches are working normally at this time and putting back in service. Notified MOC & OCC.

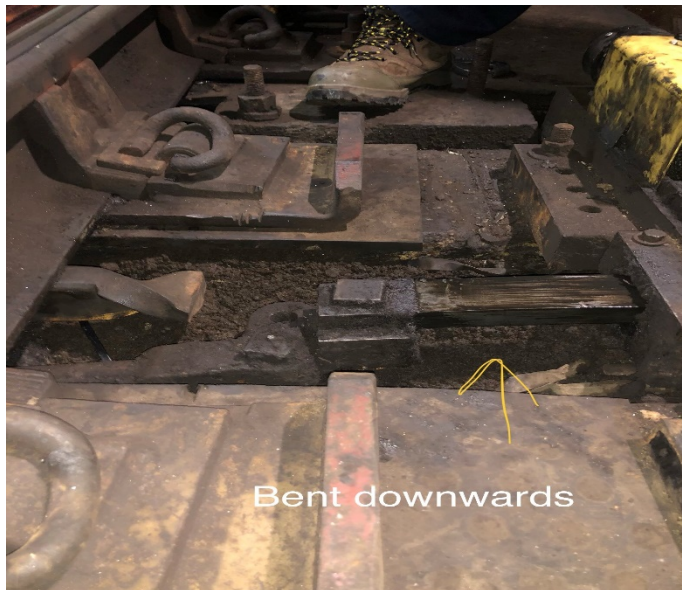
Photo 2 – Shows bent rod from track bed

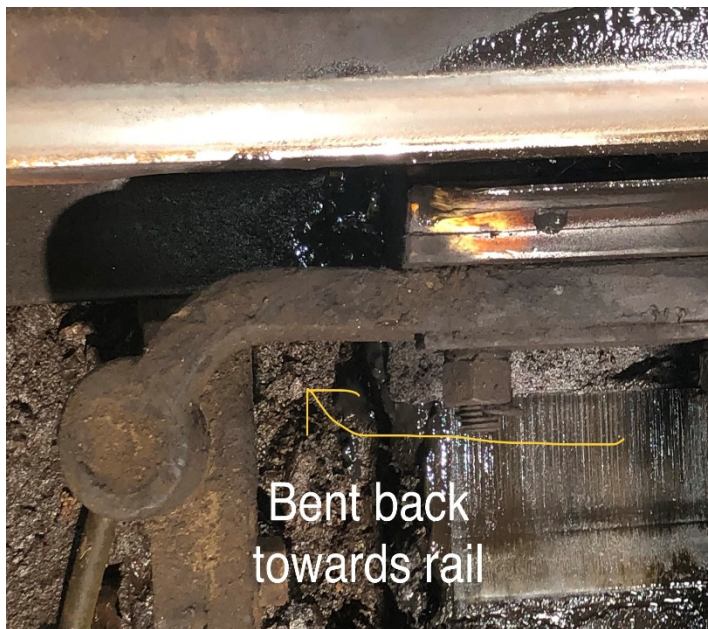
There were no injuries reported at the time of the incident. Damage to throw rod and operating bar was identified by ATC responders. Roadway Worker In-Charge (RWIC – Unit 6015), Equipment Operator (E/O), and ROCC Radio Rail Controller were removed from service and interviewed by SAFE personnel.

Photo 3 – Shows bent operating bar

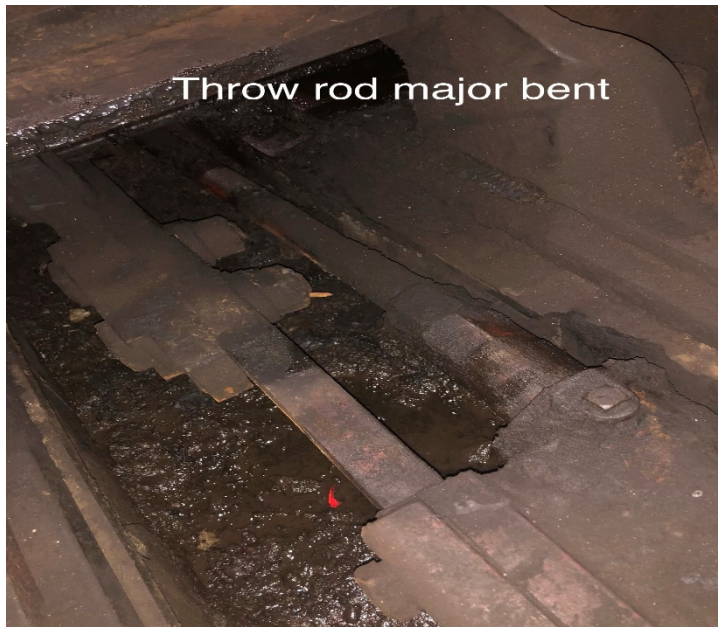
Photo 4 – Shows bent throw rod
