FINAL REPORT OF INVESTIGATION A&I E17277

RWP Event

Adopted by the Metrorail Safety Commission at its meeting on May 14, 2019.

Washington Metrorail Safety Commission
777 North Capitol Street, NE, Suite 402
Washington, DC 20002

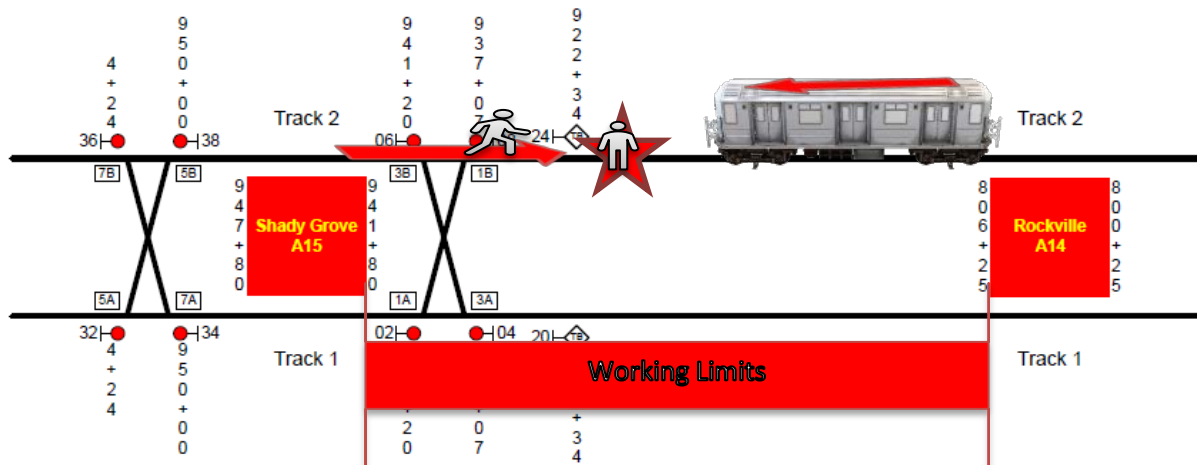
Field Sketch/Schematics

Between A15 and A14 at CM A2 916+20

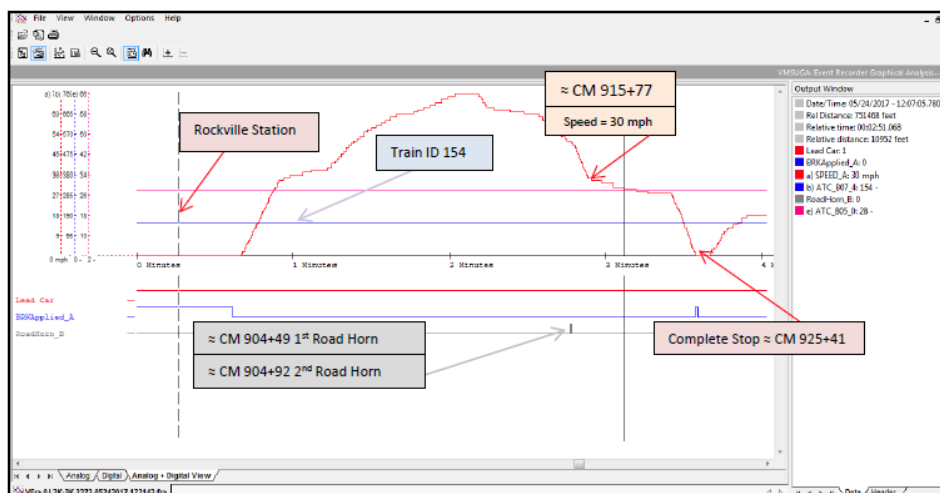
Per CENV analysis, The T/O sounded the horn approx. 1200ft prior to the location of the workers (CM A2-916+20). The speed of the train at CM 915+77 was 30 mph, which correlates with (redacted name) calculation of 25 mph at CM 916+20
