FINAL REPORT OF INVESTIGATION A&I E18159

April 23, 2018
Collision with Object

Adopted by the Metrorail Safety Commission at its meeting on June 11, 2019.

| Location: | Minnesota Avenue Rail Station (D-09) |

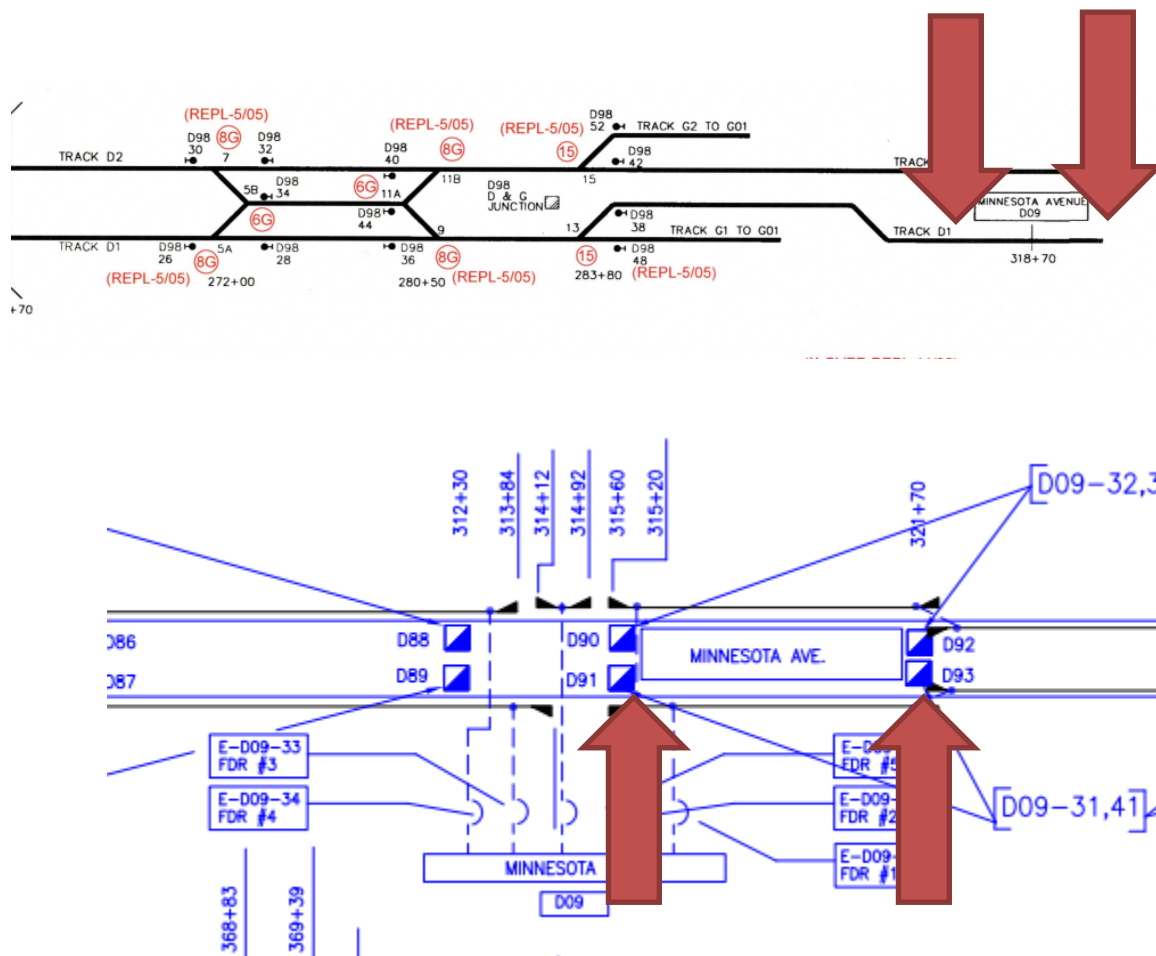
Field Sketch/Schematics

Minnesota Avenue Rail Station (D09) – Track 1 - Outbound

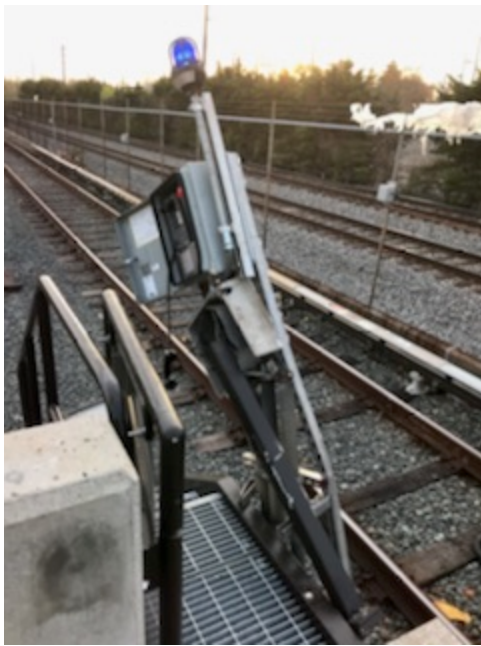
Photo 1 - ETS Box D93

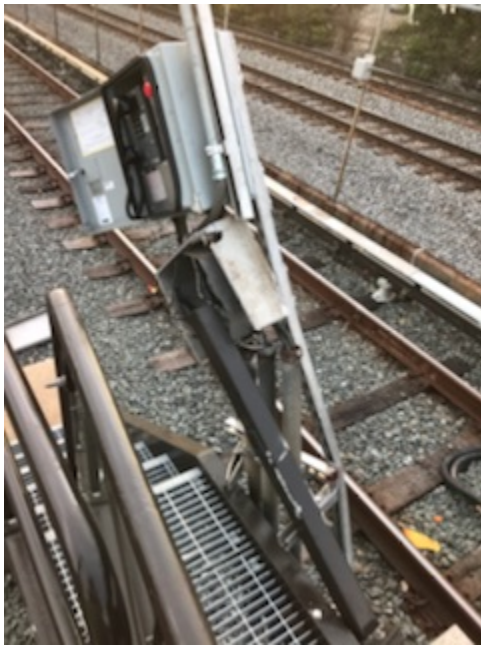
Photo 2 - ETS Box D93

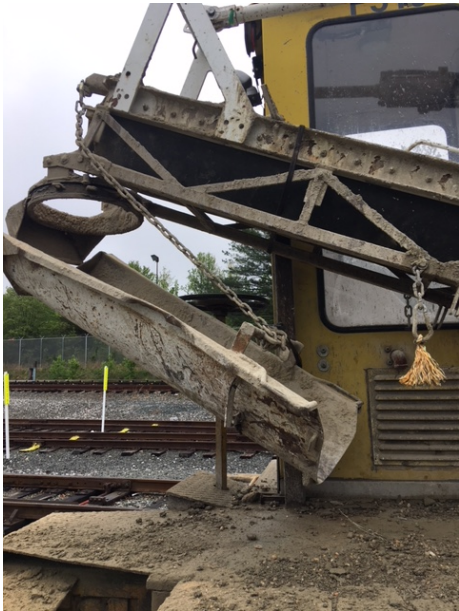
Photo 3 -Damaged Chute Secured

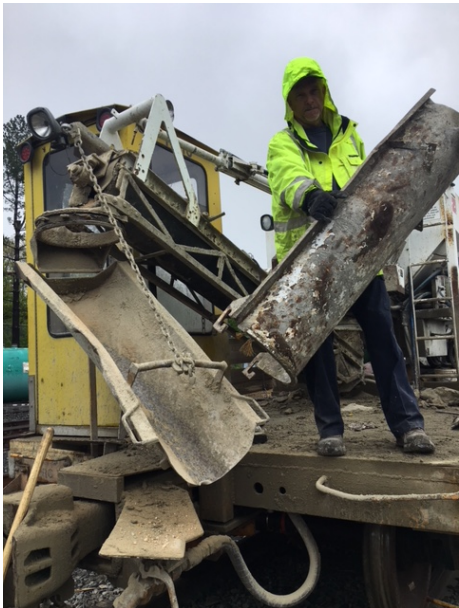
Photo 4- Second Section of Chute Damaged

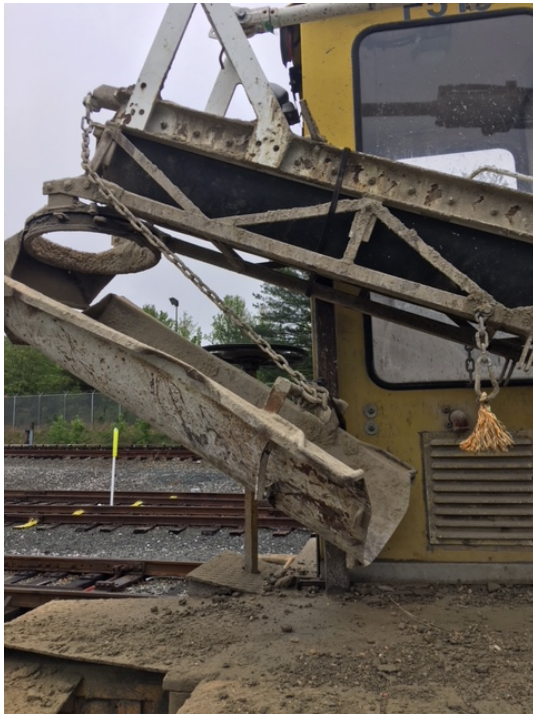
Photo 5 - Damaged Chute
