FINAL REPORT OF INVESTIGATION A&I E19090

February 18, 2019

Customer Fatality

Greenbelt Station (E10), Track 1

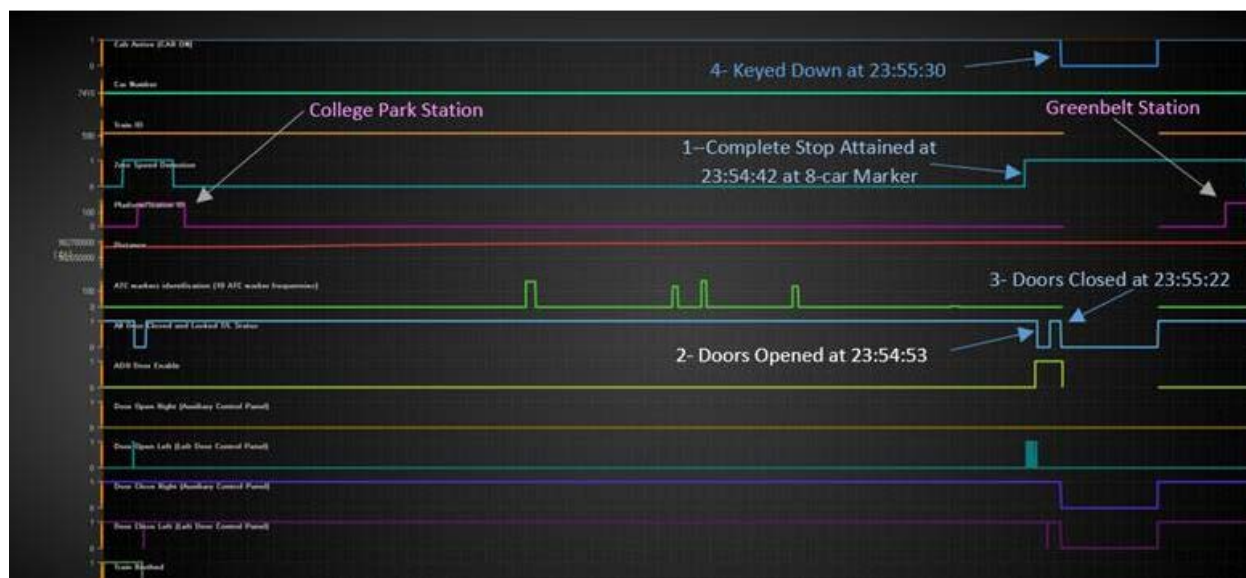
Illustration 1

1. Train ID 591 arrived at Greenbelt Station at 23:54:42
2. The left side doors were commanded open at 23:54:53
3. Doors were commanded close at 23:55:17 and All Doors closed was attained at 23:55:22
4. Lead Car 7410 was keyed down at 23:55:30.

Furthermore, there was no data to support there were any anomalies with the train that may have contributed to this incident.

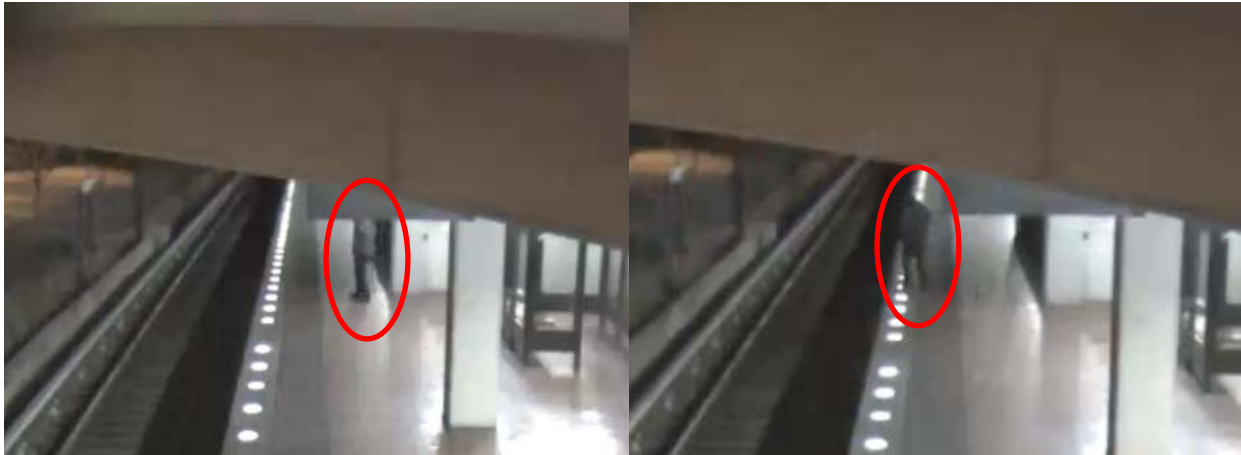
Photo 1 - Time: 23:05:19 hrs., Customer moves towards Track 1

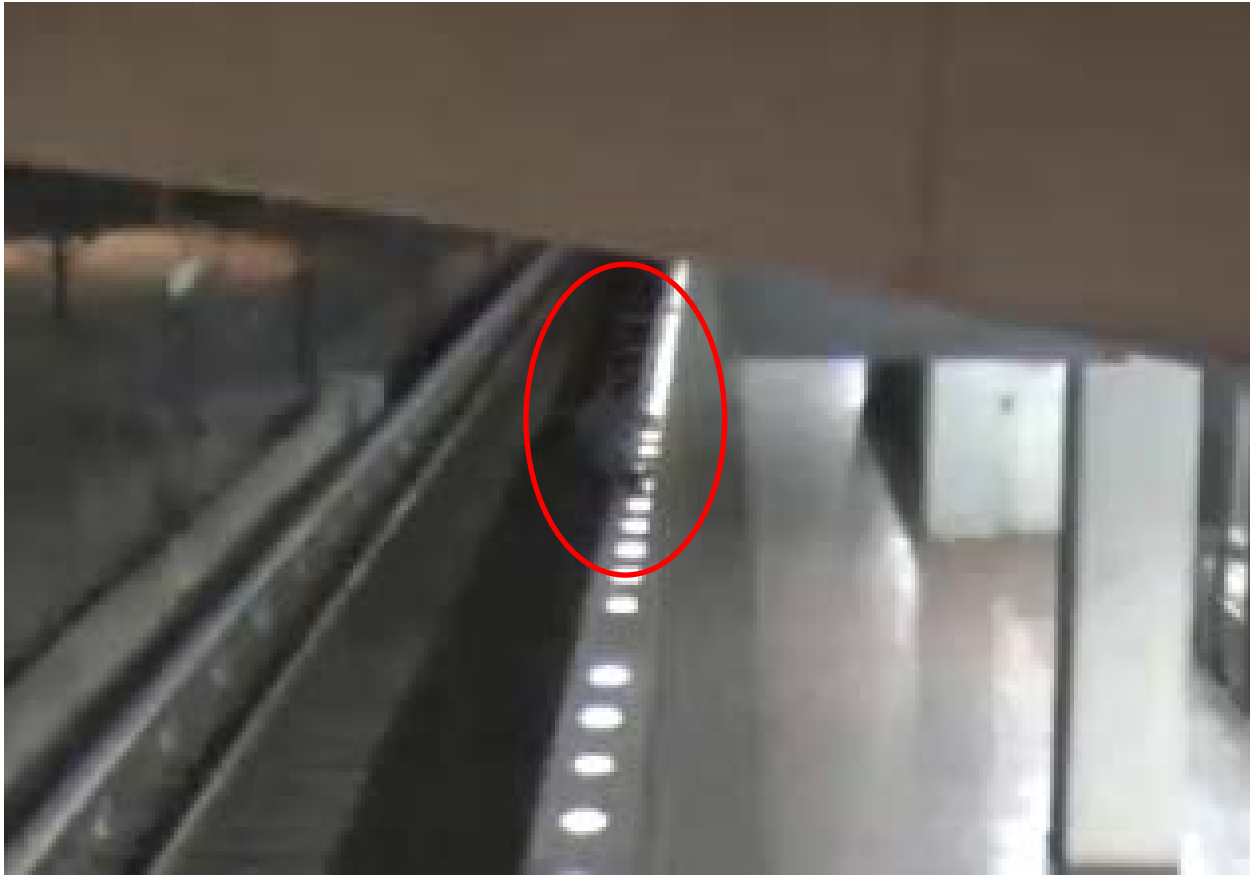
Based on the salient facts, SAFE concludes based on platform video review, the customer appeared to be unsteady on his feet while positioned close to the platform edge and subsequently fell into the roadway before being struck by Train ID 591, Lead Car 7410. Station's CCTV and Car 7410 Forward Facing Camera did not display a human form on the roadway after the customer fell onto the roadway. It is most probable that the customer was positioned under the platform in the area of refuge that was not within CCTV camera view; however, fouling the dynamic envelope of the train when Train ID 591 entered the station limits.

Photo 2 - Time: 23:05:35 hrs., Customer falling off the platform and falls onto the roadway on Track 1 at the Greenbelt Station (E10).

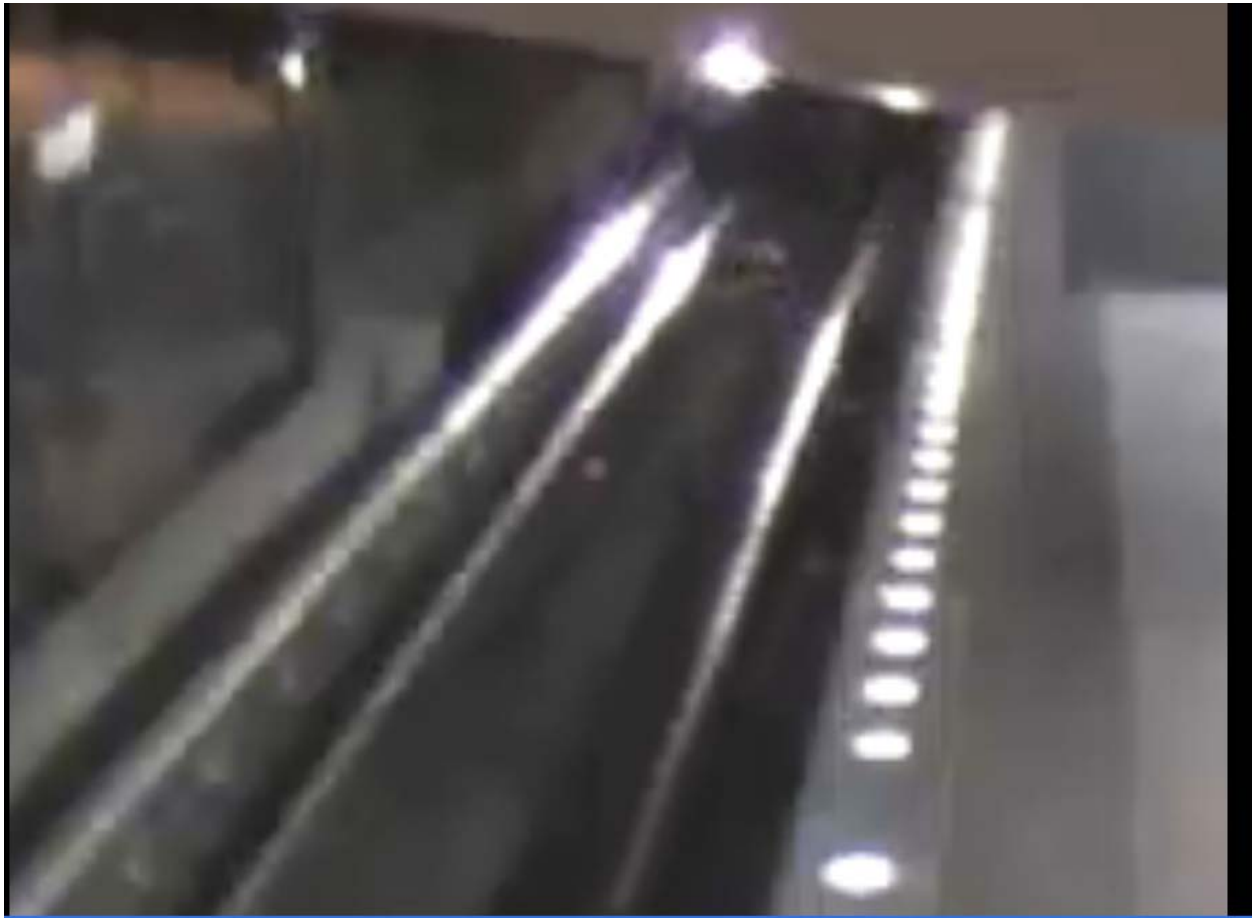
Based on review of the front facing camera review from Lead Car 7410, it was not apparent that a body was on the roadway as the train entered the station. **Note:** See photos 5,6 and 7 below. Additionally, platform video did not display the customer on the roadway after the fall and as Train ID 591 arrived at the station (see photo 3).

Photo 3 – Train ID 591 arriving at 23:54:26 hrs.,

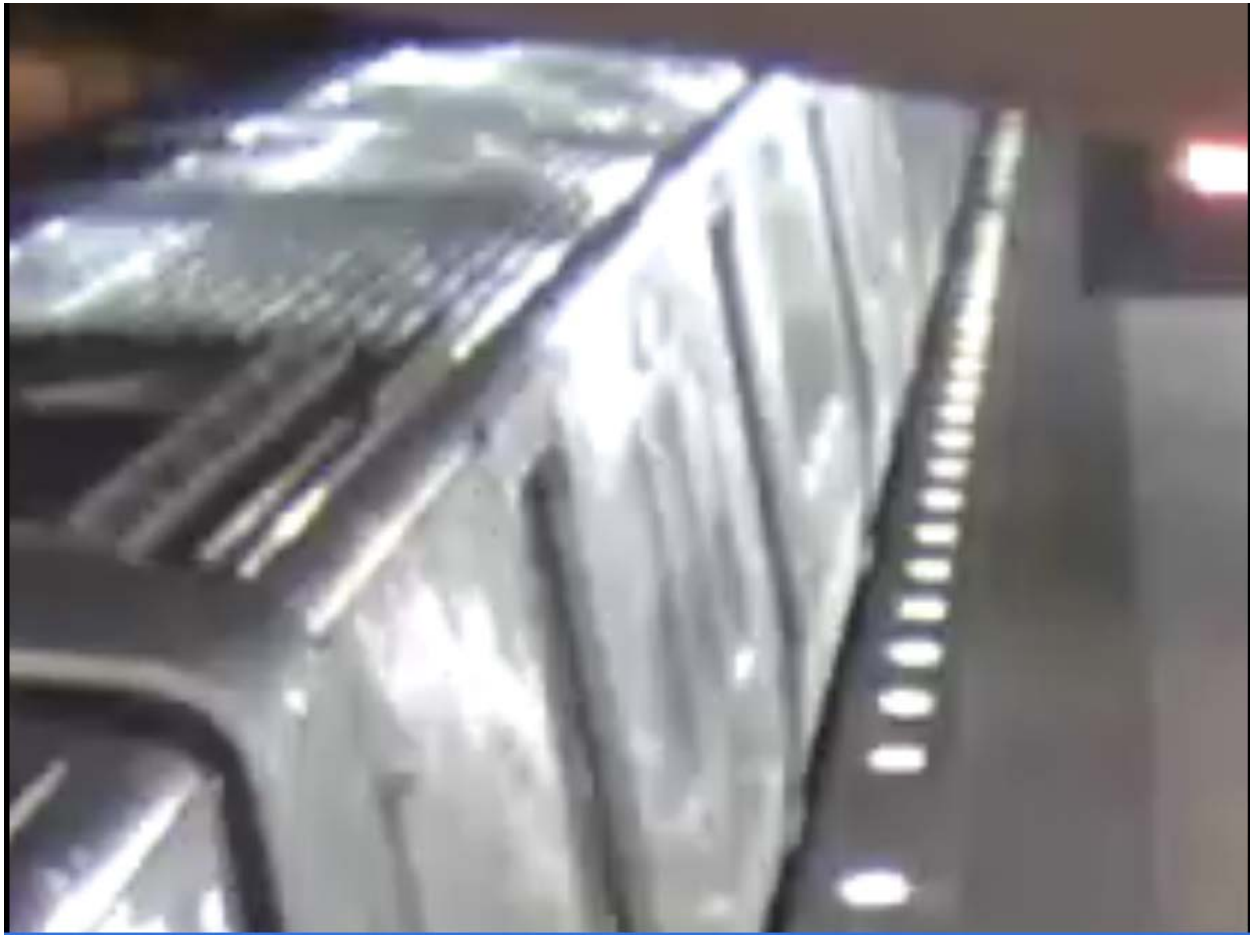
Photo 4 – Train ID 591 arrived at 23:54:48 hrs.,

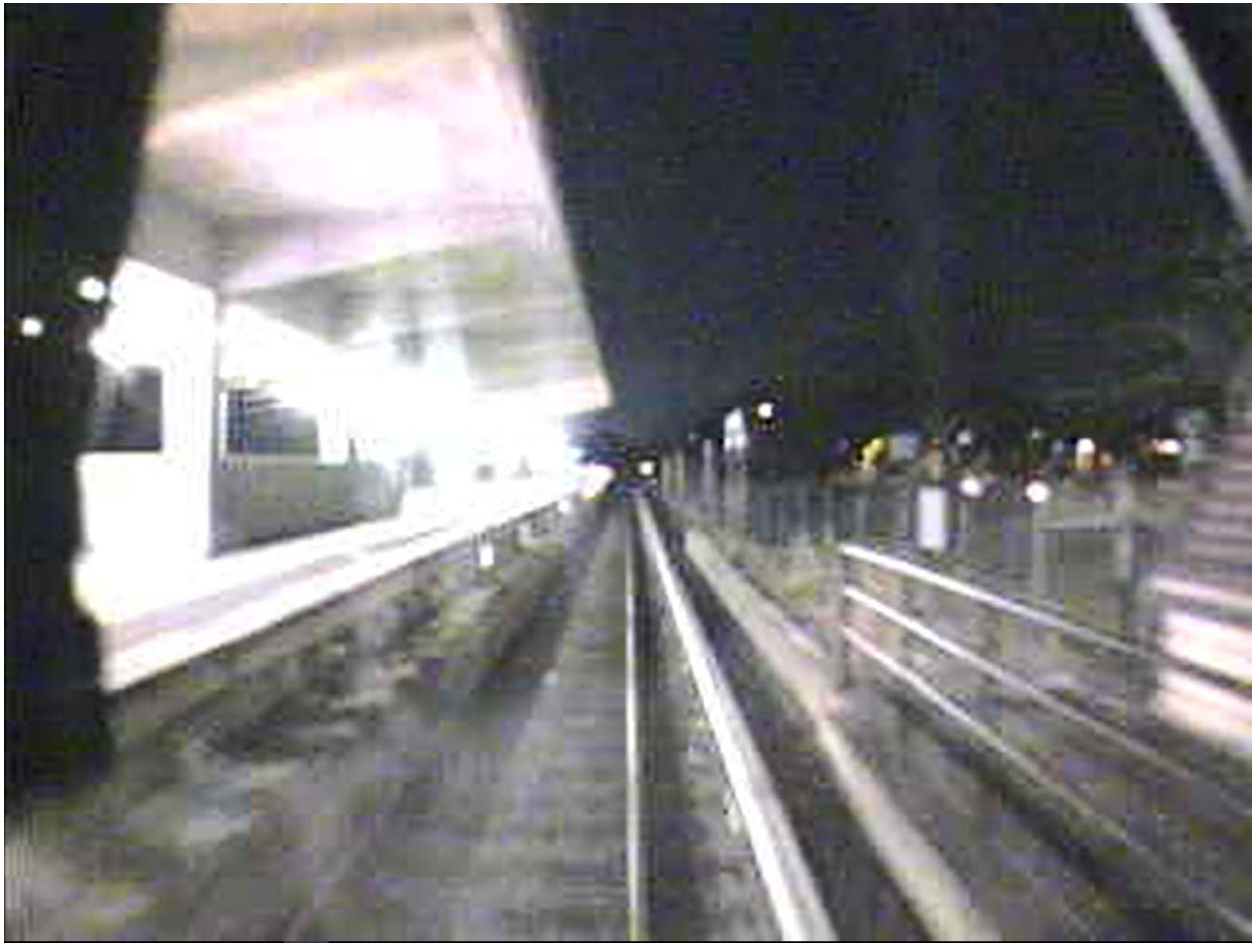
Photo 5 – Forward facing camera view of the approximate area where customer fell onto the roadway.

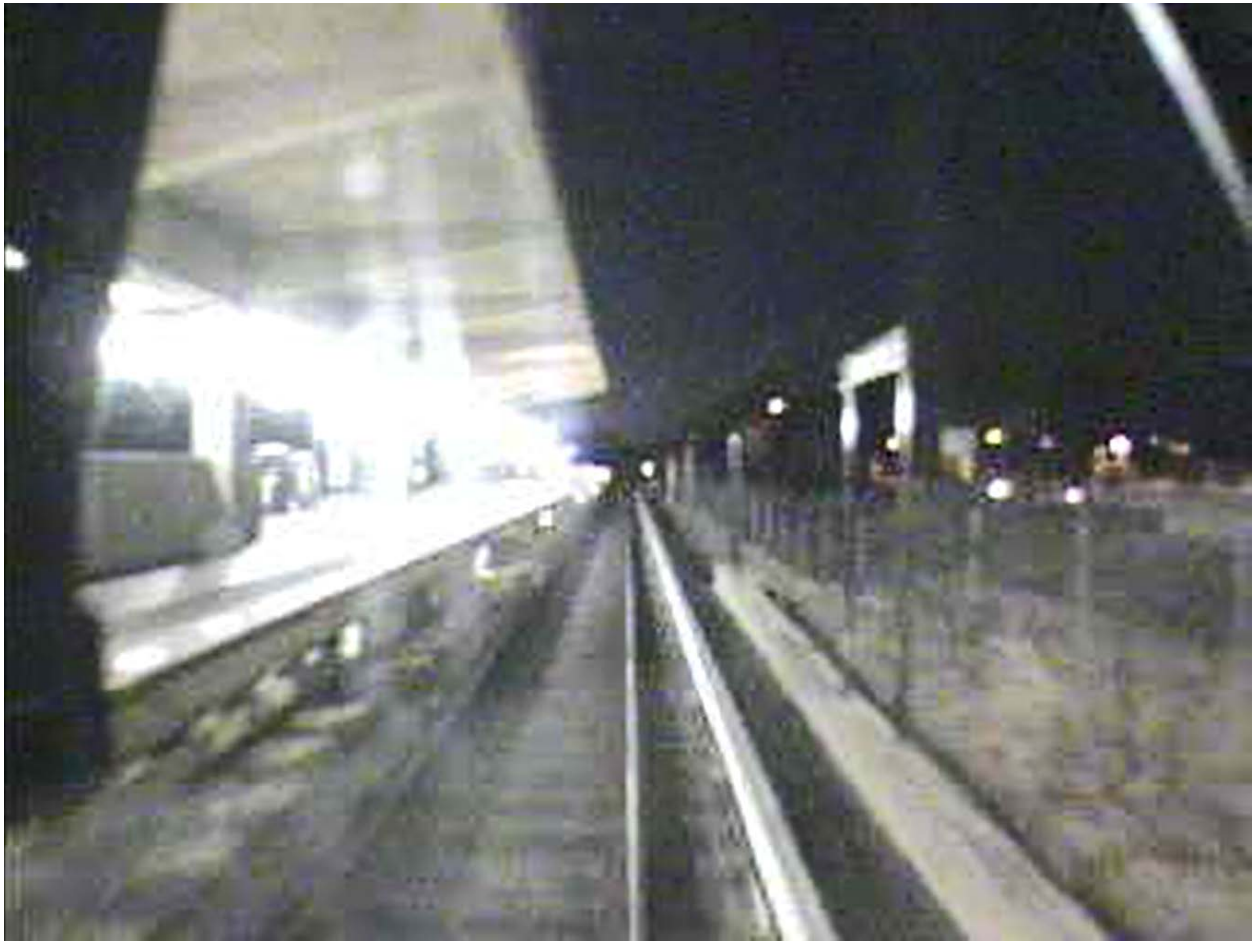
Photo 6 – Forward facing camera view of the approximate area where customer fell onto the roadway.

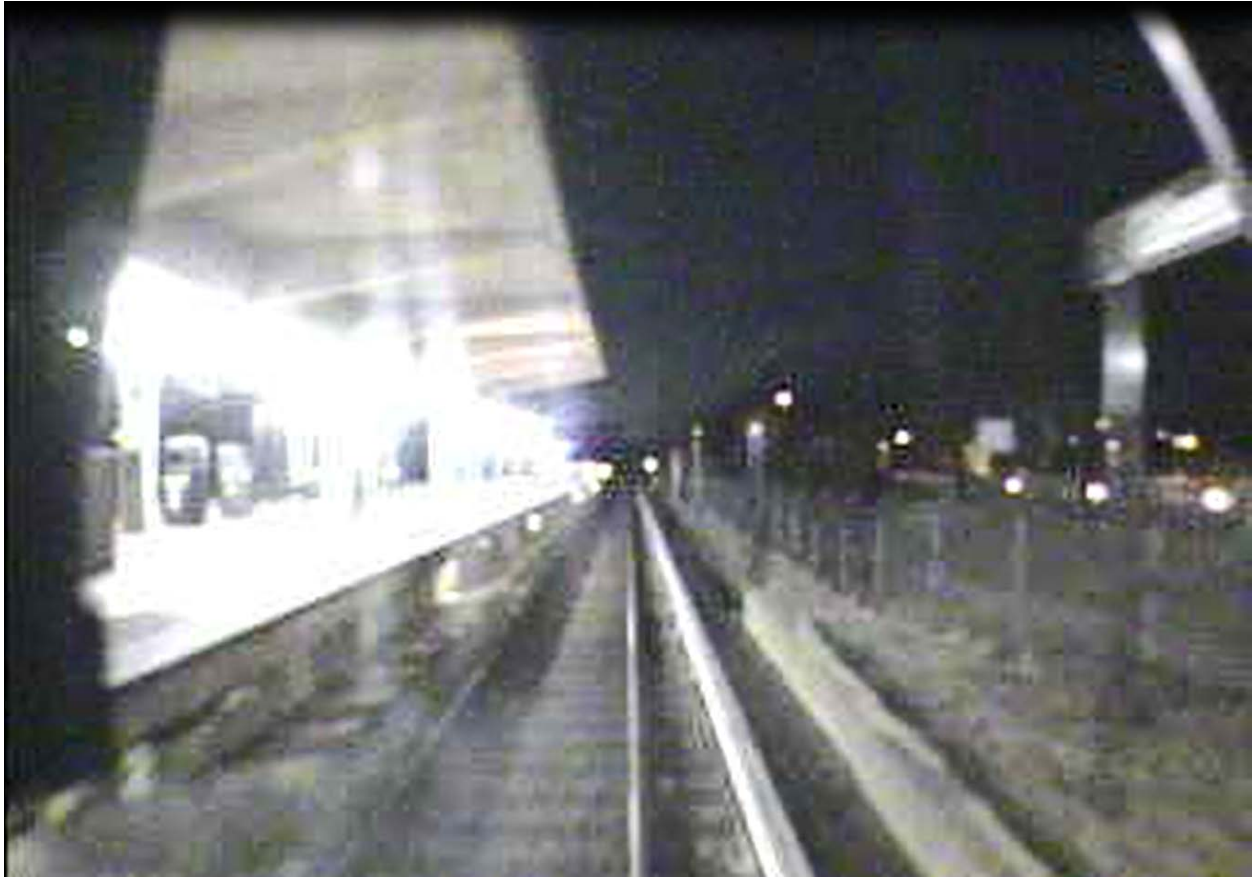
Photo 7 – Forward facing camera view of the approximate area where customer fell onto the roadway.

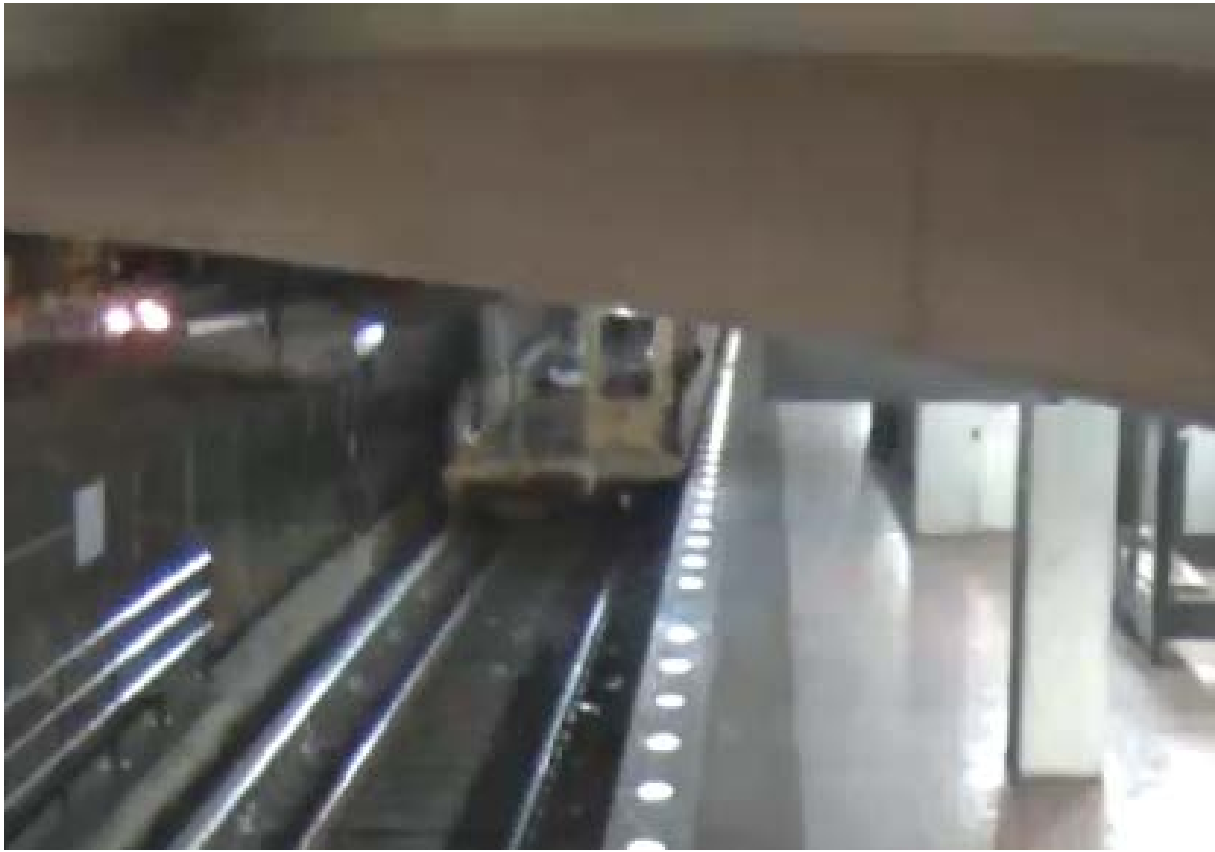
There were two TRST units that returned to Greenbelt yard via Greenbelt Station, Track 1. The first unit went through the station at 05:14 hrs., and the second unit which subsequently notified ROCC of what appeared to be the body on the roadway at 05:21 hrs.

Photo 8 – Prime Mover (PM) arriving on February 19, 2019 at 05:14 hrs.

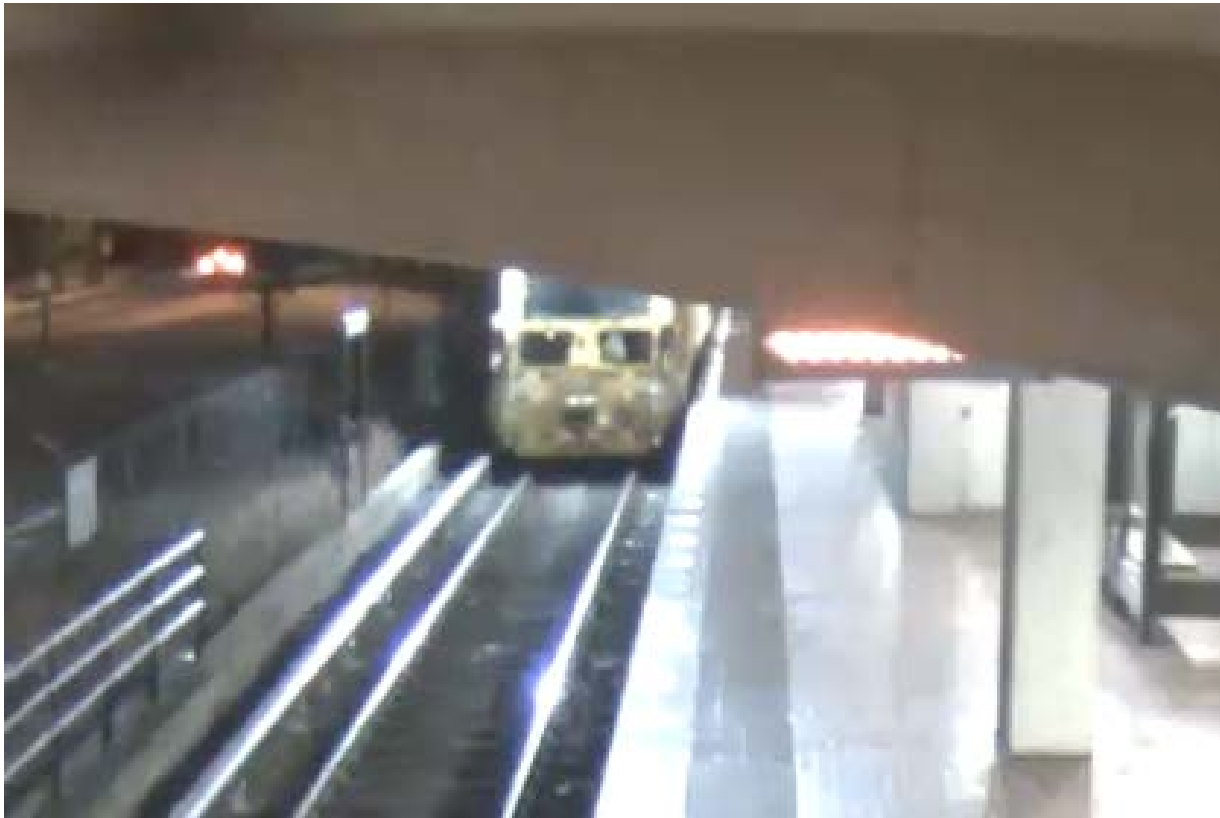
Photo 9 – Prime Mover (PM) arriving on February 19, 2019 at 05:21 hrs.
