FINAL REPORT OF INVESTIGATION A&I E18365
August 23, 2018
Derailment

FINAL REPORT OF INVESTIGATION A&I E18365**SMS 20180823#73715**

Date of Event:	8/23/2018
Type of Event:	Derailment
Incident Time:	01:35 hrs.
Location:	National Airport Rail Station (C10)
Time and How received by SAFE:	01:36 hrs., On-call Phone
Safety Officer Response:	Yes
Time of Safety Officer Arrival:	02:10 hrs.
Time of Safety Officer Departure:	04:00 hrs.
Rail Vehicle:	Hi-Rail Unit-M1699
Injuries:	None
Damage:	None
Emergency Responders:	MTPD, SAFE, TRST, ATC, CTEM

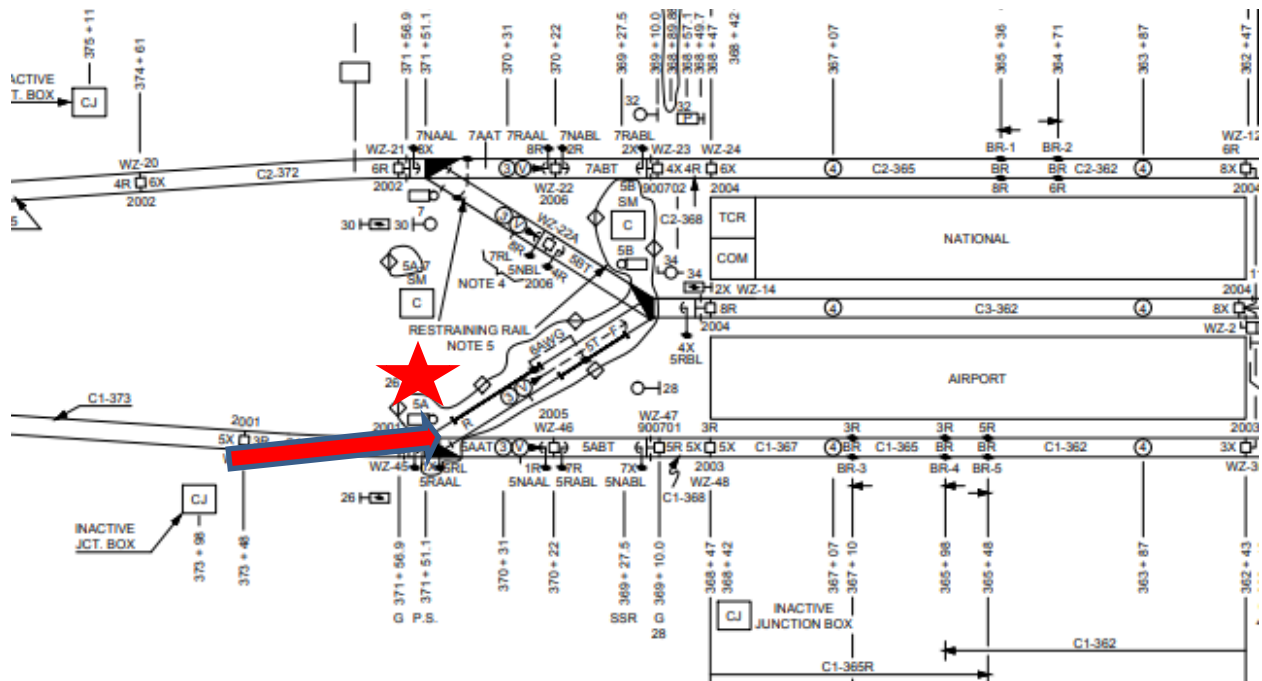
Field Sketch/Schematics

The incident area was located at Chain Marker (CM) C1-370+00. The area is described as a:

- Tangent to Spiral Area
- Direct fixation track
- Restricted view: curve as defined in Roadway Access Guide
- Inbound train movement

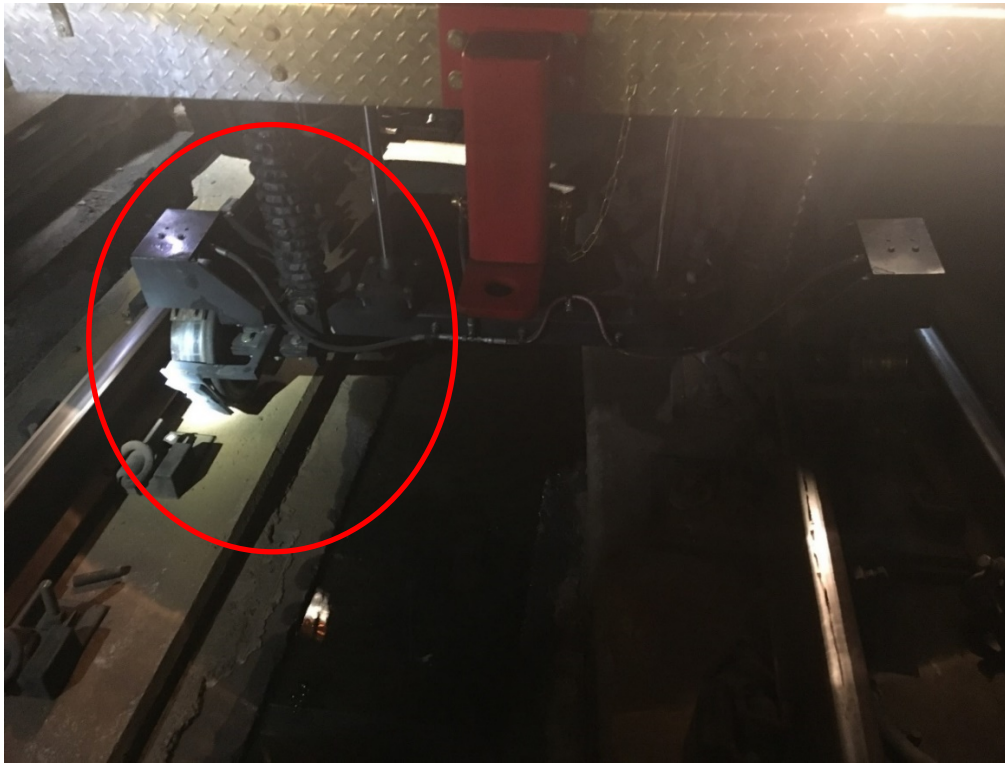
Considering all the salient facts, SAFE has concluded that this event was a result of Unit-M1699's front piston rod on the Hi-Rail gear not being fully engaged. This allowed the rubber tire of Track Hi-Rail Unit-M1699 to ride on top of the rail and caused the fixed Hi-Rail system to derail. Track and Structures (TRST) stopped usage of Contractor Track Hi-Rail Unit-M1699 and it has since been removed from Washington Metropolitan Area Transit Authority (WMATA) system.

1. SAFE concurs with the TRST findings and has concluded that the root cause of this incident is that the unit front piston rod on the Hi-Rail gear was not fully engaged. See Attachment 1.
2. The above condition allowed the rubber tire of Track Hi-Rail Unit-M1699 to ride on top of the rail and caused the fixed Hi-Rail system to lose contact with the running rail as it traversed C10, Switch 5.

Photo 1 – Unit-M1699 Derailed at CM C1-370+00

1. TRST shall take the appropriate action deemed necessary to support prevention of repeated recurrence.
 - a. **TRST stopped usage of Contractor Track Hi-Rail Unit-M1699 and has since been removed from WMATA's system.**

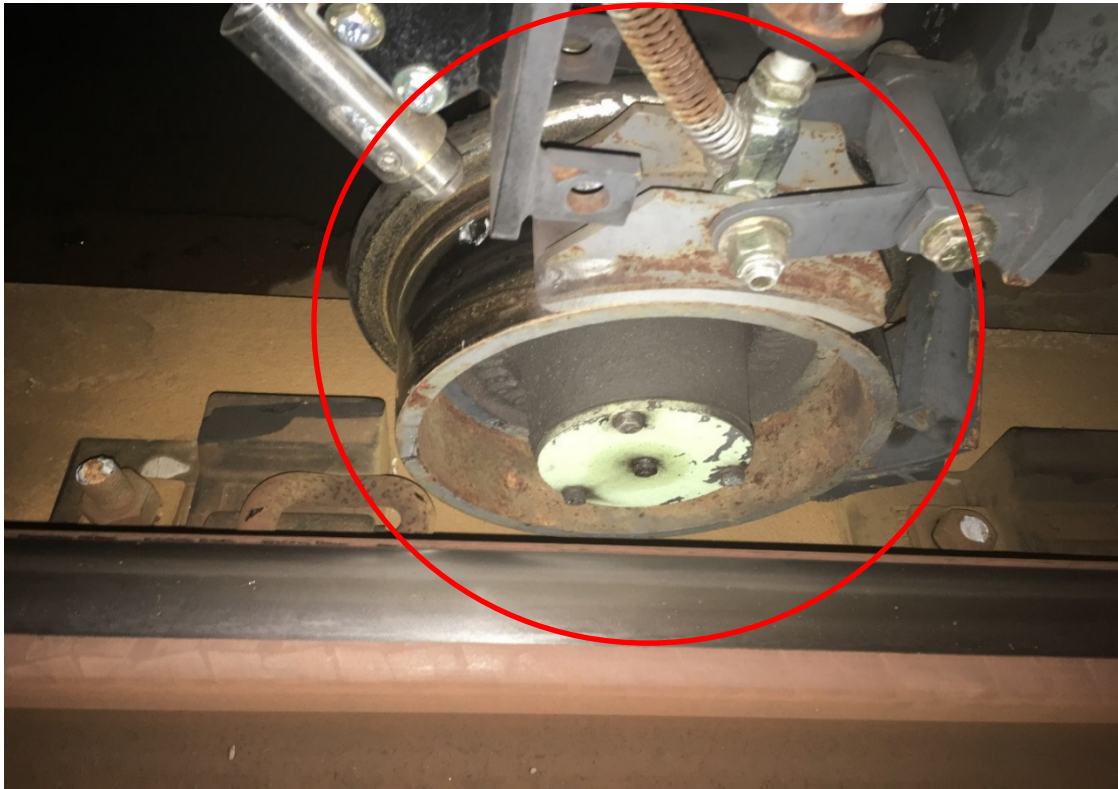
- CTEM inspected Track Unit-M1699, the unit front piston rod on the Hi-Rail gear was not fully engaged.

Photo 2 - Right Front Truck Derailed Gauge Side

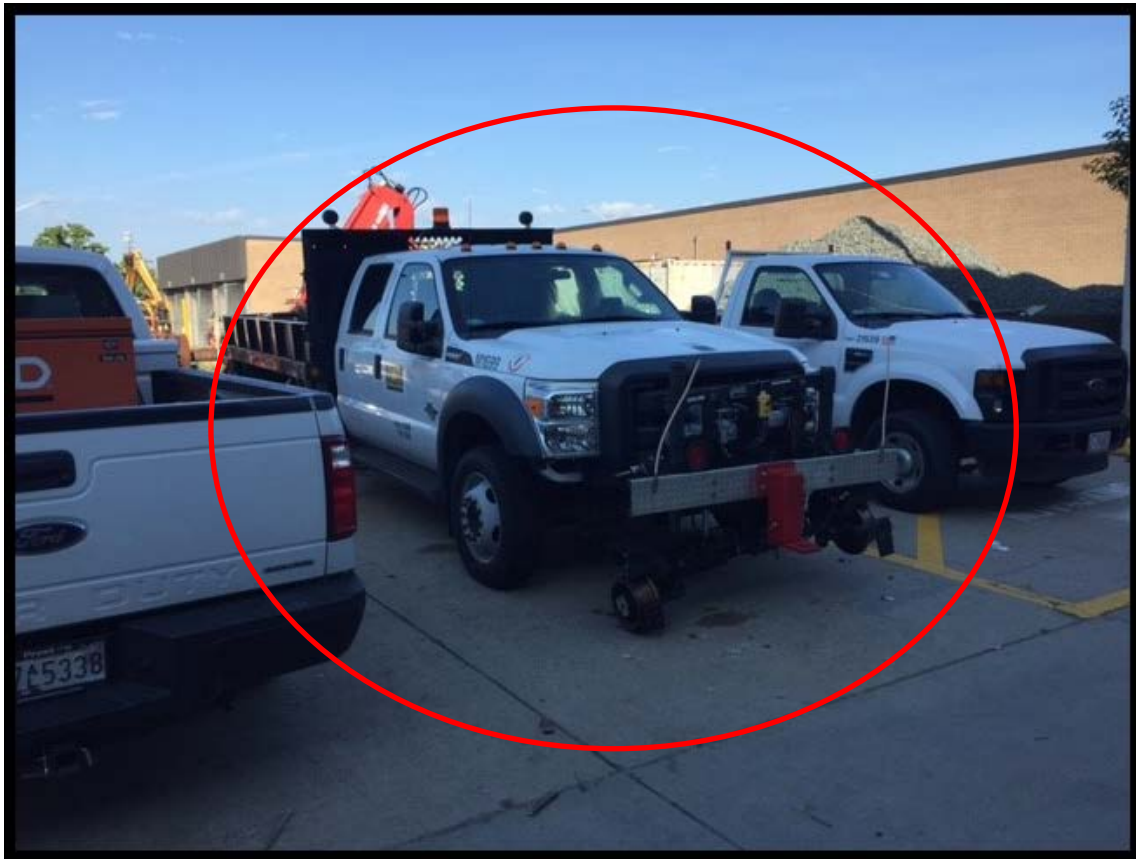
Photo 3 - Hi-Rail Vehicle Unit-M1699 has been removed from WMATA system.
