FINAL REPORT OF INVESTIGATION A&I E18368

August 25, 2018

Train Pull Apart

FINAL REPORT OF INVESTIGATION A&I E18368**SMS 20180825#73780MX**

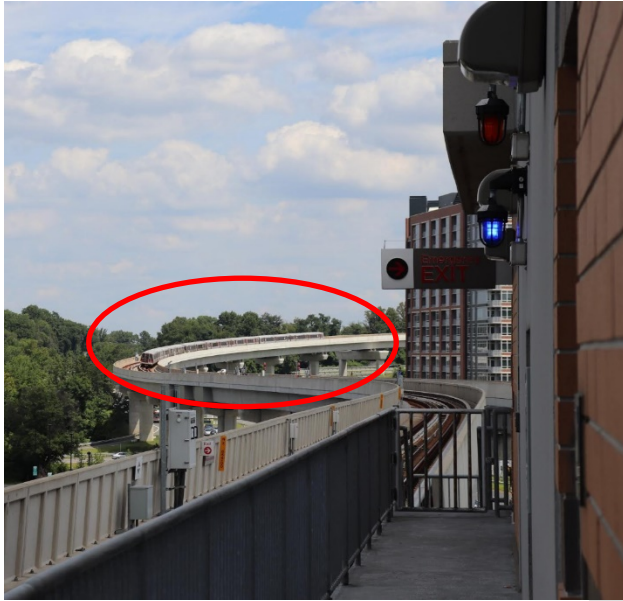
Photo 1 – Train ID 604 final rest point, CM N1-633+00

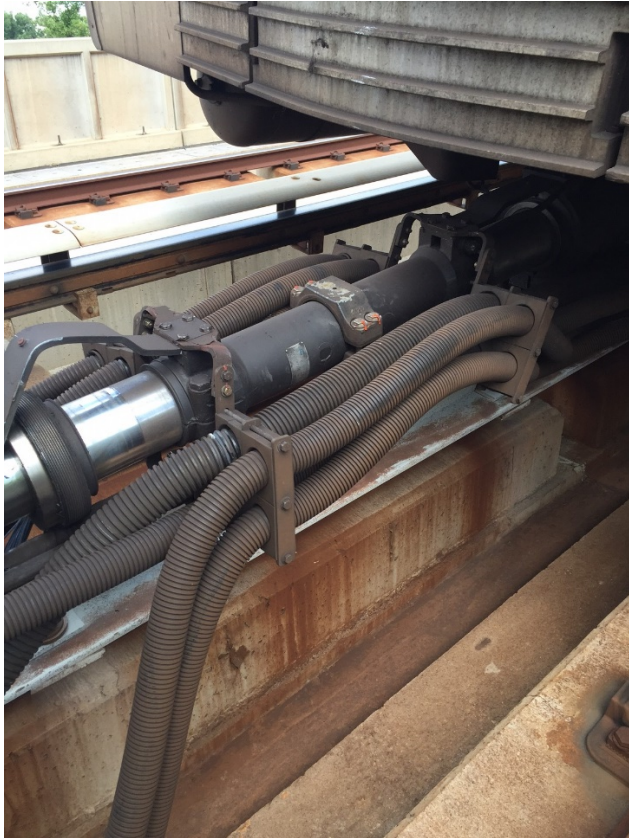
Photo 2 – Car 6039 Semi-Permanent Drawbar

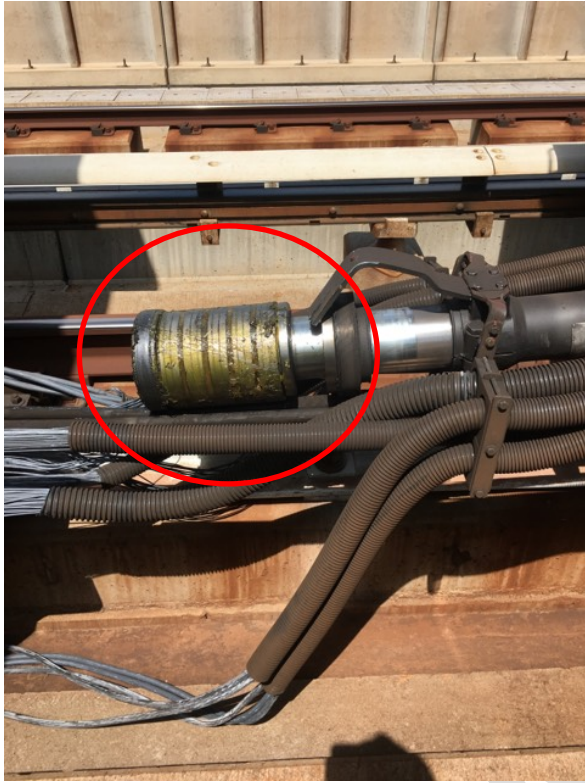
Photo 3 – Car 6039 Friction Spring

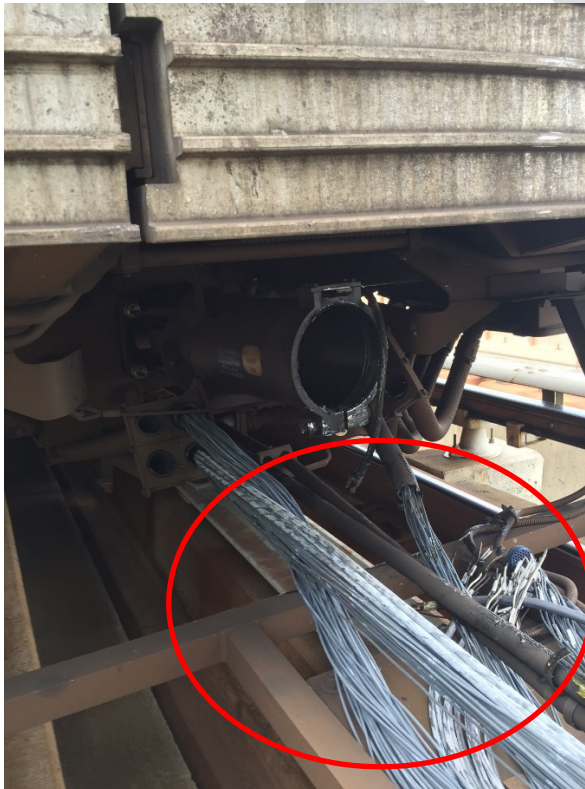
Photo 4 – Car 6038 Trainline Wiring Damage

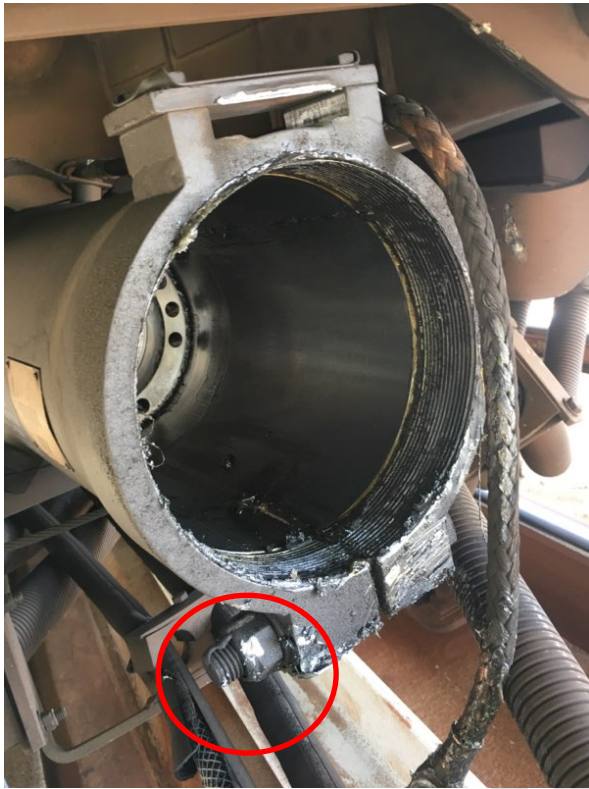
Photo 5 – Car 6038 Buffer Tube Screw torque strip moved

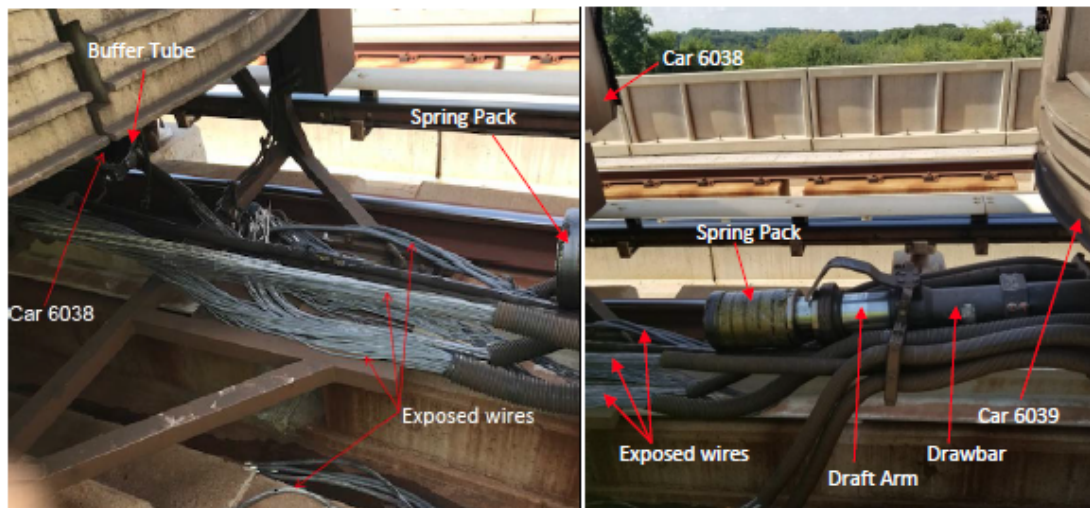
Figure 1a – Car 6038 - View of pull apart (Buffer Tube and exposed car to car wire)

Figure 1b – Car 6039 – View of pull apart (Exposed car to car wire, Spring Pack & Drawbar)

10. The car to car jumper wire support, mounted on 6039's drawbar was damaged, (Fig 4).
11. Some of the car to car jumper wires were ripped apart (Fig. 1)

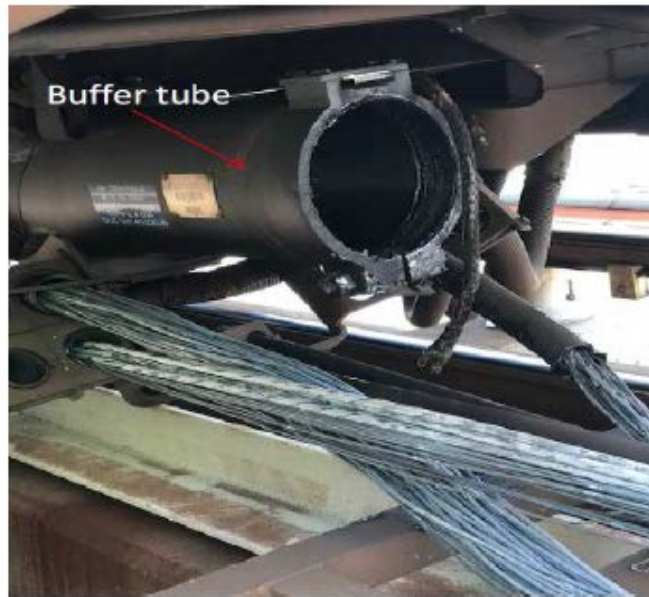
Figure 2 – Buffer tube (Car 6038)

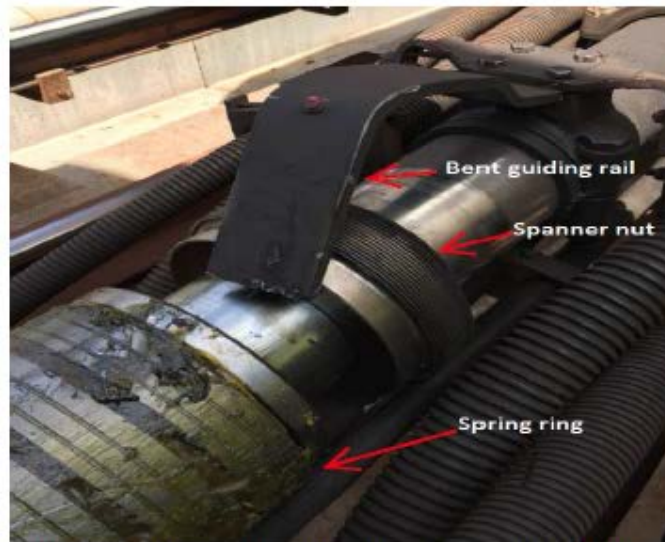
Figure 3 – Bent guiding rail and Ring spring (Car 6039)

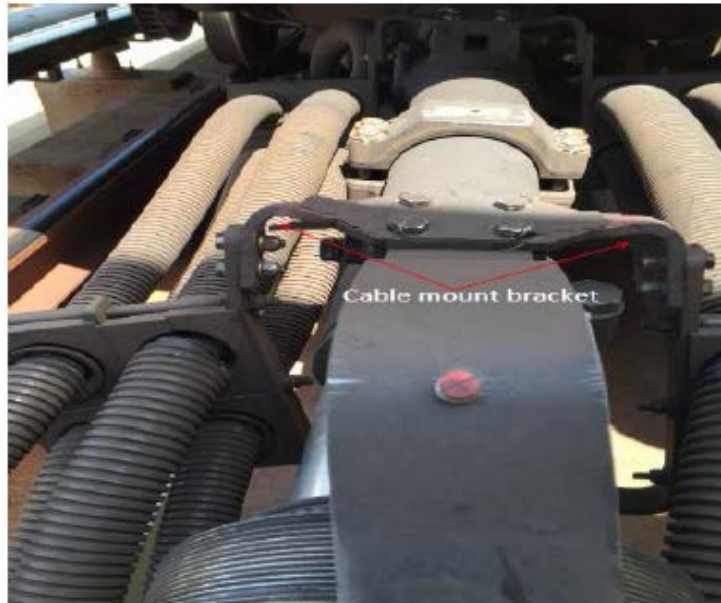
Figure 4 – Damaged Upper cable mount bracket (Car 6039)

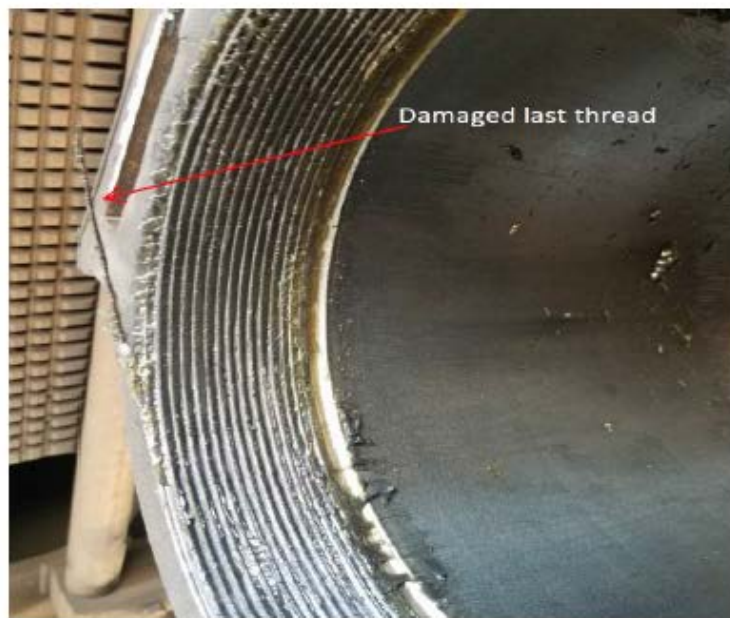
Figure 5 – Only last thread was damaged on Buffer tube (Car 6038)

6. The Buffer tube lock screw and nut were intact (Fig. 6).
7. The Buffer tube threads were dirty but not damaged, except for the last (outer) thread, (Fig. 5).

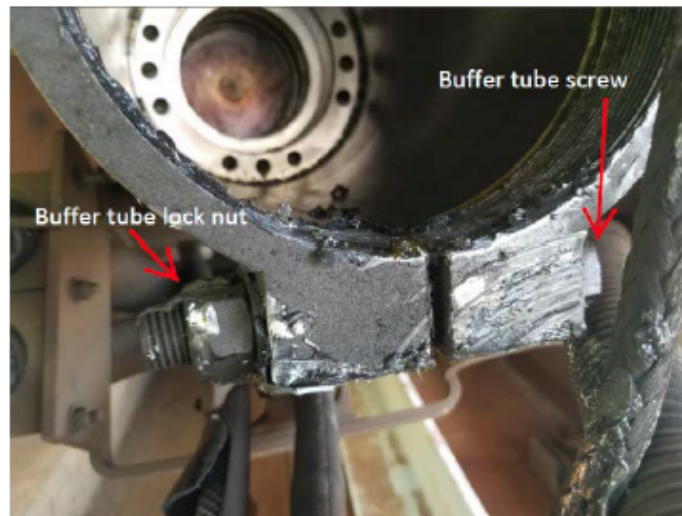
Figure 6 – Buffer tube, screw and lock nut

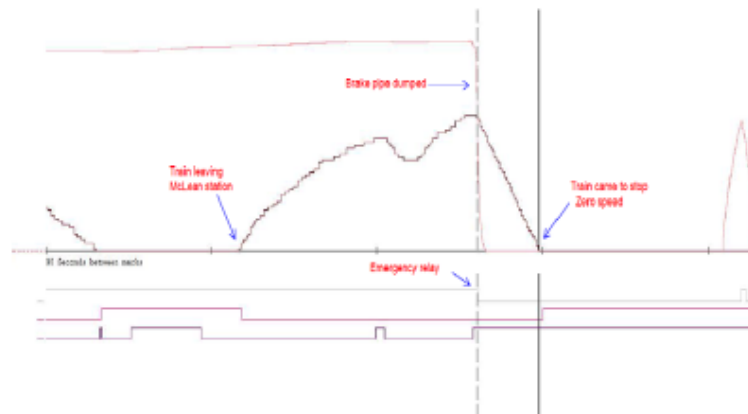
Train ID # 604 left McLean metro station on track # 1 at 10:30:15 and traveled 1867ft before dumping the brake pipe at CM636+68 at a speed of approximately 44MPH. The train travelled an additional 265ft before coming to a complete stop at Chain marker CM634+03 at 10:31:11, see figure 7

Figure 7 – Leaving McLean station, Brake Pipe Dumped – Emergency Brake applied

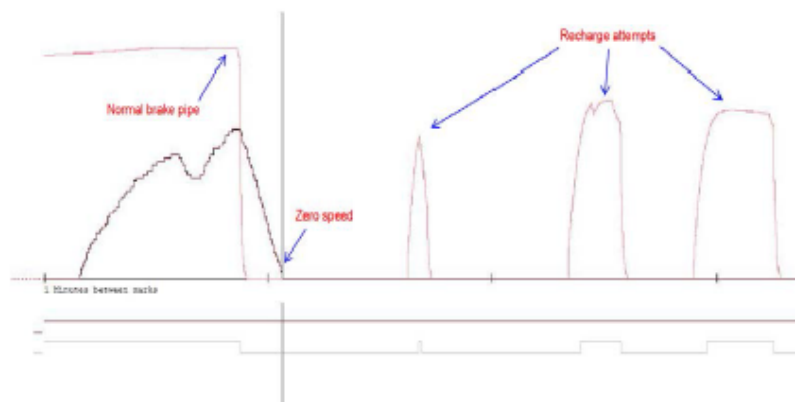
The operator attempted to recharge the pipe beginning at 10:31:43, during which the pressure reached 86.43psi, but was unable to maintain air pressure. The operator made a 2nd and a 3rd unsuccessful recharge attempt at 10:32:25 and 10:32:59 respectively, see Figure 8.

Figure 8 – Recharge attempts

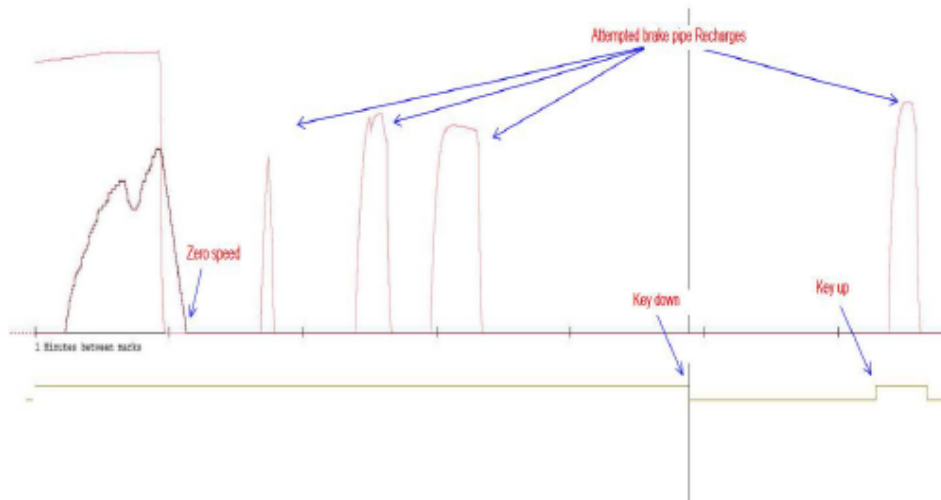
ID # 604 was keyed down at 10:34:54 then keyed back up at 10:36:18 to recharge the brake pipe one last time at 10:36:23, see Figure 9.

Figure 9 –Train key down / up and recharge

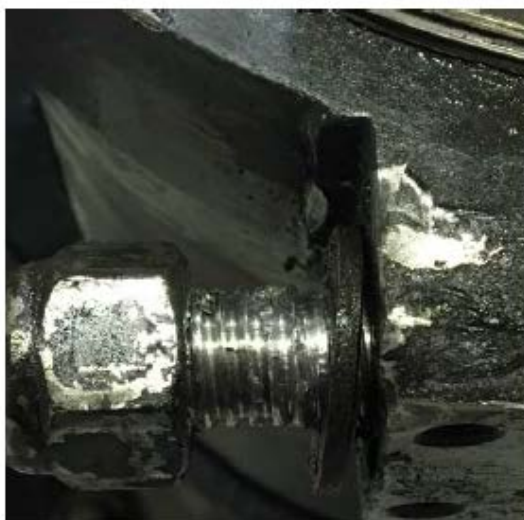
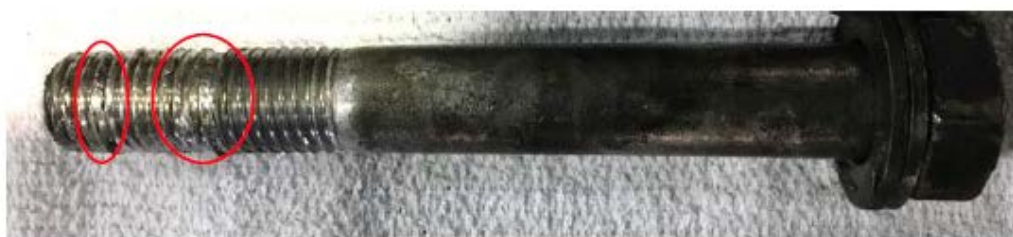
The semi-permanent coupler of 6038, the associated Buffer tube and the Drawbar/Draft bar assembly (from 6039) were removed and transported to the overhaul shop for further analysis and testing. The tube was placed in the MRO shop rebuild fixture, where the draft bar was inserted (into the Buffer tube) and the spanner nut screwed in, without loosening the Buffer Tube locking screw and nut, (Fig 10). During the next step of the testing, it was discovered that the lock screw and nut were moving freely. After removing the lock nut and screw, the screw threads were found with signs of galling which were consistent with that of a cross-threaded bolt, (Fig. 11). Although it was demonstrated that the torque of the locking screw exceeded the required 226 ft-lbs, the cross-threads provided a false reading. The false reading resulted in a torque value which was less than the required value and ultimately resulted in a reduced clamping force (of the buffer tube), which allowed the spanner nut to back out over time.

Figure 11a – Cross Threaded Buffer tube lock Screw

Figure 11b – Cross Threaded Buffer tube lock Screw

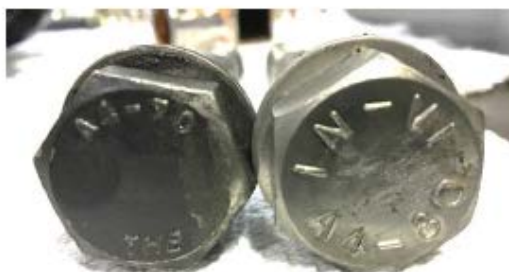
An investigation of the tube lock screw shows that the installed A4 – 70 screw (bolt) does not match any available WMATA documentation. Per OEM documentation the correct screw is A4-80 (Deller P/N: 5016020150, WMATA P/N: C18-36-6091). See Figure 12.

Incorrect A4-70 screw Correct A4-80 screw
Figure 12 – A4-70 and A4-80 Locking Screws
Page 11 of 13

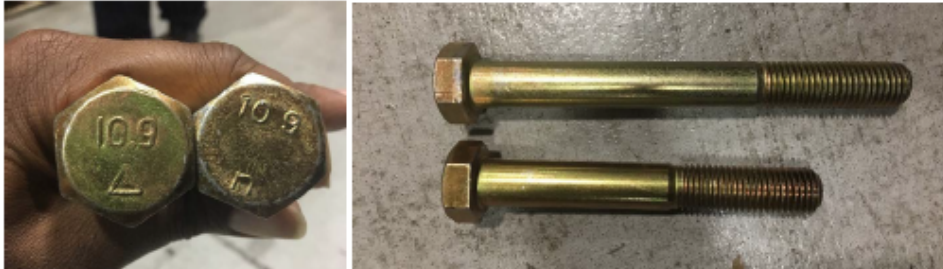
Further investigations revealed that an incorrect bolt (zinc plated, GR 10.9) was in stock under P/N: C18-36-6091. See Figure 13. This is due to an incorrect part description within Windchill.

Figure 13 – Incorrect Zinc Plated bolts. Found in stock room under C18-36-6091 (& C18-36-6051)

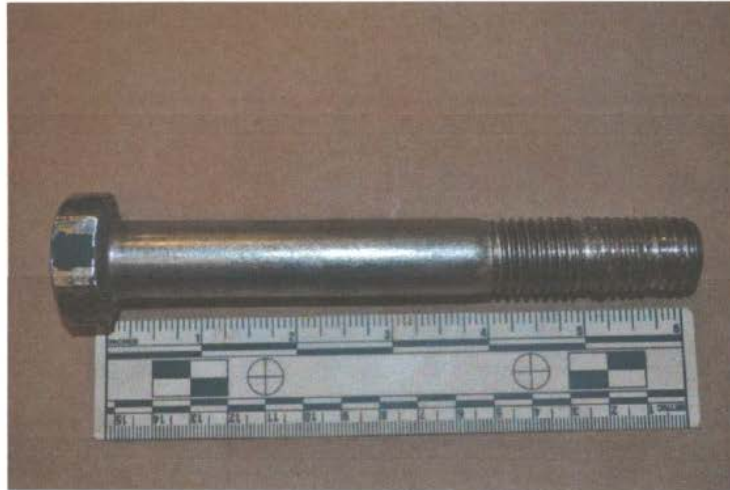
The bolt is shown as-received in Figures 1 and 2. The bolt head was marked THE and A4-70. The THE marking is the manufacturer's mark. The A4-70 indicates a stainless steel bolt of strength class 70 (cold worked 300-series stainless similar to Type 316). Checking both bolt and nut with a magnet revealed neither was magnetic. This is consistent with construction of both items from a 300-series stainless steel.

Figure 1: Overall view of submitted bolt.

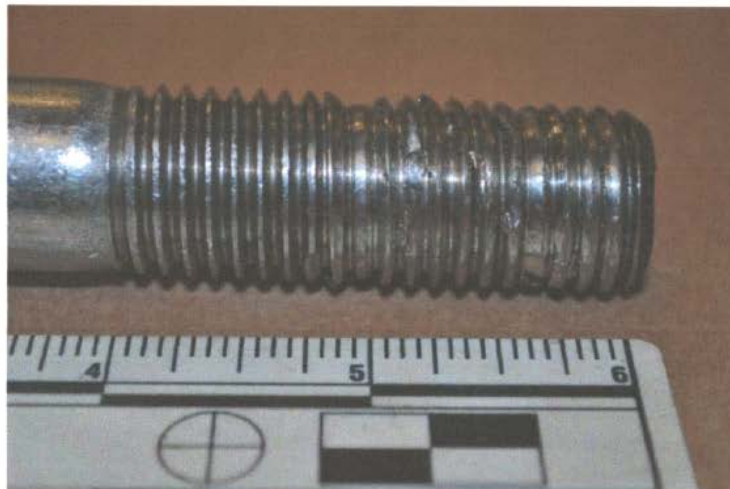
Figure 2: Overall view of thread damage on the submitted bolt.

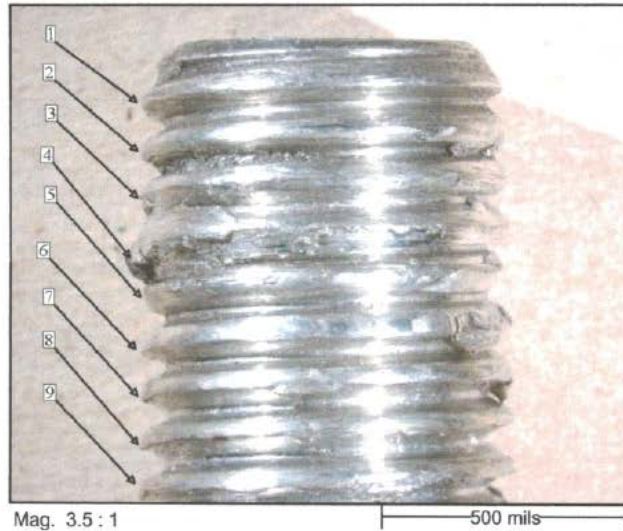
Examination of the threads of the bolt revealed severe material movement, thread shearing, and some small regions of heat tint, Figures 3 through 6. Damage to the nut threads was similar, Figure 7. Aligning the nut with the extent of the bolt thread damage revealed that over ½-inch of the bolt thread damage was visible to the installer, Figure 8. The damage to both items was consistent with galling. Type 316 and other 300-series stainless steels are known to gall readily when self-mated or similarly mated. According to the Industrial Fasteners Institute (IFI), high speed fastener installation contributes to galling due to the heat generated during such assembly. Low speed wrench can help mitigate or prevent galling, as can use of lubricants containing substantial amounts of molybdenum disulfide, graphite, mica, or talc. Some proprietary extreme pressure waxes and greases can also be used to mitigate the problem.

Figure 3: Detail of thread damage on threads 1-9, numbered from terminal end of bolt.

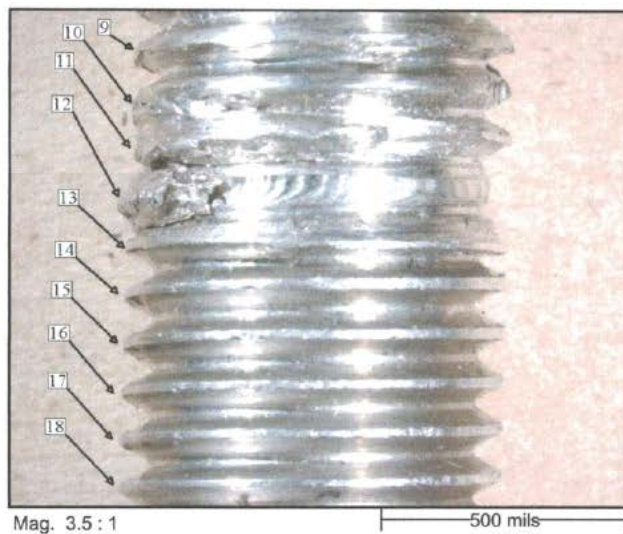
Figure 4: Detail of threads 9-18. Threads 19 and 20 were undamaged.

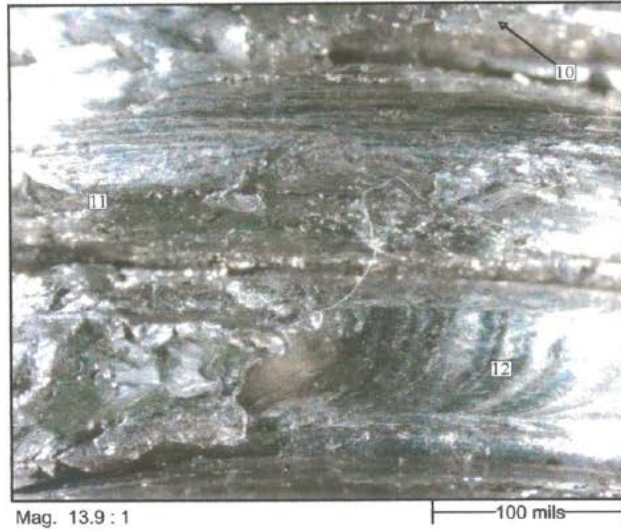
Figure 5: Higher magnification of damage to threads 10-12 showing material movement and thread shearing.

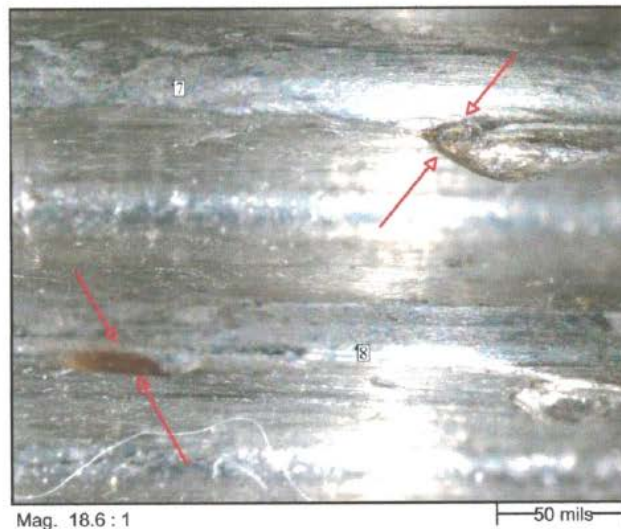
Figure 6: Heat tint on threads 7 and 8, arrows.

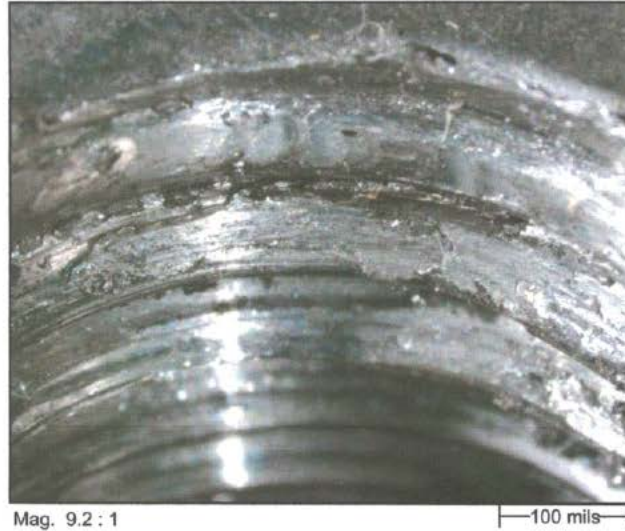
Figure 7: The nut threads were damaged in the same way as the bolt threads.

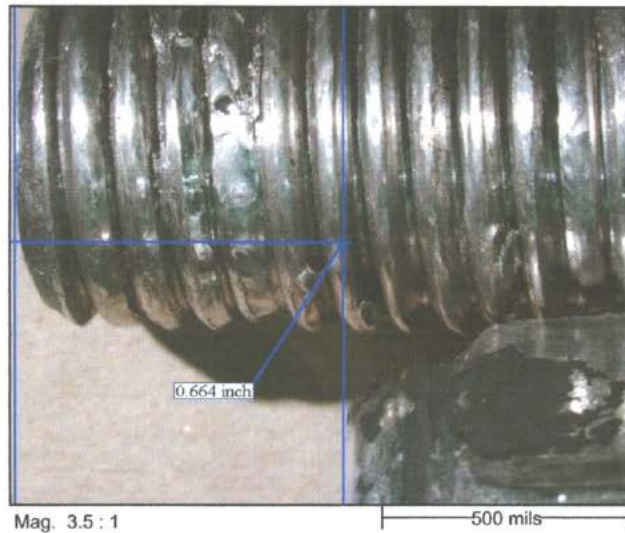
The thread damage exhibited by both bolt and nut was consistent with galling. The 300-series stainless steels are known to exhibit a propensity to gall when self-mated or similarly mated. While rolled threads can help mitigate the problem, they will not prevent it. Heat generated during the use of power equipment during installation of such fasteners can lead to severe galling and is not recommended for stainless steel fastener hardware. If power equipment must be used, lowered speeds are necessary, and may still lead to galling without use of lubrication. Note that use of lubrication can lead to over-torquing of fastener assemblies. The damage observed precluded the need for chemical analysis, mechanical testing, or metallurgical examination.

Figure 8: With nut placed at damaged terminus, over 1/2-inch of thread damage is visible.
