FINAL REPORT OF INVESTIGATION A&I E16203

Collision

Adopted by the Metrorail Safety Commission at its meeting on April 8, 2019.

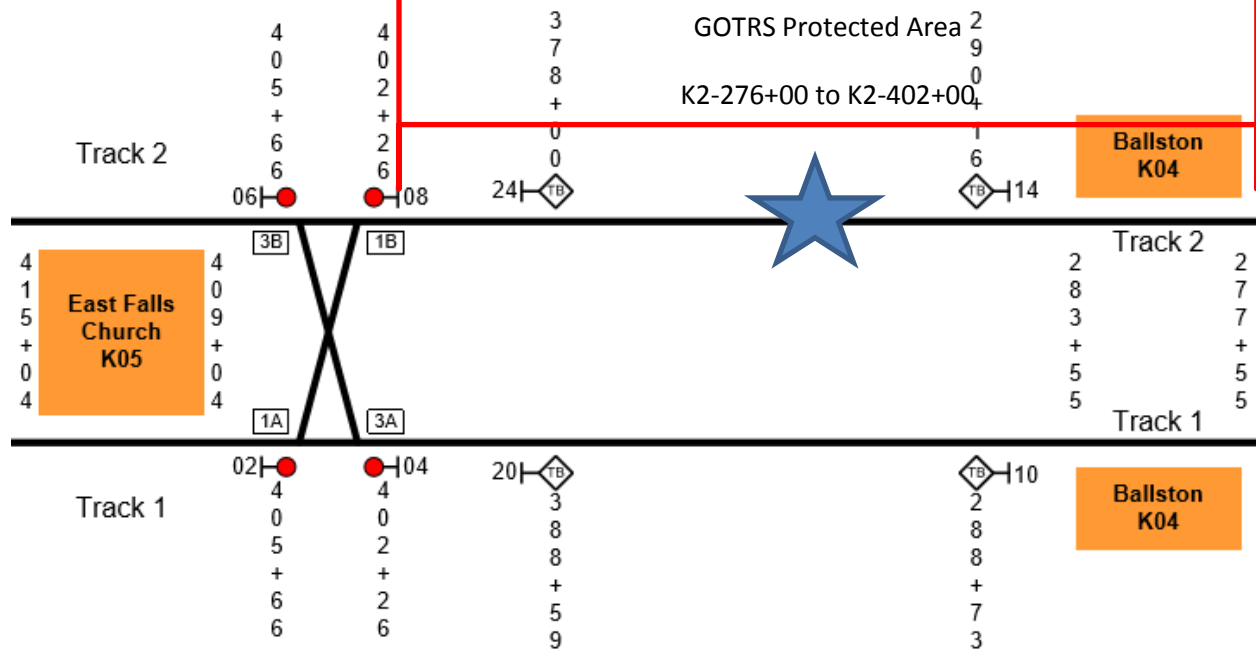
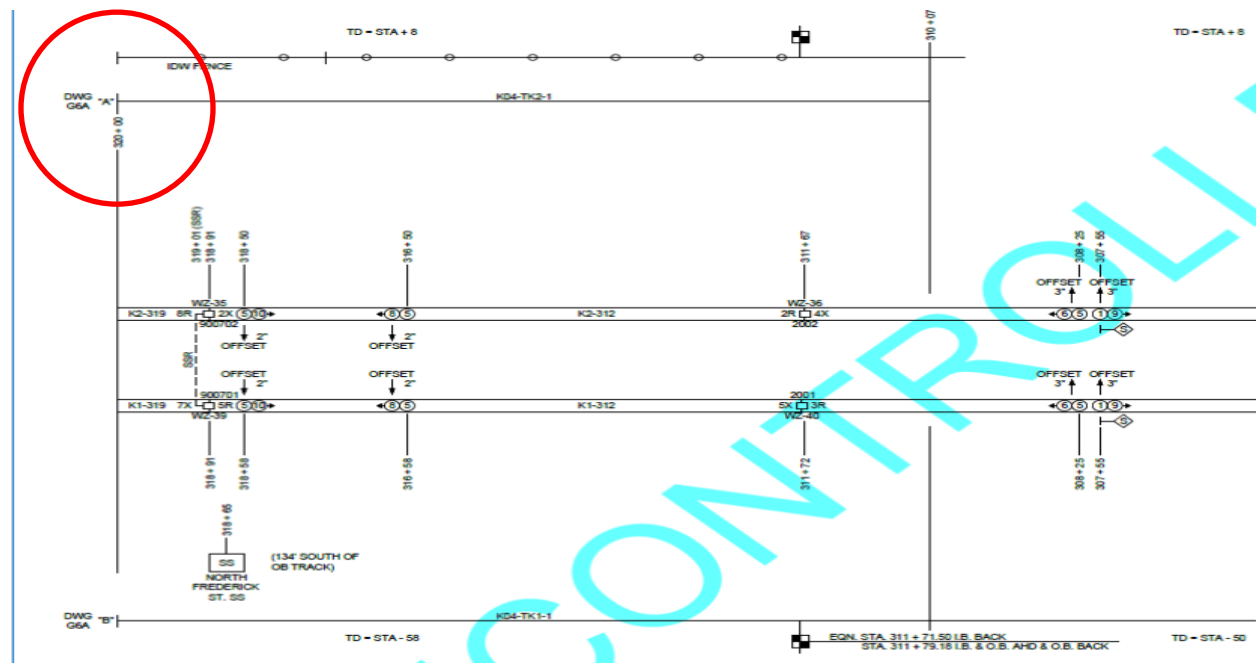
IDW location

Based on the MOC summary report for July 18, 2018, a Track Supervisor responding to the work zone reported finding a damaged cable associated with the IDW on Track 2, CM K2-320+00. Track Supervisor reported track vehicle #802, a tie crane, while working in the area more than likely, damaged the IDW cable located on the fence line separating the WMATA right of way from I-66 roadway. MOC notified Automatic Train Control (ATC) personnel and dispatched the group to repair the damaged cable. Upon ATC arrival an assessment was performed of the damaged equipment. The entire IDW Box required replacement. The IDW cable was reinstalled to the box, the alarm was reset and the IDW system for this area was placed back in service. SAFE was informed of the damage to the cable/fence and Work order #12860253 was generated. (See attachment 1).

Based on the salient facts, it is most probable that the tie crane made contact with the IDW box while positioning the ties along the fence line. SAFE has no further actions on this matter and recommends E16203 for closure.

- An investigation was performed by ATC personnel who responded to the reported damage identified by Track Supervisor
- The IDW cable was repaired by ATC personnel.
