FINAL REPORT OF INVESTIGATION A&I E18442

October 15, 2018
Greenbelt Yard Collision

Washington Metrorail Safety Commission
777 North Capitol Street, NE, Suite 402
Washington, DC 20002

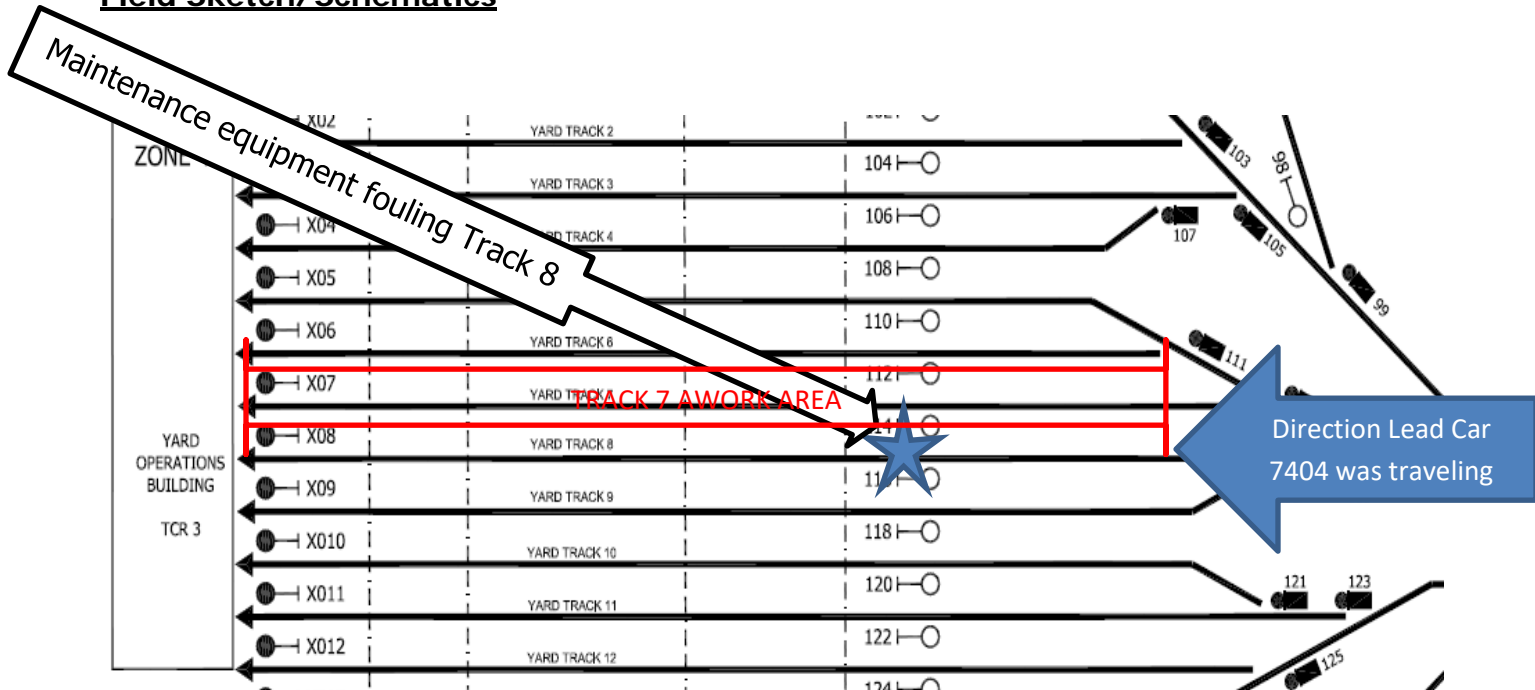
Field Sketch/Schematics

Greenbelt Yard Track 8

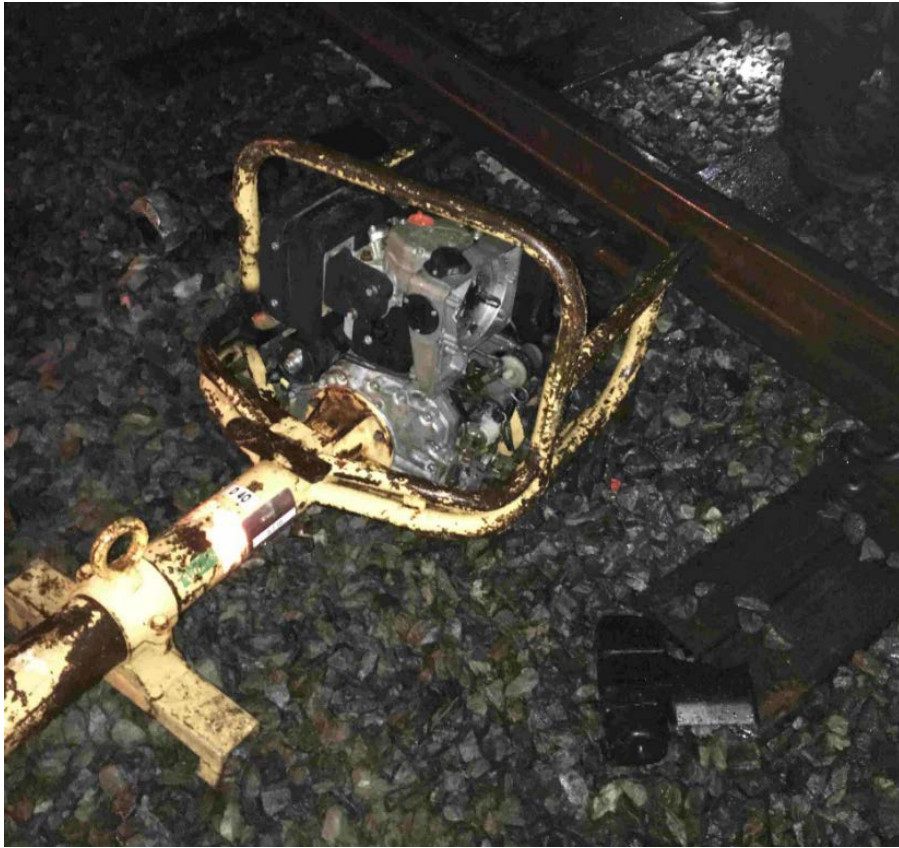
On October 14, 2018, at approximately 23:50 hrs., the T/O on Non-Revenue consist L7404-05x7412-13x7328-29x7356-57T was instructed by the Greenbelt Tower I/O to store train on Yard Track 8. After receiving a lead to yard Track 8, the train made contact with a rail tie and a Geismar Torque Wrench which were improperly stored during a prior maintenance activity on Track 7 and were fouling Track 8. The T/O reported stopping the train after hearing a loud bang. The T/O notified the I/O that the train was unable to clear the track and the T/O requested to reverse ends and store the consist on another track. As a result of this minor collision with the fixed object, the train sustained damage to the Collector Shoe Assembly on car 7404 and damage to the Air Spring Cut-Out Valve on car 7412.

Photo 1 - Geismar Torque Wrench

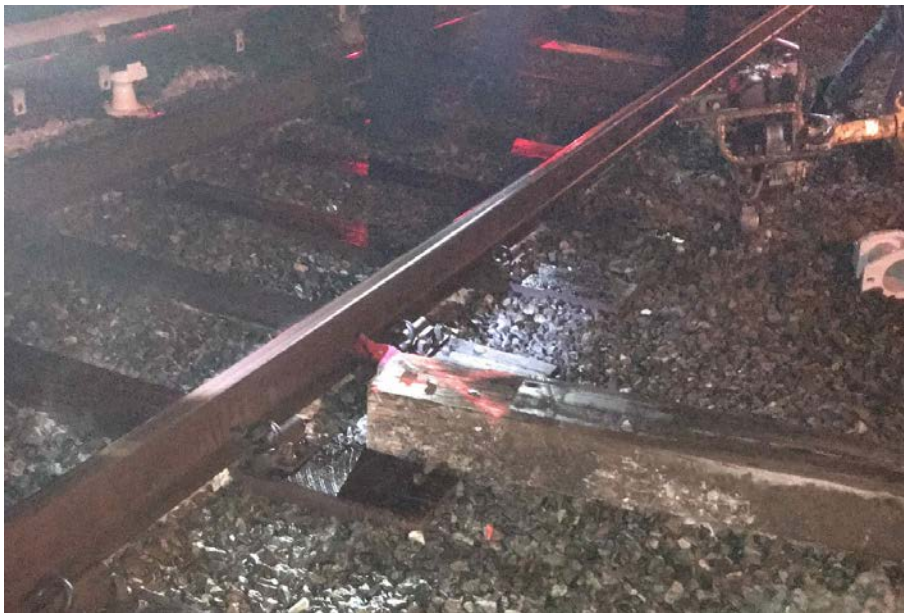
Photo 2 - Rail Tie

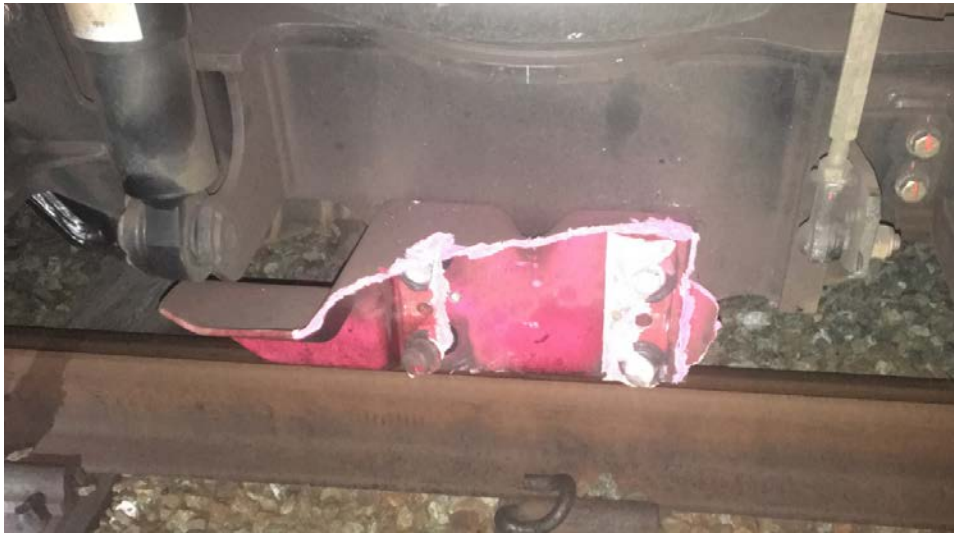
10 VERIFIED COLLECTOR SHOE ASSEMBLY #1 HAS SUSTAINED INTENSIVES DAMAGES.REPLACED COLLECTOR SHOE ASSEMBLY AND SHORT CABLE.(PARTS FROM TRUCK SHOP)

Photo 3 – Damaged Collector Shoe Assembly

Remarks: VERIFIED FAILURE, R/R COLLECTOR ASY. & POWER CABLE, TORQUED & STRIPPED ALL HARDWARE, OK FOR SERVICE PART PROVIDED BY MRO

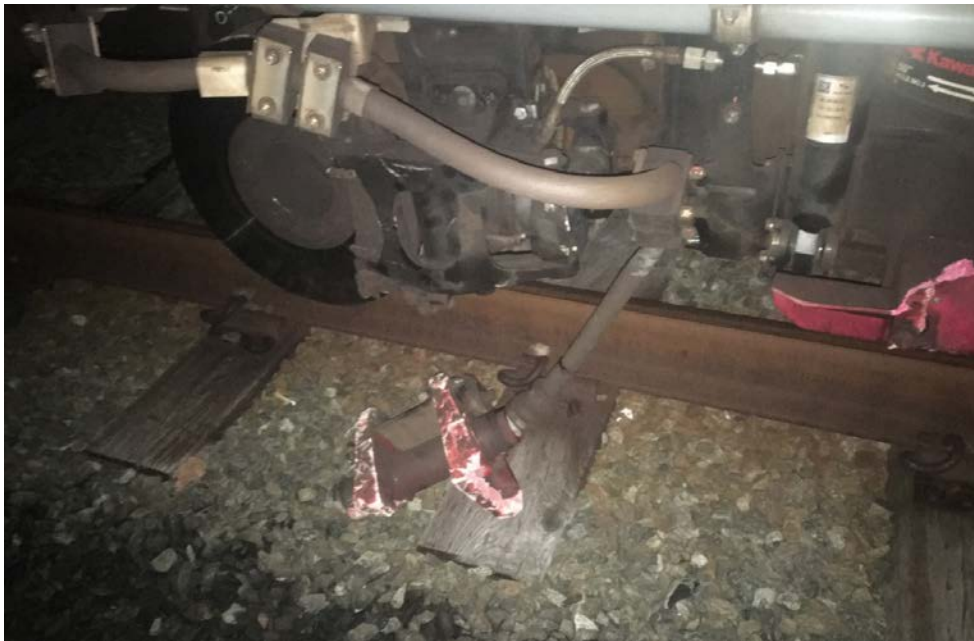
Photo 4 – Damaged Collector Shoe Assembly
