### FINAL REPORT OF INVESTIGATION A&I E18544

December 4, 2018 Injured Employee

# FINAL REPORT OF INVESTIGATION A&I E18544

### SMS 20181205#76192

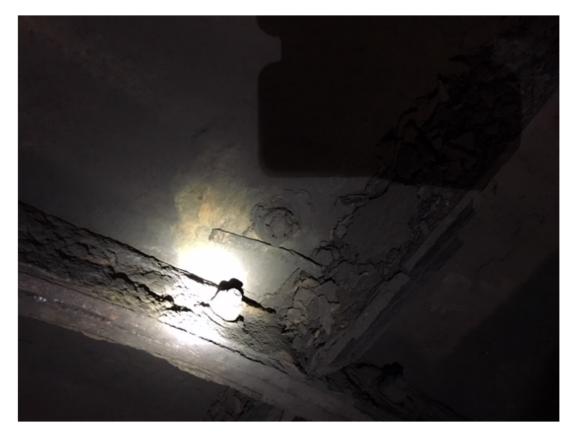
On December 4, 2018 at approximately 0845 PM, a STRUCTURE MAINTENEACE employee was performing chemical injection between L'Enfant Plaza station and the "L" line bridge metro rail stations (Right of Way) During the midnight shift assignments. At approx. chain marker L-1 70+00. A structures maintenance work crew was assigned to an onsite training session with the product vendor for chemical injection of deteriorating steel liner within the tunnel section of the ROW. While the maintenance crew was utilizing <u>a</u> electrical powered injection pump, when <u>a</u> injection port blew out and caused the pressurized chemical to blow back onto <u>a</u> employee The injection port had become dislodged from the steel liner structure while the injection processed was stopped. The pressurized chemicals <u>made contact with</u> the employee face and frontal body area, including facial hair, covering his protective safety glasses and Tyvek safety suit.

- A. Employee should have monitored the injection pump pressure, before attempting to remove the injection pump nozzle.
- B. Employee should have been wearing proper personal protective equipment (PPE) for the assigned task

Supervisor Should have evaluated the work process and proper PPE was provided and assigned for type work being performed.
