**FINAL REPORT OF INVESTIGATION A&I E19226**

May 6, 2019  
C99 Yard Derailment

**FINAL REPORT OF INVESTIGATION A&I E19226****SMS 20190506#79719**

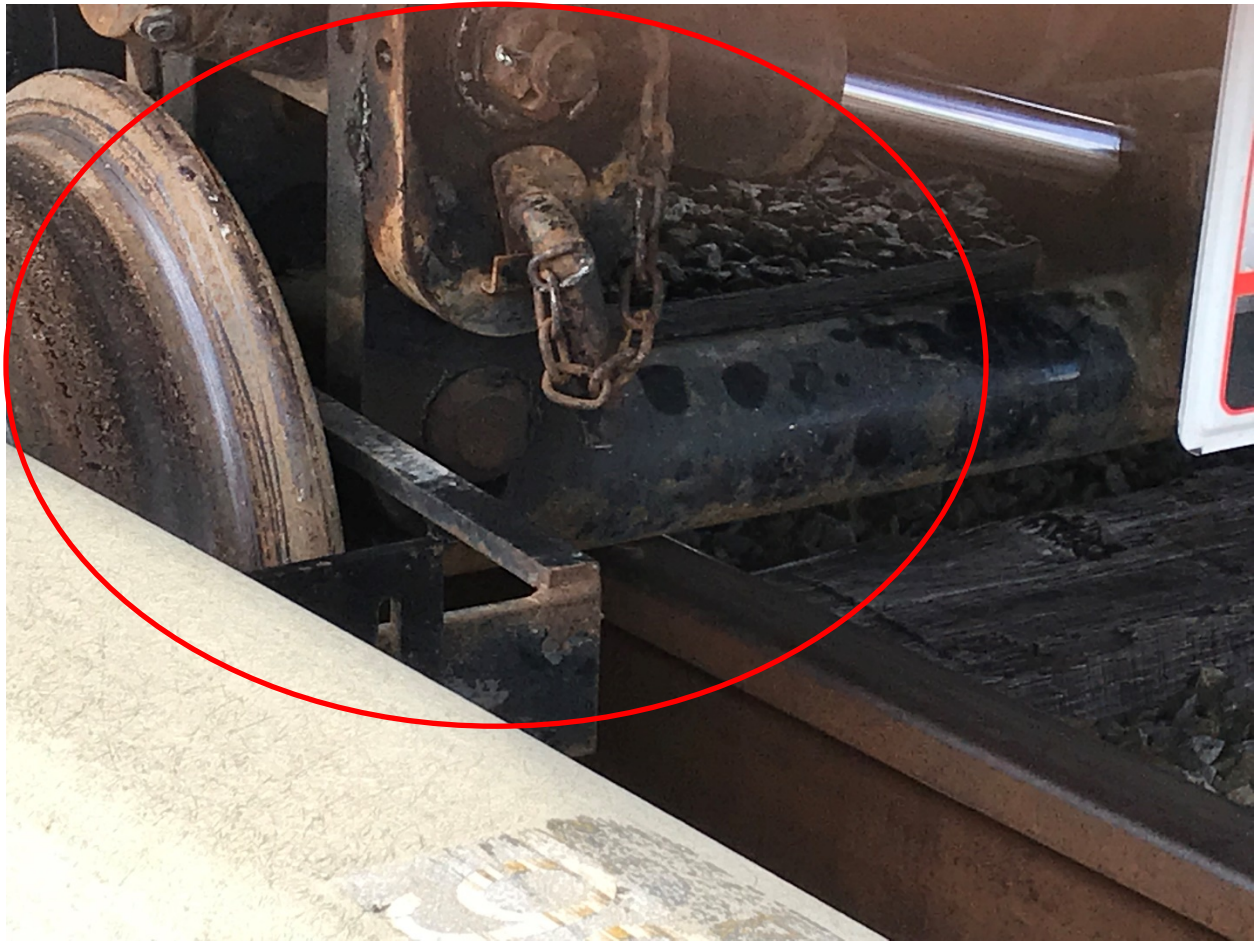
2. The original tires installed on the rear axle were (11R22.5) approximately 41.4-inch in diameter. The tires installed by Kiewit contractors on the rear axle (425/65R22.5) were approximately 44.2 inches in diameter. The changing of tires requires the high rail gear to be adjusted to maintain proper loading per the manufacturer Diversified Metal Fabricators (DMF) as stated in the manual for the 1630 rail gear. Due to these adjustments not being performed there was insufficient loading of the rear high rail allowing the wheel flange to climb the rail resulting in a derailment.

Photo 2 – Left Rear of HRU Wheel Derailed

1. Before HRU can be returned to service on WMATA's property, CTEM recommends the following to support prevention of repeated recurrence.
  - a. **The front and rear high rail wheel bearings must all be replaced.**
  - b. **The high rail gear must be inspected for damage, adjusted to accommodate the new tire diameter and certified by a DMF factory authorized technician.**

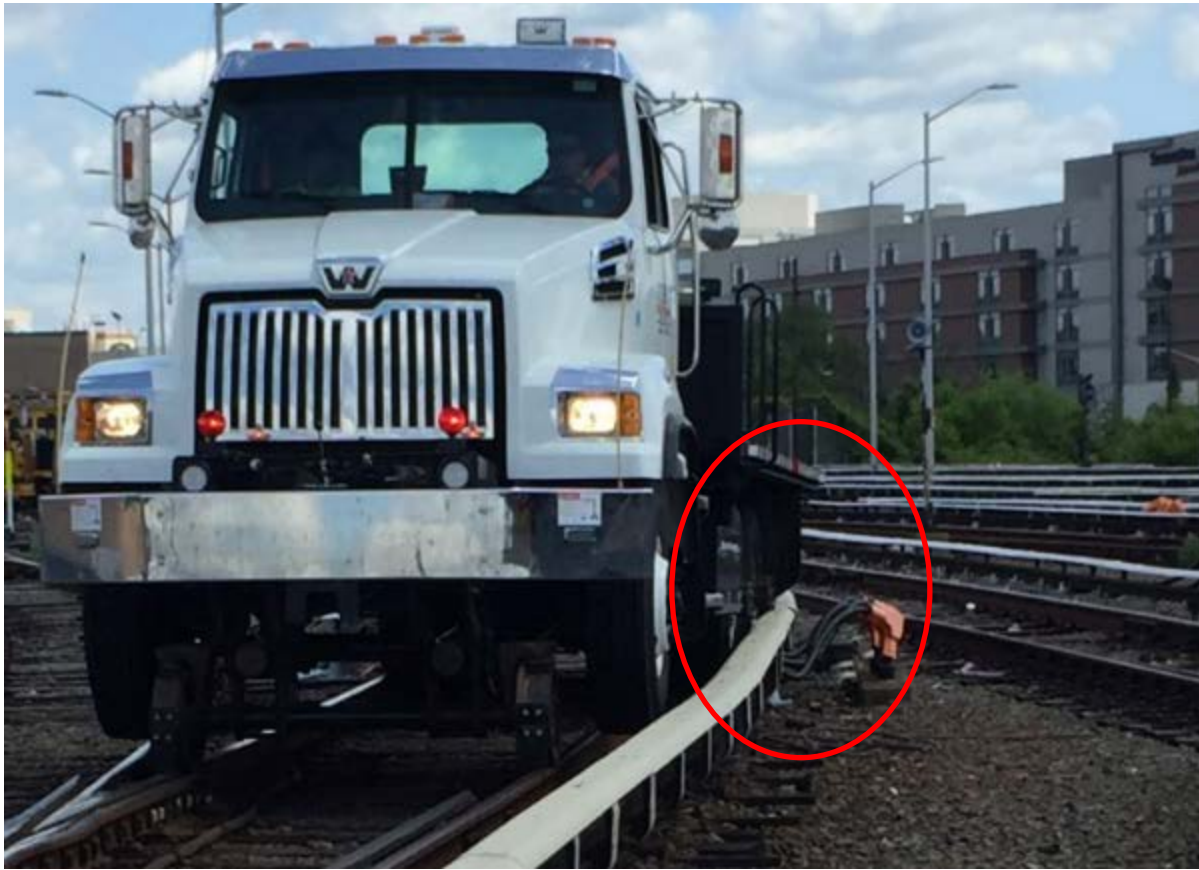
During the process of traveling in reverse on the rail through the switches, the rear of the HRU de-railed and the rear-driver side rail wheel on the Hi-Rail equipment contacted the third rail causing them to arch flash. Track and Structures (TRST) personnel responded to the scene with a Prime Mover (PM) and was able to lift the rear of the vehicle and set it back on the running rails without further incident. The vehicle was driven to the crossing/stop sign near the west end of the shop, the high rail equipment was raised, and the vehicle was removed from the roadway onto the road at approximately 15:00 hrs. The derailment took down power from tracks 10 through 20. Power was restored to all tracks in the yard at approximately 15:30 hrs., with no damage reported. There were workers walking in front of the HRU when the incident occurred. The workers on the ground alerted the Kiewit Contractor Equipment Operator (CE/O) to stop the vehicle when they observed that HRU had climbed over the guard rail associated with the switch and subsequently derailed. The CE/O and the Pilot Operator (P/O) were sent for post incident testing.

Photo 3 – Left Rear of HRU Made Contact with the Third Rail

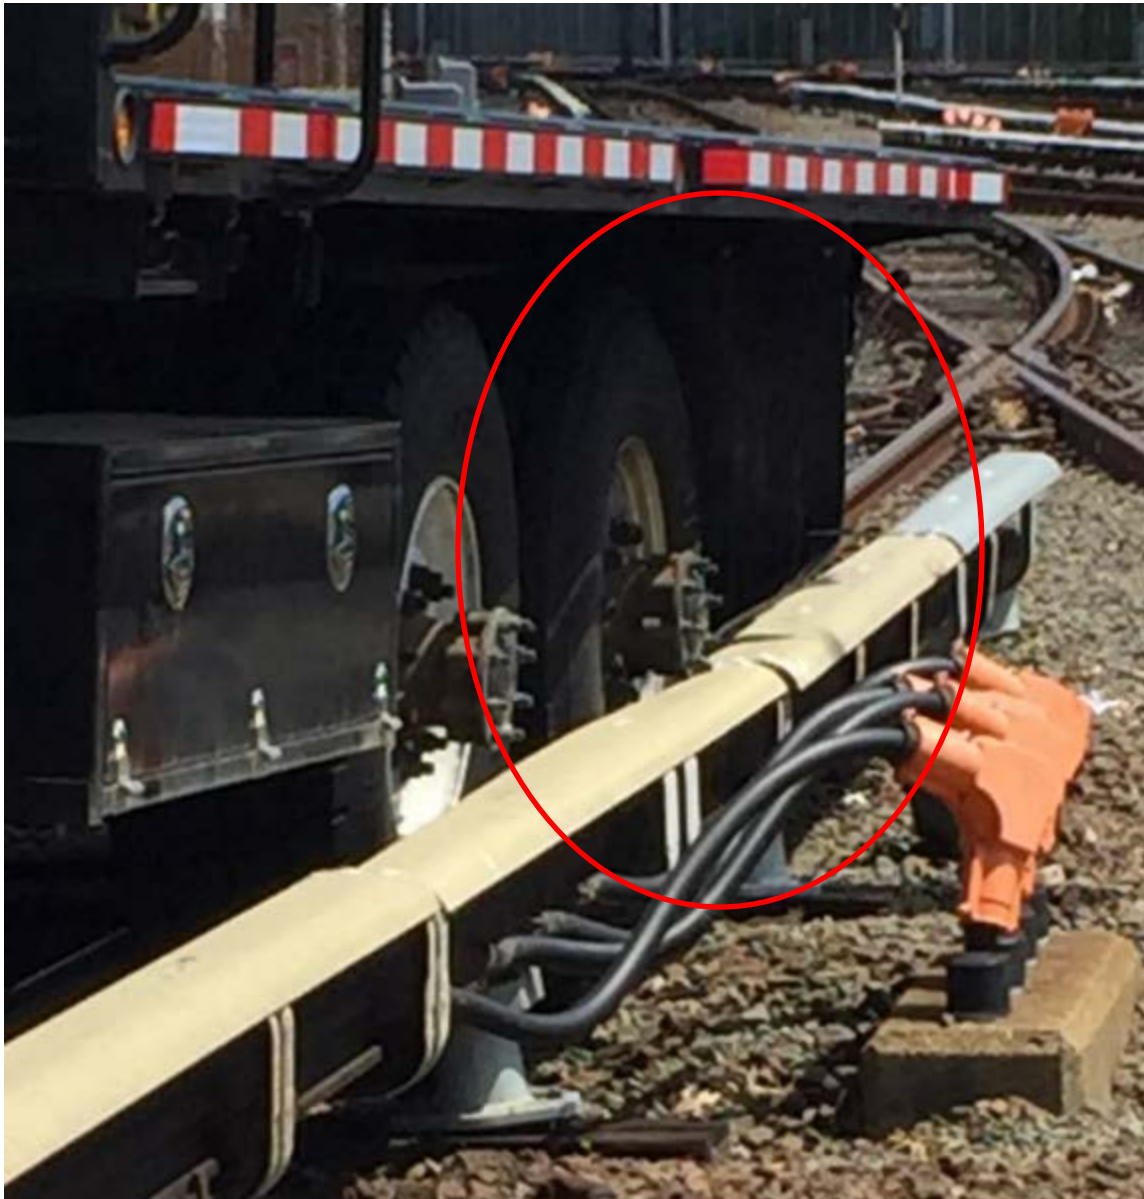
Photo 4 – Left Rear of HRU Made Contact with the Third Rail
