**FINAL REPORT OF INVESTIGATION A&I E18479**

November 1, 2018

Employee Injury

**FINAL REPORT OF INVESTIGATION A&I E18479****SMS 20181101#75442**

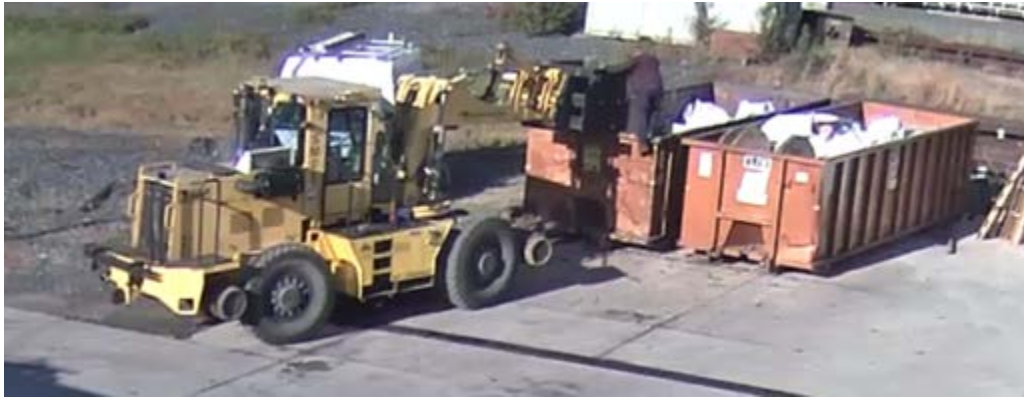
Photo 1 – Employee standing on top of the container

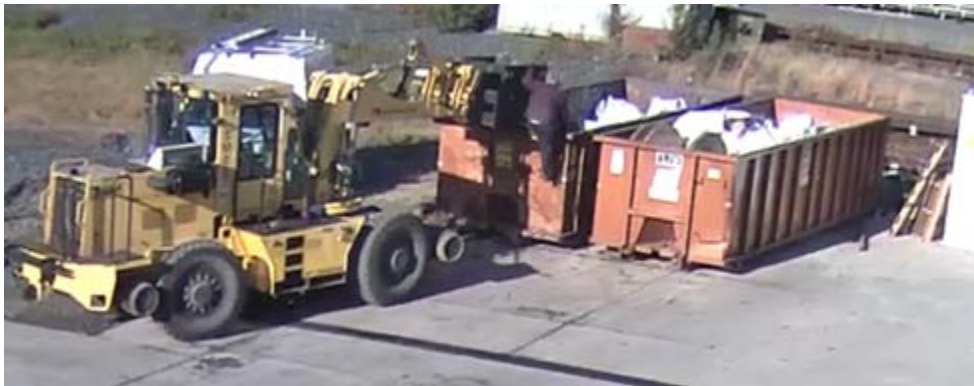
Photo 2 - Employee stepping down

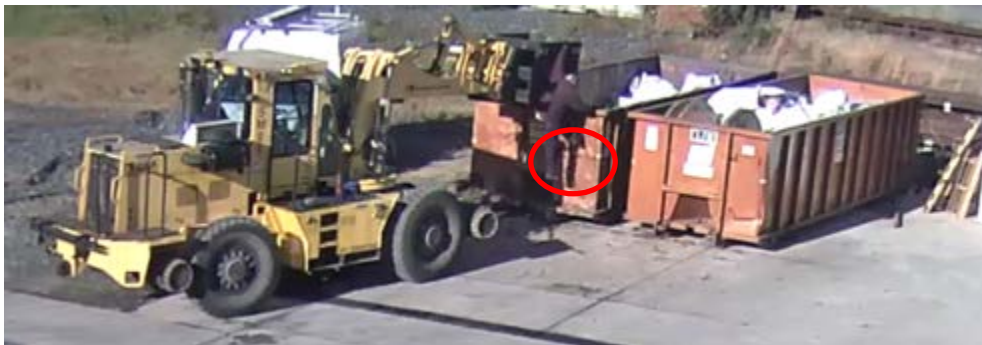
Subsequently, when the employee was climbing down, he lost his footing, and fell injuring his left wrist. Further investigation revealed, the step ladder rungs on the dumpster were

damaged prior to the incident. The damaged ladder rungs served for poor footing climbing on and off the dumpster. However, the dumpster's ladder is intended for inspection purposes only not to climb on the container notated on the fall hazard sign on the container.

Photo 3 – Employee losing his footing

- The employee was transported for medical attention
- The dumpster was removed and replaced with a container in good condition.

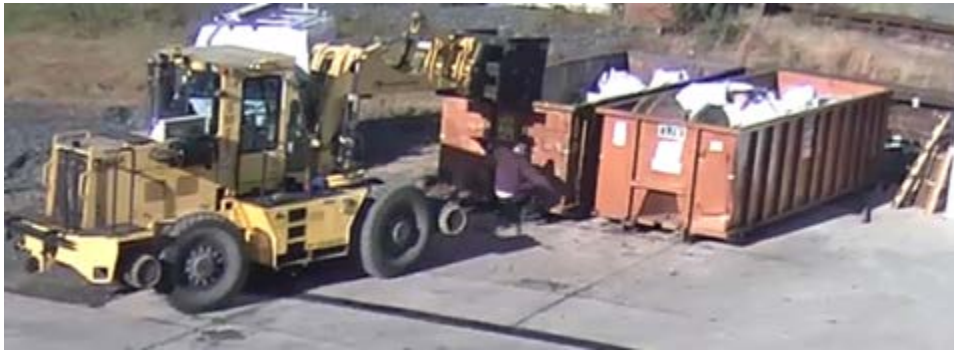
Photo 4 – Employee falling to the ground

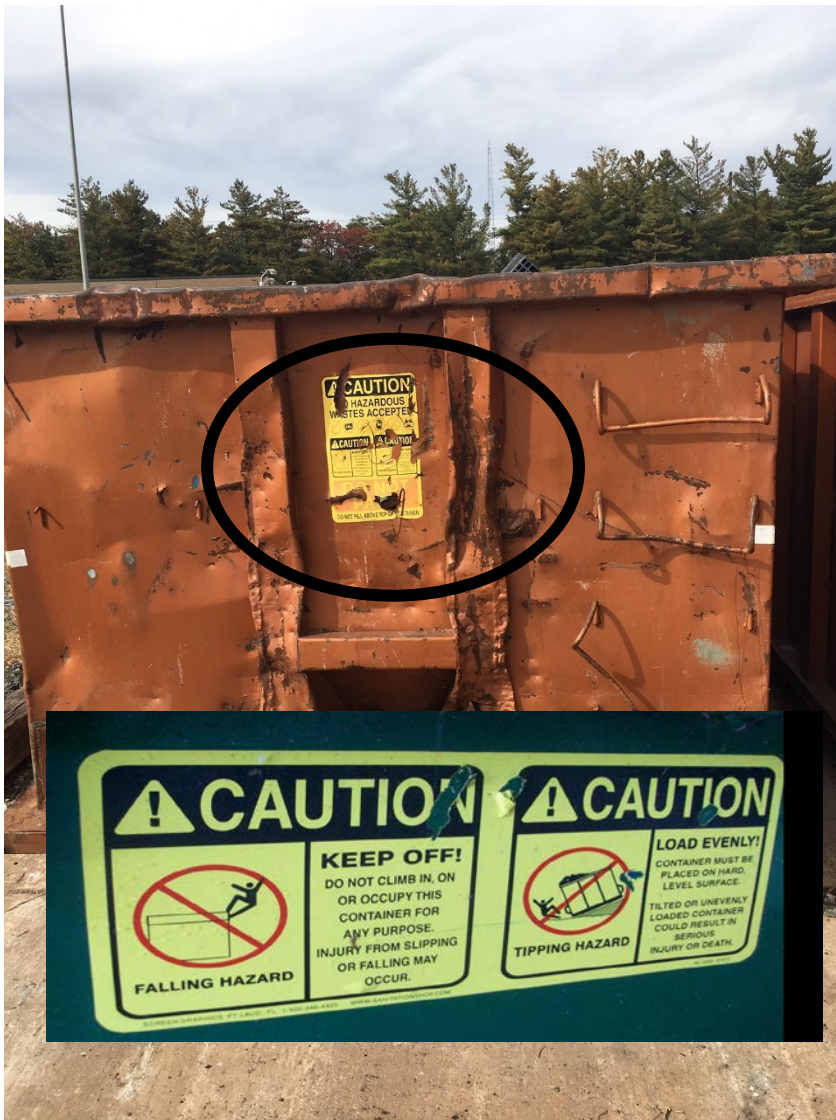
Based on the salient facts, the employee climbed on top of the dumpster to remove contents from a container. As he descended from the dumpster, he lost his balance and fell to the ground fracturing his wrist. The step ladder rungs on the dumpster was damaged (See photo 5). The damaged ladder rungs served for poor footing climbing on and off the dumpster. However, the dumpster's ladder is intended for inspection purposes only not to climb on the container (See photo 6). The container was removed and replaced with an undamaged container. TRST created a "Memorandum" on this incident (see attachment 2), letting employees know the hazards of standing on top of the dumpster container. SAFE is also creating a JHA for TRST on the procedures of dumping trash and debris from the work flats into the dumpster (see attachment 2).

Photo 5 - Warning Label on container reflects the same language as illustrated on Illustration 1

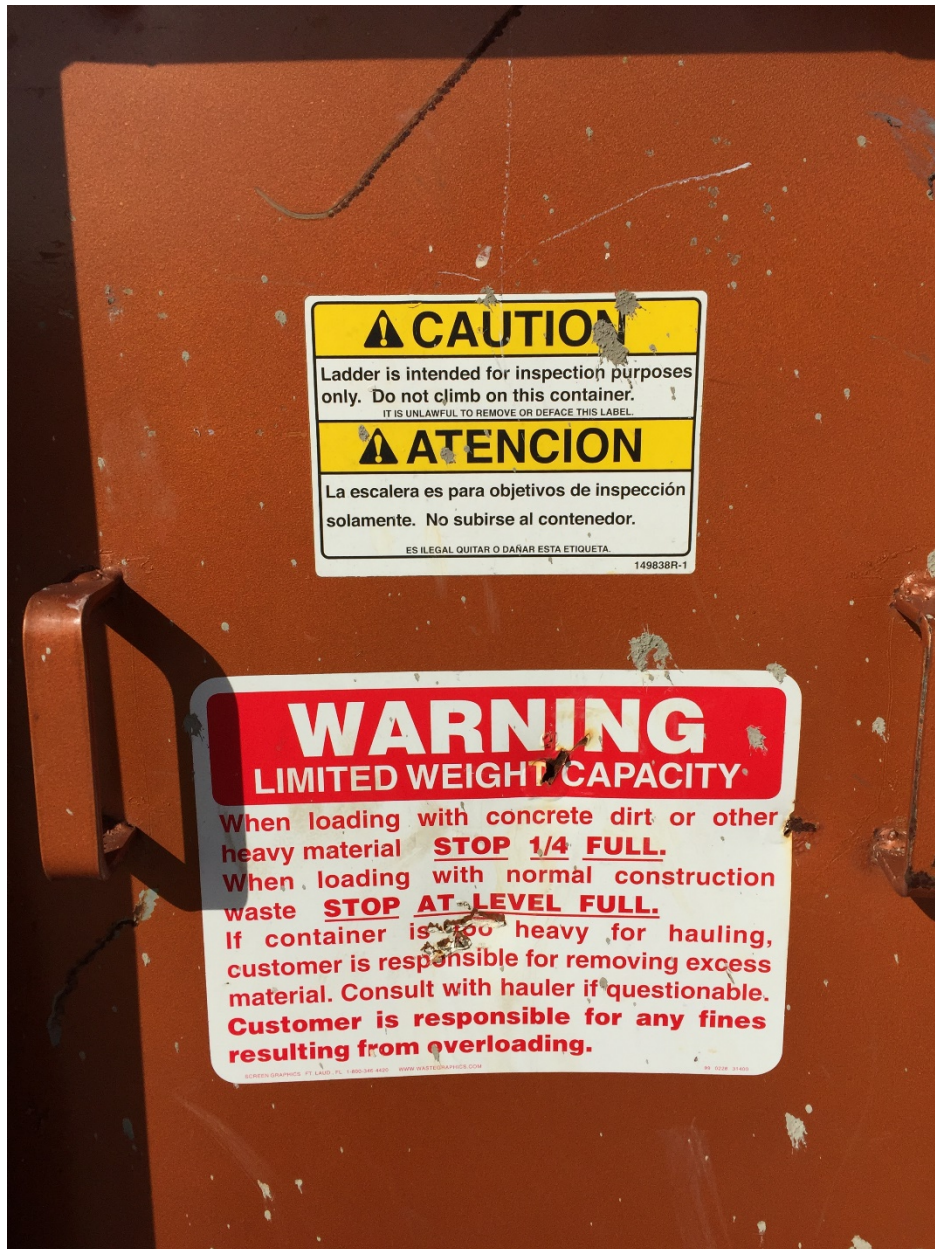
Photo 6 – Caution sticker
