FINAL REPORT OF INVESTIGATION A&I E19252

Train Movement with Doors Open

Adopted by the Washington Metrorail Safety Commission at its meeting on October 8, 2019.

FINAL REPORT OF INVESTIGATION A&I E19252**SMS #20190521#80061**

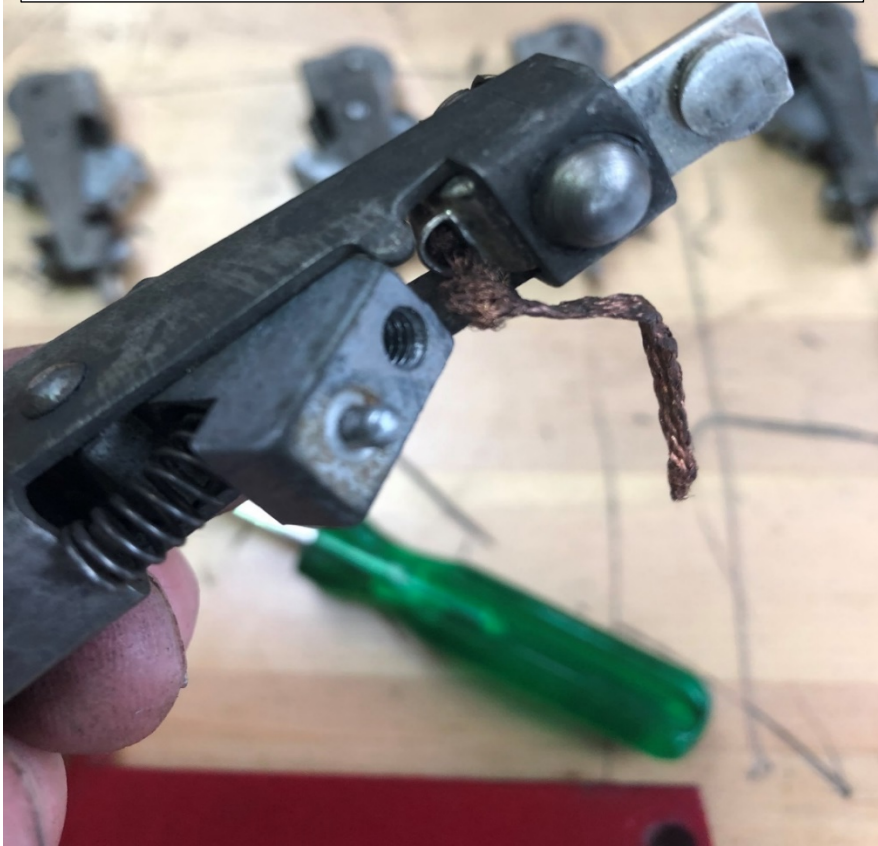
Photo 1 - Major Finding / Root Cause of Door event involving Car 3135

SAFE further concludes, CENV, Virginkar and Associates, Inc., and CMNT post-incident inspection of the rail car determined the shunt (wire) on MC1 Cam Switches inside the MC failed. The MC1 wire contacted the door check relay circuit (MC7) and became energized when MC moved to the power position giving a false indication that doors were closed. This enabled the train to take power while the doors were open. When the train reached a speed of 2-mph, a redundant safety feature (Zero Speed Relay) overrode the DCKR relay subsequently initiating the Door Close and Full-service Brake command.

A Tear-Down Inspection was performed at WMATA Maintenance Repair and Overhaul (MRO) Shop. The MC1 shunt was broken and shorting to the MC7 Cam Switch Assembly and determined as the root cause of this door event. There are 22 Cam Switch assemblies in the MC and all were inspected with 13 found good, 2 with major defects, 2 with significant defects, and 5 others with minor findings. Please refer to Photos 1-9

MC1 Cam Switch showing broken shunt that shorted to MC7 when the MC was in Power Position P1 through P5 and Emergency Position.

- CMNT shall overhaul impacted MC's per OEM and engineering specifications
- Engineering shall research upgraded designs for an insulating shield that will prevent recurrence of failure i.e., contacting/bridging another circuit within the MC.

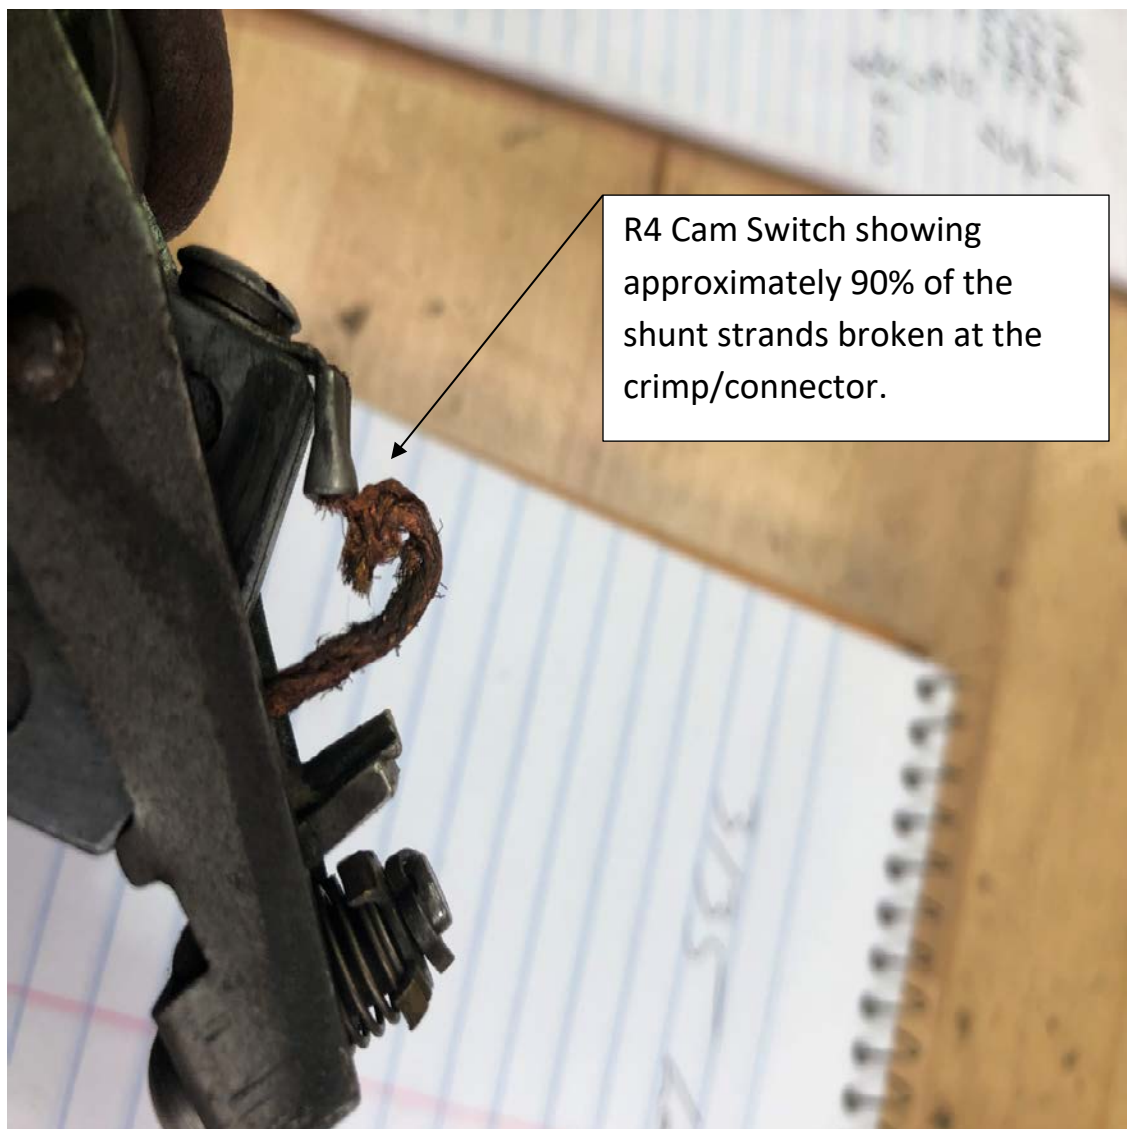
Photo 2 - Major finding, shunt damage

R4 Cam Switch showing approximately 90% of the shunt strands broken at the crimp/connector.

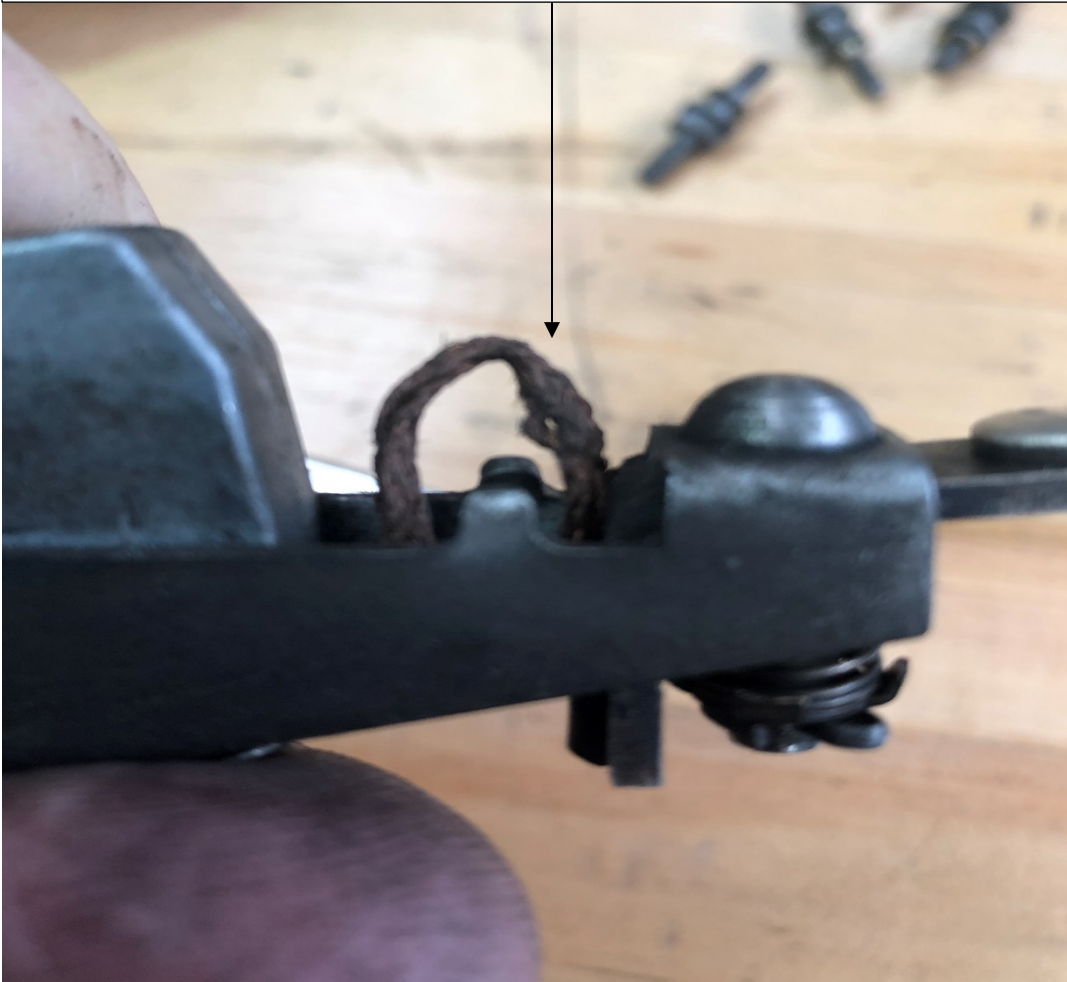
Photo 3 – Significant finding, shunt damage

MC2 Cam Switch showing some damage to shunt where the shunt wears during movement.

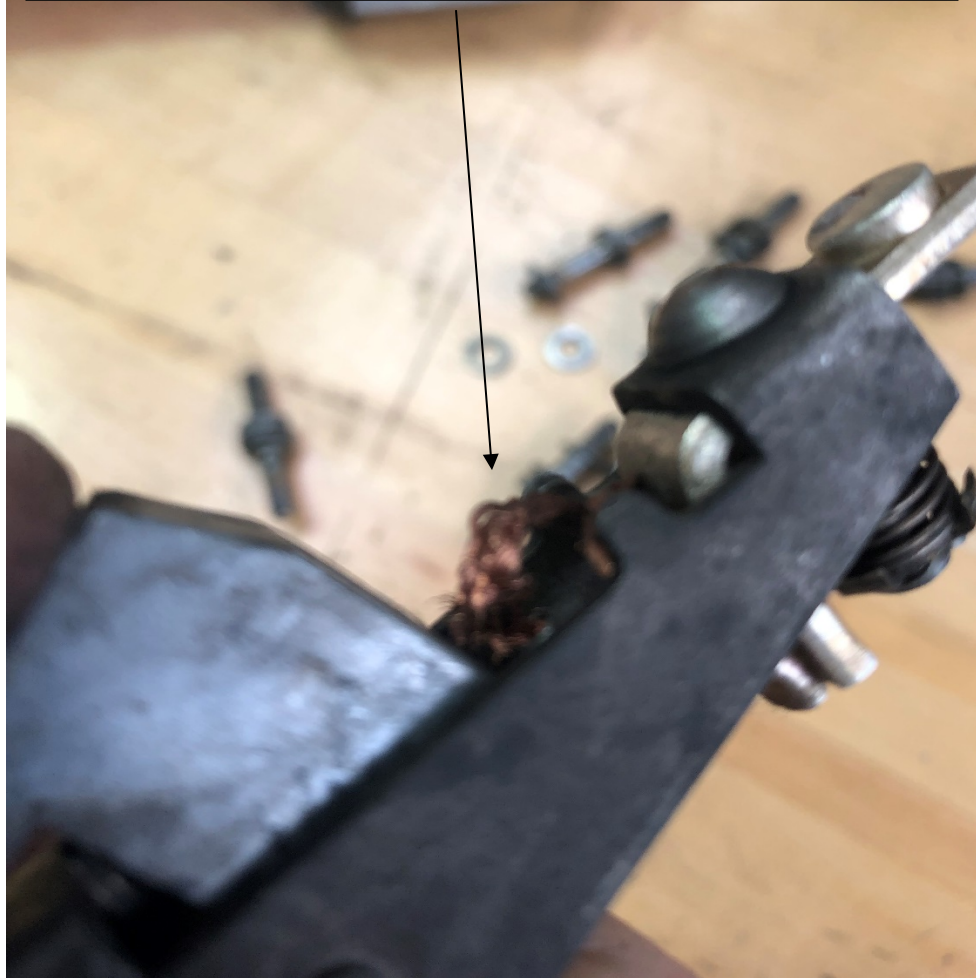
Photo 5 – Significant finding, shunt damage

EM Cam Switch showing splaying of shunt; however minimal strands found broken.

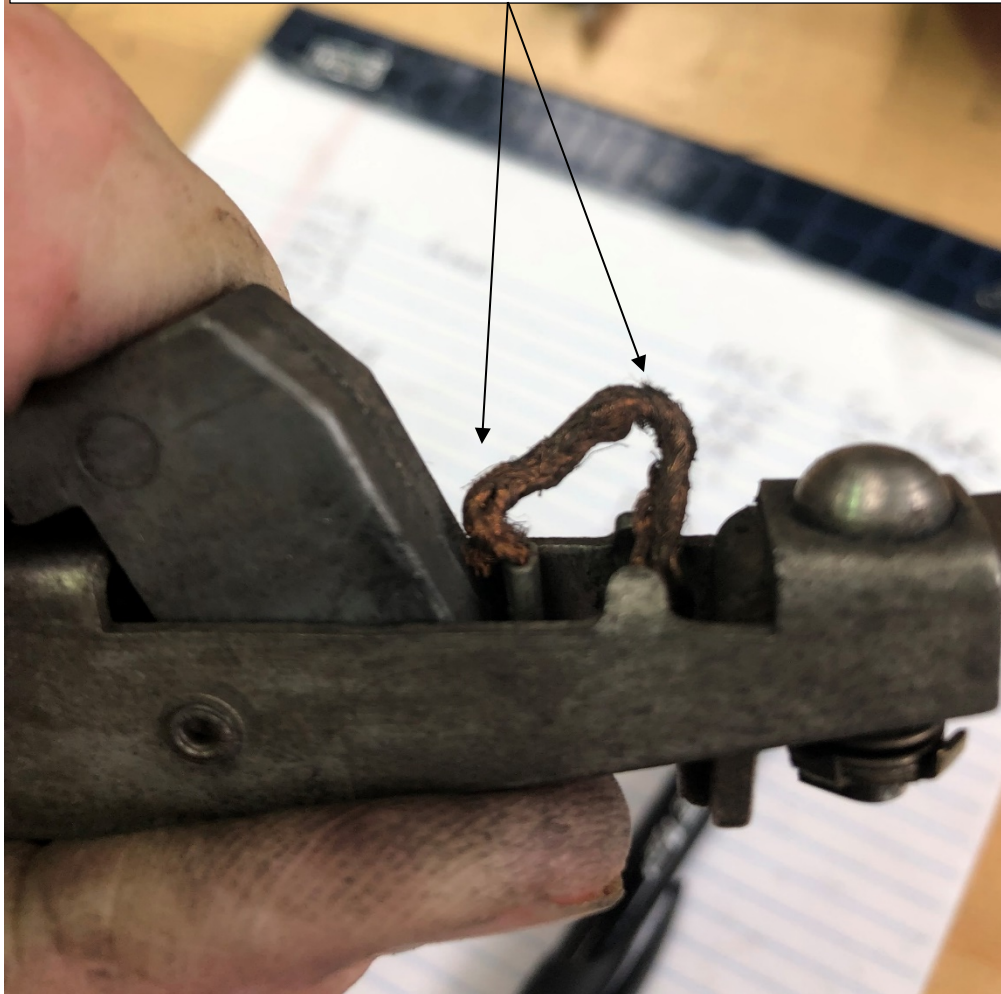
Photo 6 - Minor Finding, shunt with Damage

PFS1 Cam Switch showing multiple fray points on the shunt and significant strands broken at the crimp / connection.

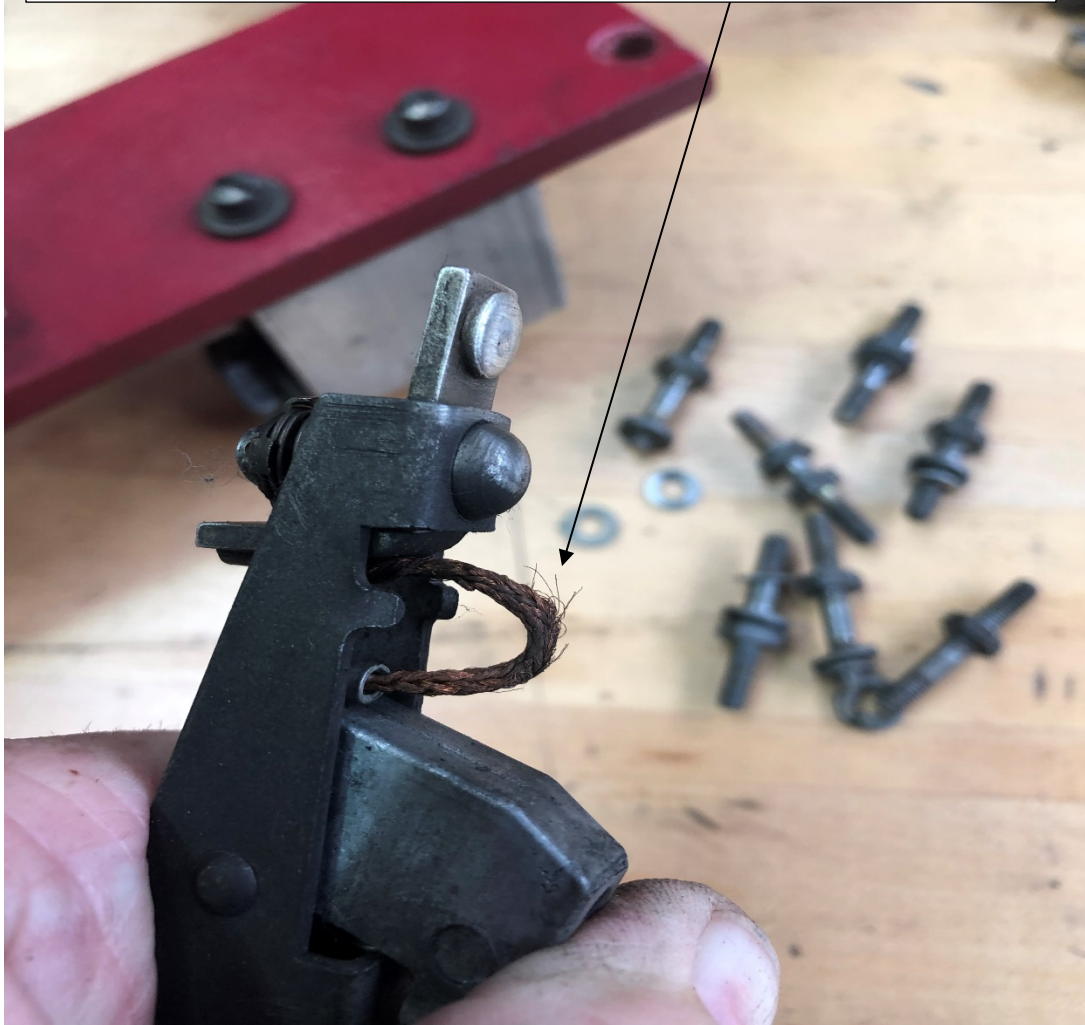
Photo 7 - Minor Finding, shunt with Damage

JSO Cam Switch showing multiple fray points on the shunt

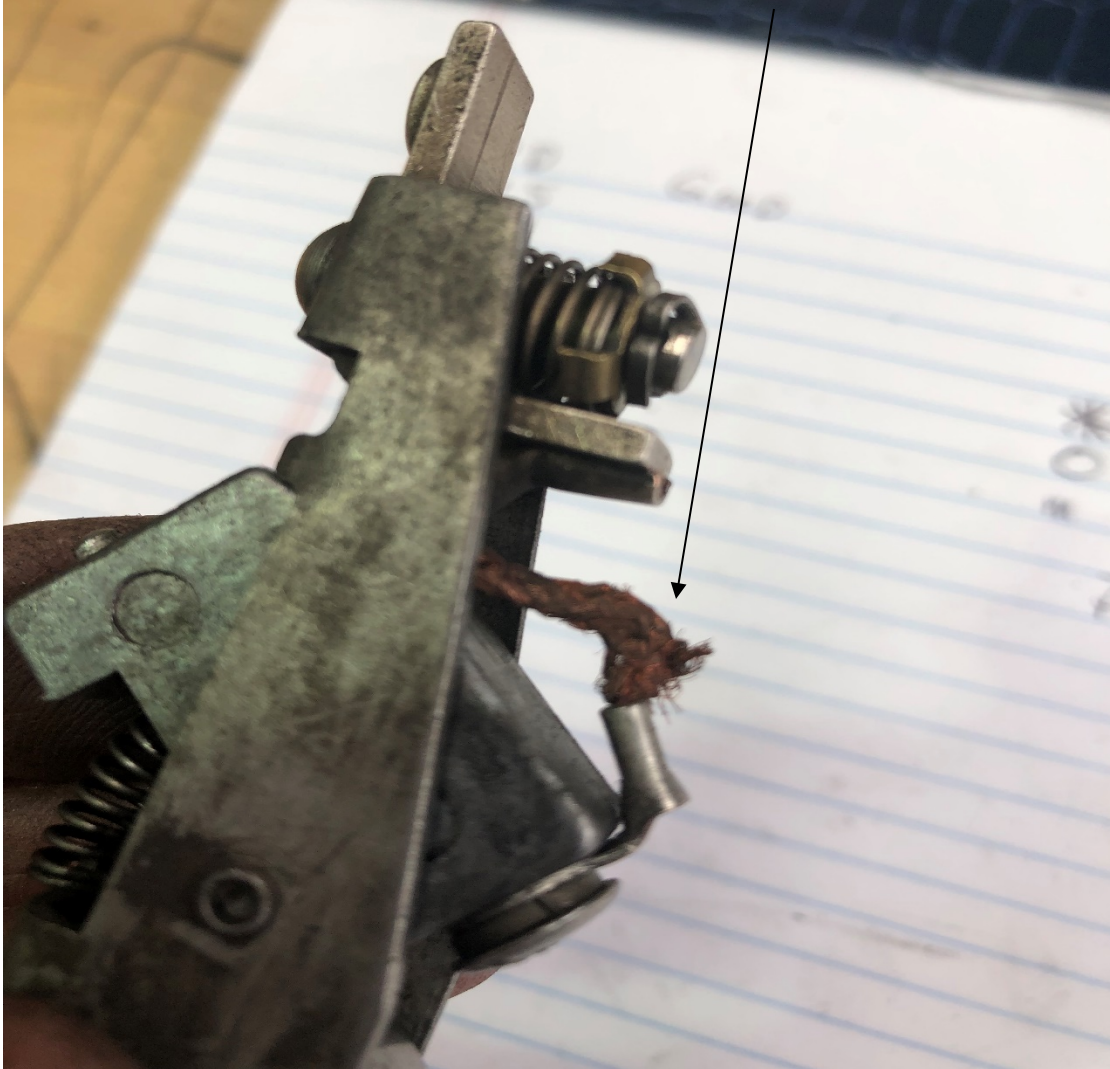
Photo 8 - Minor Finding, shunt with Damage

SFS1 Cam Switch showing significant strands of the shunt frayed /broken at the crimp / connection.

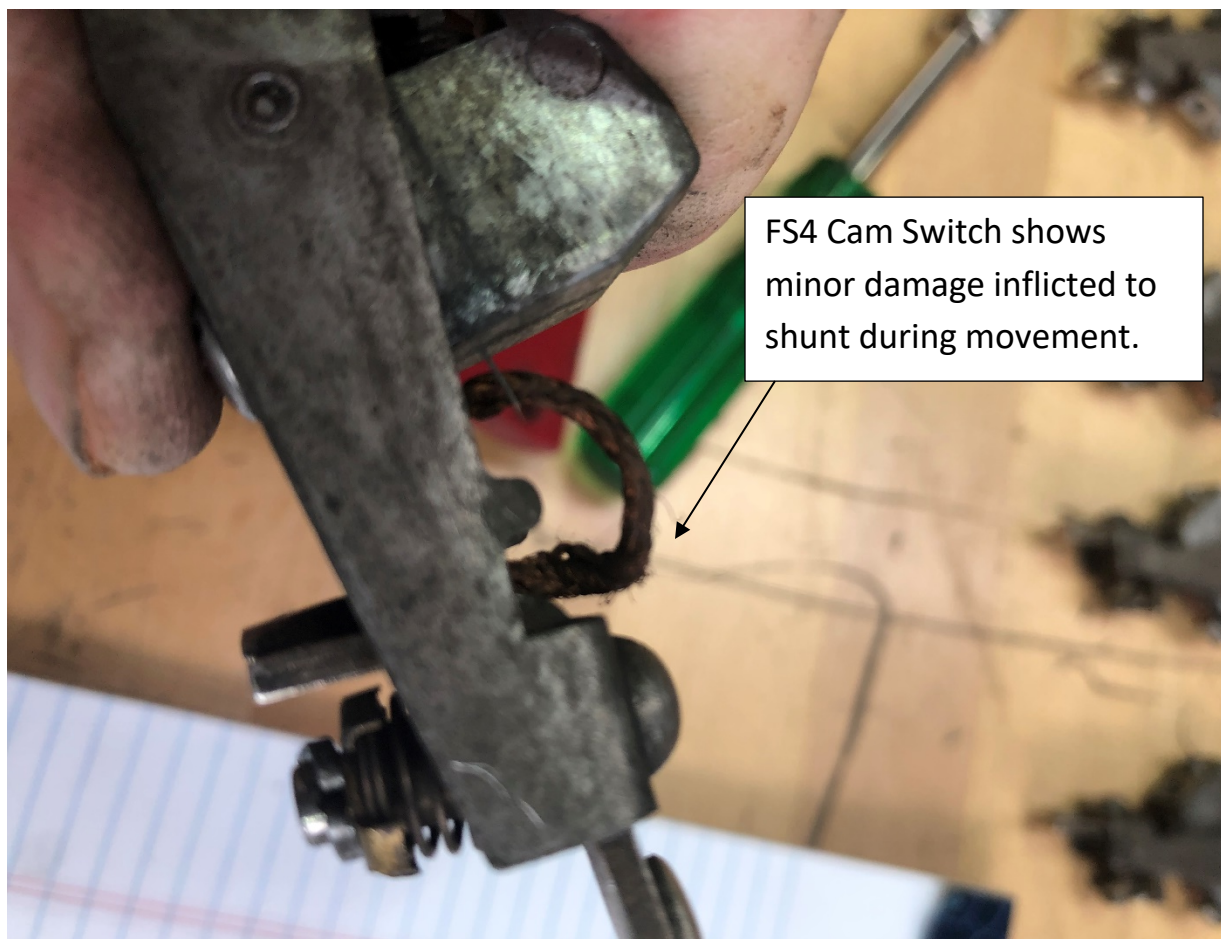
Photo 9 - Minor Finding, shunt with Damage

FS4 Cam Switch shows minor damage inflicted to shunt during movement.

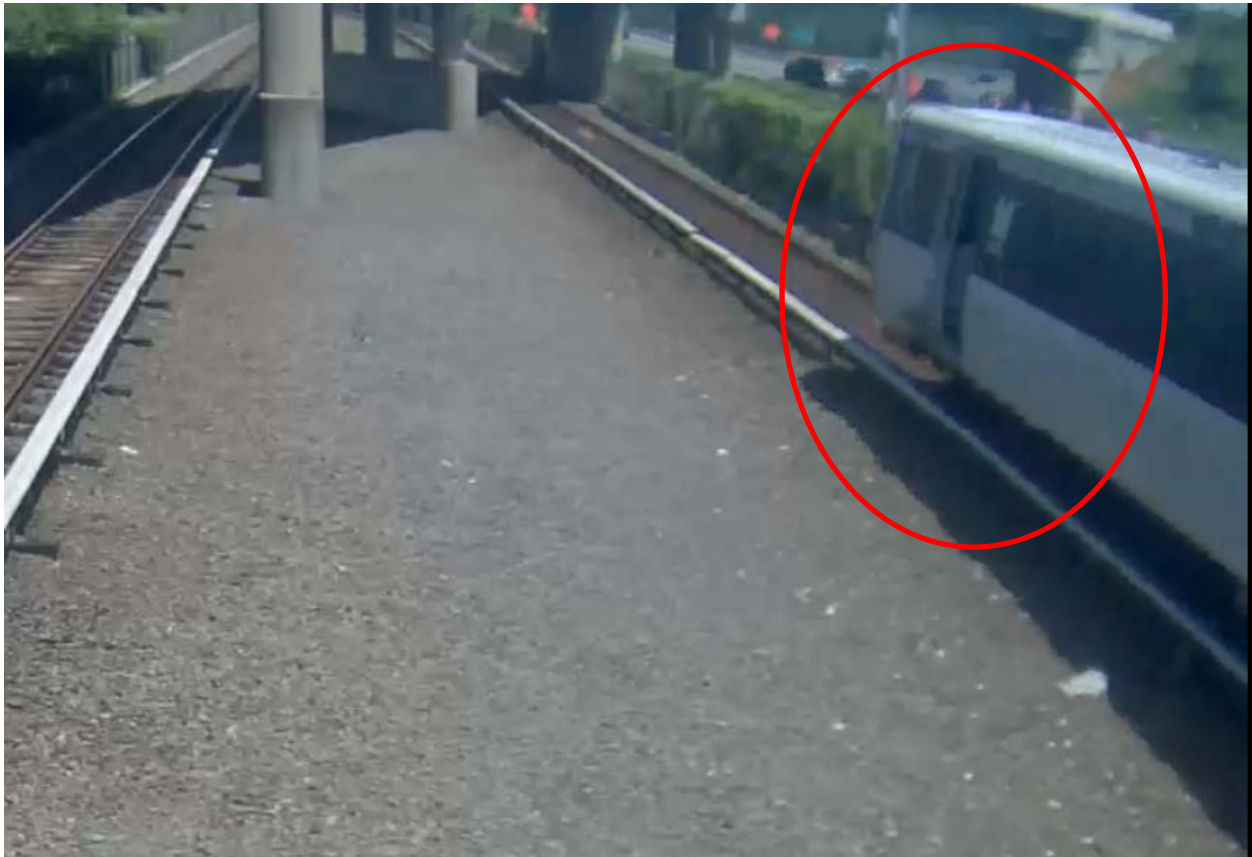
Photo 10 – 13:55:19 Doors open while train in motion outside platform limits

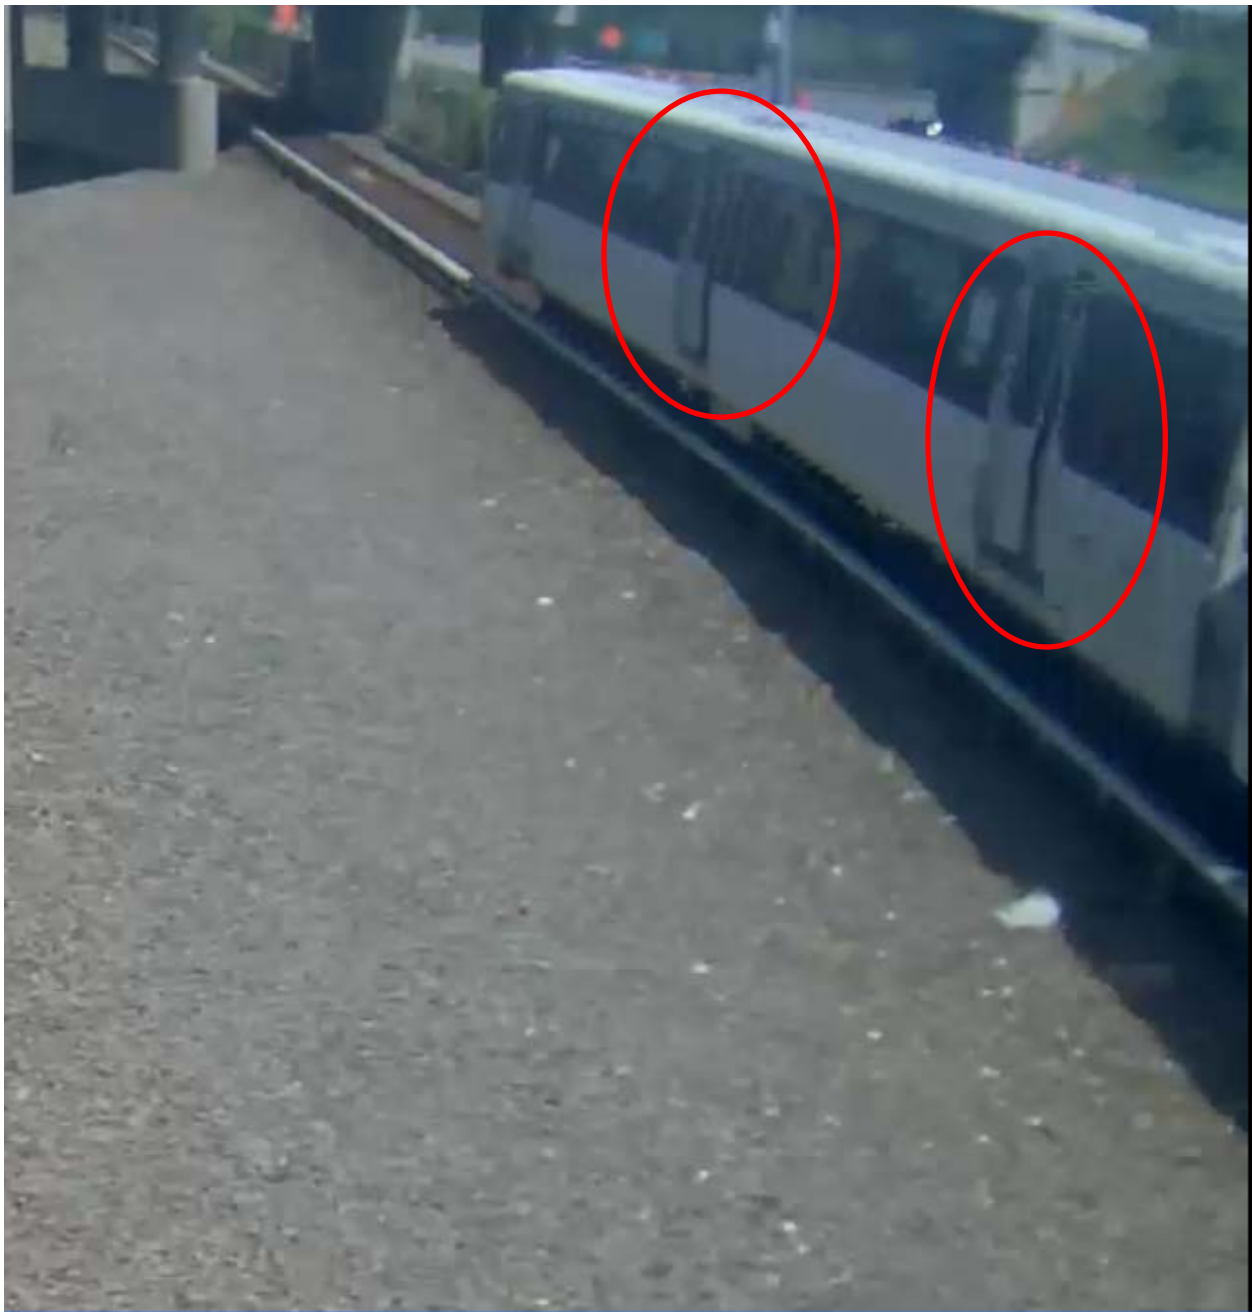
Photo 11 – 13:55:20 doors began to close while inertia prevents right leaves from closing.

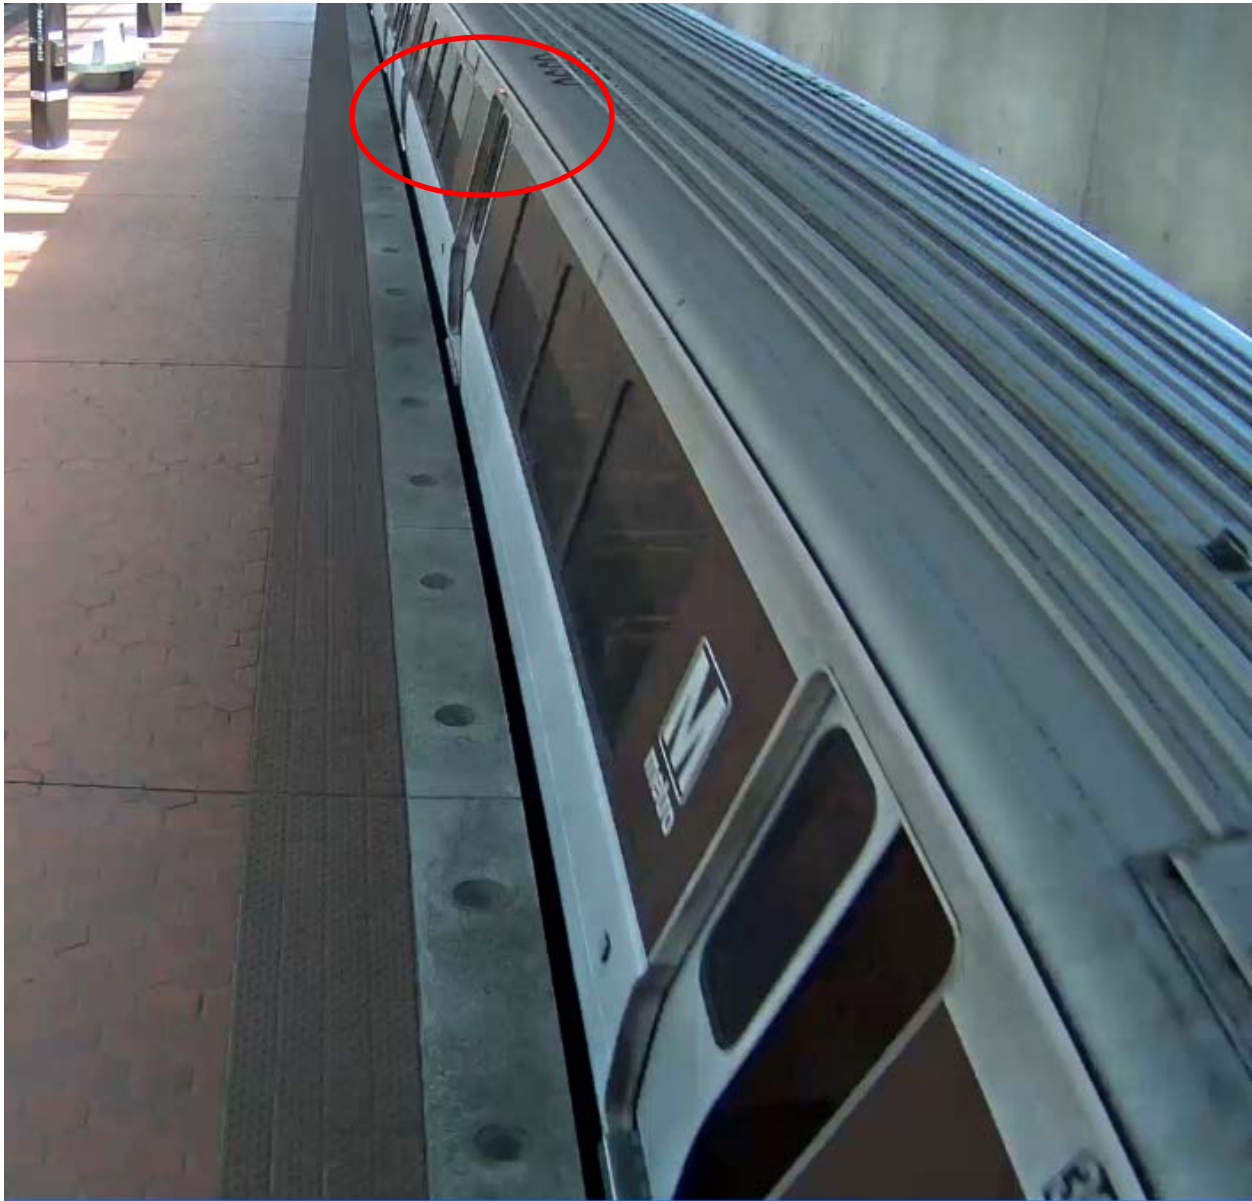
Photo 12 – 13:55:20 door indication lights illuminated while train in motion
