**FINAL REPORT OF INVESTIGATION A&I E19326**

Failure to service station

W-0019

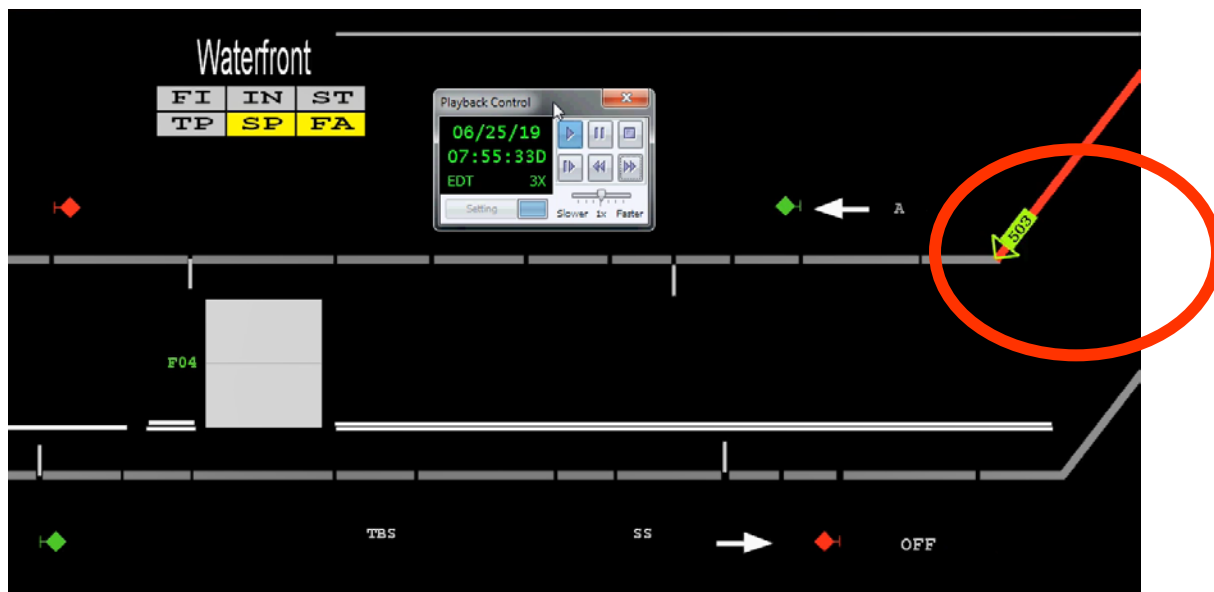
07:55:33 hrs. An Outbound, Green Line Revenue Line Train ID 503 on approach to F04, Track 2.

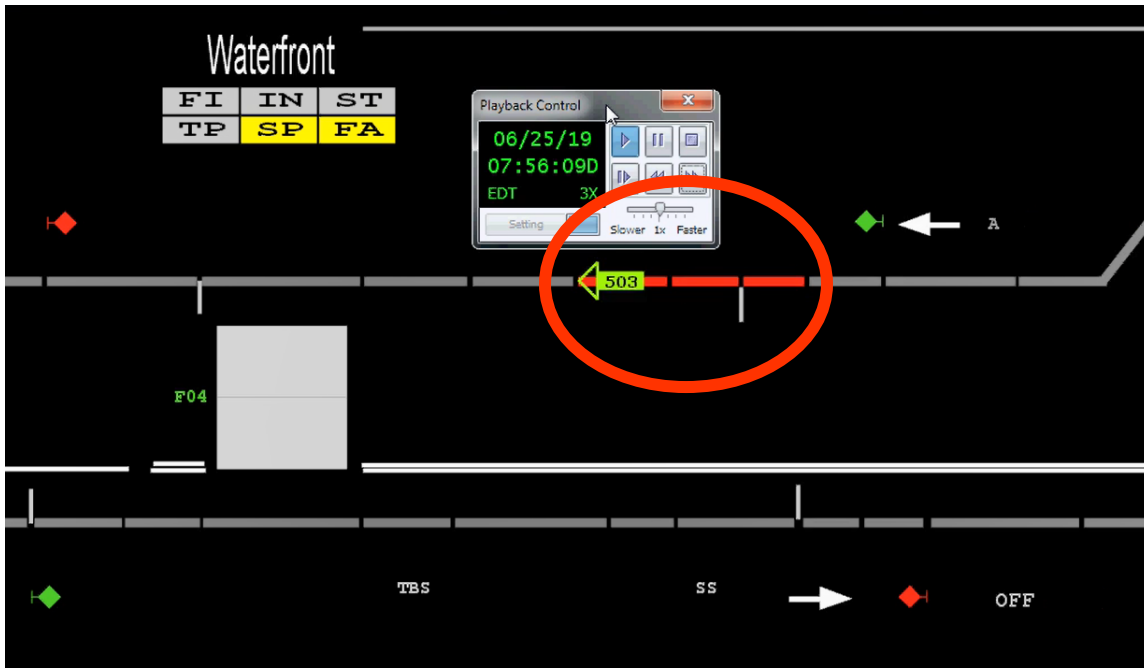
07:56:09 hrs. An Outbound, Green Line Revenue Line Train ID 503 on approach to F04, Track 2.

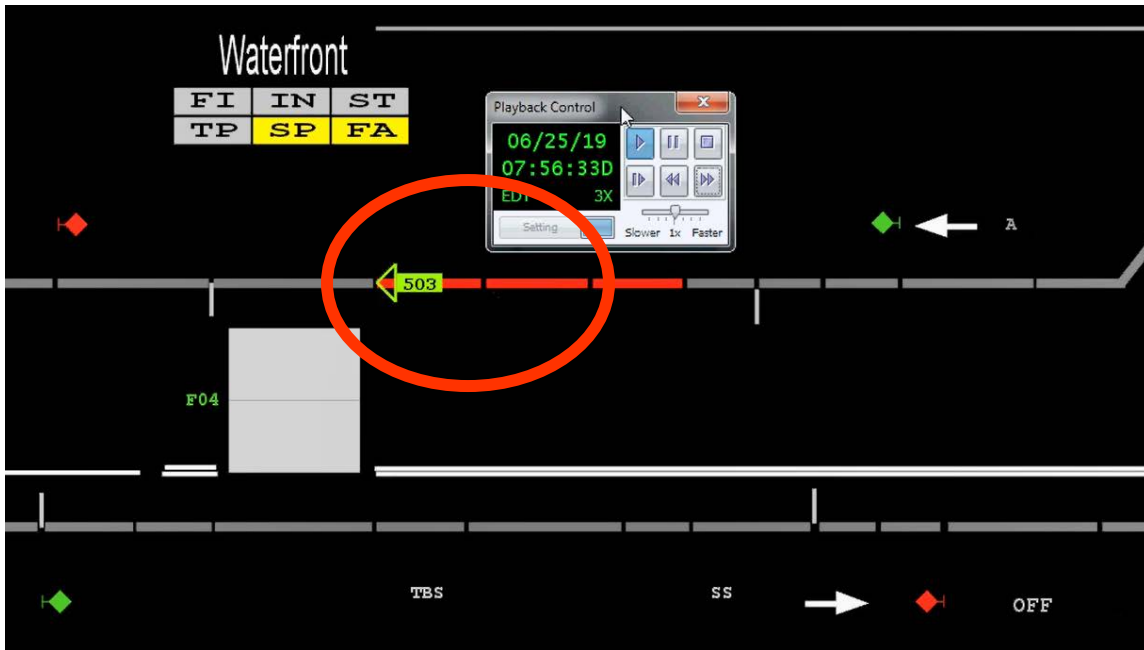
07:56:33 hrs. An Outbound, Green Line Revenue Line Train ID 503 entering F04, Track 2.

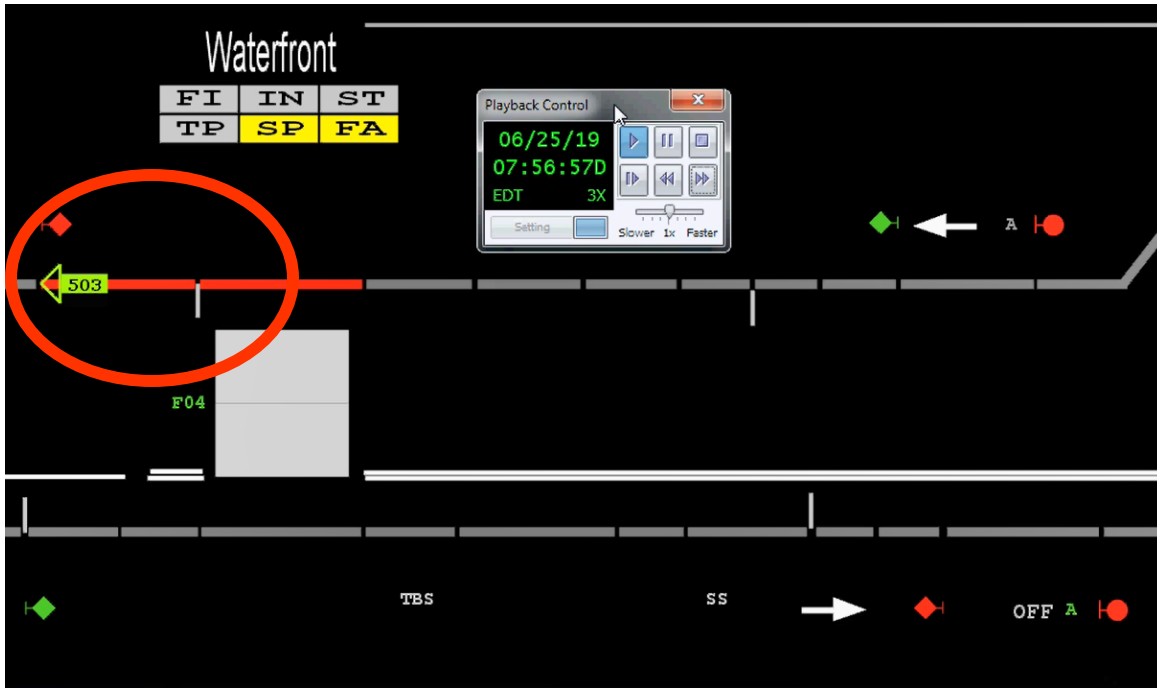
07:56:57 hrs. An Outbound, Green Line Revenue Line Train ID 503 failed to service F04, Track 2 nor attempted to stop at F04

Based on the salient facts presented in the investigation, SAFE concludes that the Train Operator involved in this incident failed to have his train under control when completely bypassing the Waterfront station. Additionally, there's no evidence to support that the train made a station stop as reported by the Train Operator.

Based the analysis performed by SAFE's Fatigue Risk Management System Safety Manager, SAFE concludes that the work and sleep schedule of the Train Operator involved in this incident may have contributed to the risk of fatigue. Fatigue may be a contributing factor for overrunning the F04 station.

1. RTRA shall submit T/O for a Fitness for Duty examination by WMATA Medical Department prior to returning for full service work duties
