FINAL REPORT OF INVESTIGATION A&I E19188

Undesired uncoupling

W-0021

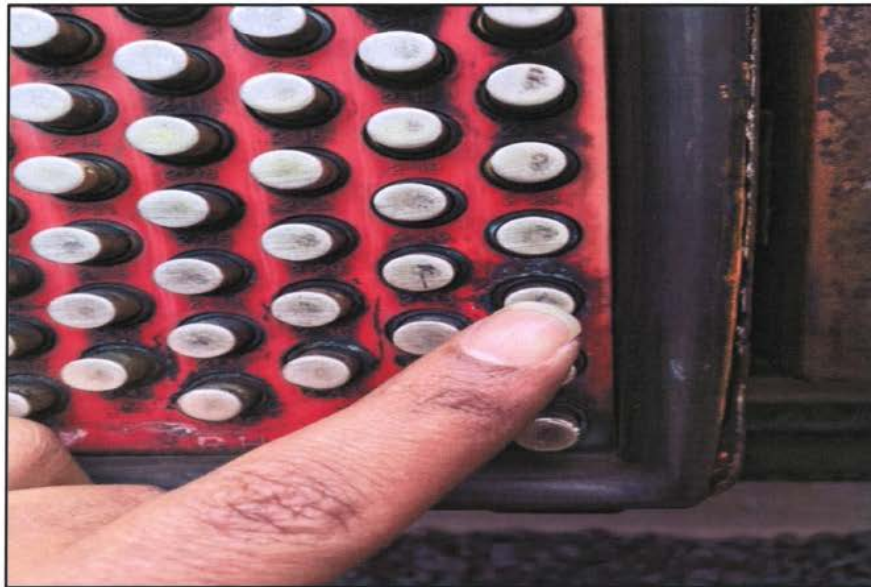
Figure 1. Car 3100 TL 56 Uncouple Pin

SAFE further concludes, moisture and corrosion identified within the coupler pin box during CENV inspection was considered as a contributing factor to this incident.

Coupler pin 2-37 (T/L 56 uncouple), of the right-hand coupler on Car 3100, showed signs of humidity and corrosion.

Removed RH Electrical Coupler contact housing for inspection and found wet gasket and moisture inside the coupler pin box. The bottom pins were corroded with signs of flashing (see figure 4).

- Replaced both electrical and mechanical F-end couplers on cars 3100 and 3114.
- Replaced master controller on lead car 3101.
- Inspected and repaired the KAS1 rotary switch from car 3114.
- The MC from car 3101 was overhauled, cleaned and lubricated. This asset can be used as a spare part or be reinstalled on the car.
- The RH electrical coupler from car 3100 must be overhauled. The remaining electrical couplers (from 3100 and 3114) must be cleaned before reinstallation on the cars.
- Performed hook tension adjustment on the front-end mechanical coupler (car 3114).

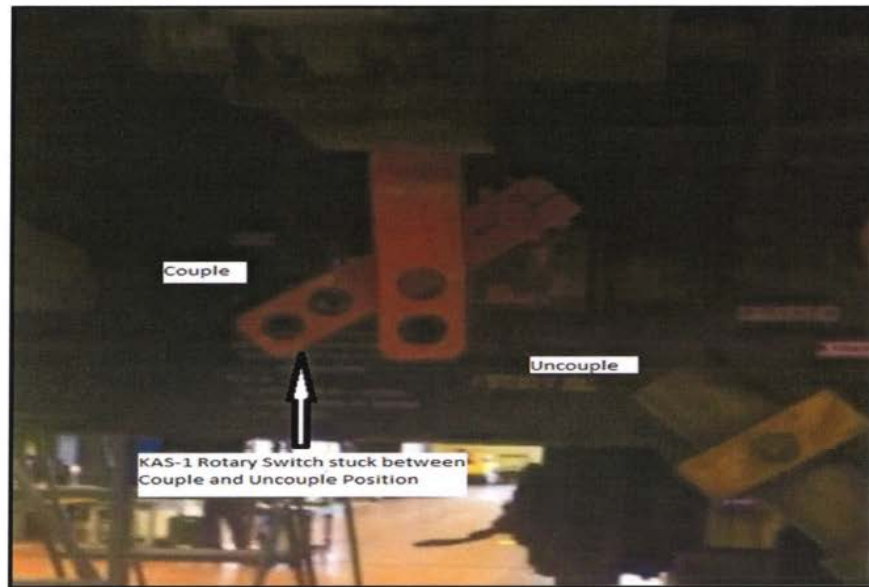
Figure 2. Car 3114 KAS 1 Rotary Switch

Consequently, the Brake Pipe recharge button was depressed (from lead car 3101) and the KAS1 rotary switches of cars 3100 and 3114 moved to the uncoupled position. The Master Controller, from lead car 3101, was then commanded to the P5 rate and the train began to move toward the Wiehle-Reston station platform.

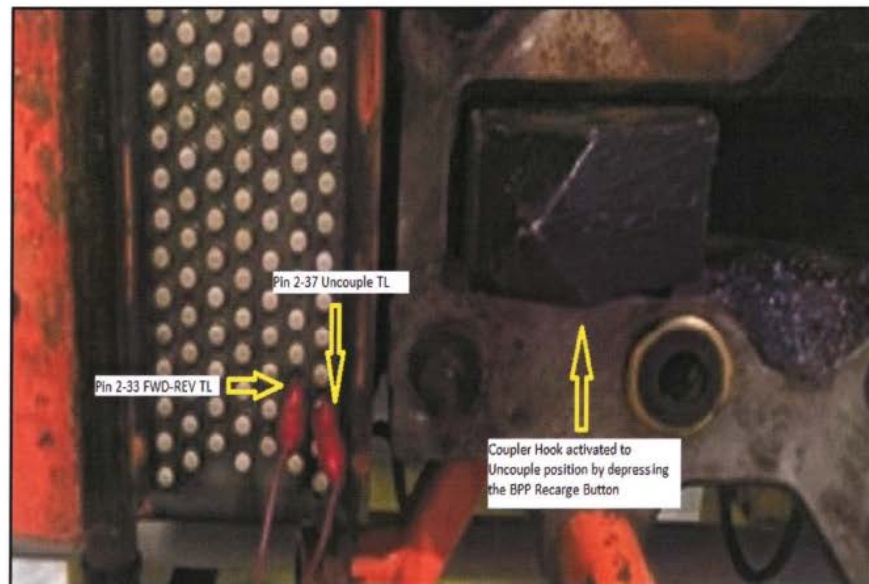
Figure 3. Short circuit, between Pin 2-33 and Pin 2-37, simulation

The FWD Train Line (T/L15) was short circuited to the Uncouple Train Line (T/L 56), when T/L 15 was energized. This short circuit provided the positive feed path to the uncoupling solenoid valve.

The negative path was provided when car 3101 was keyed up and the Brake Pipe Recharge button was depressed.

When these two conditions were present, the uncoupling solenoid valve was activated and initiated the uncoupling. CENV successfully simulated the incident, by short circuiting the FWD TL to the Uncouple TL and depressing the Brake Pipe Recharge button, thereby confirming the root cause. It must be noted, that based on the VMS data, the reason for the de-energization of the Emergency Brake trainline (T/L 82) was likely caused by train operator manipulation of the Master Controller.

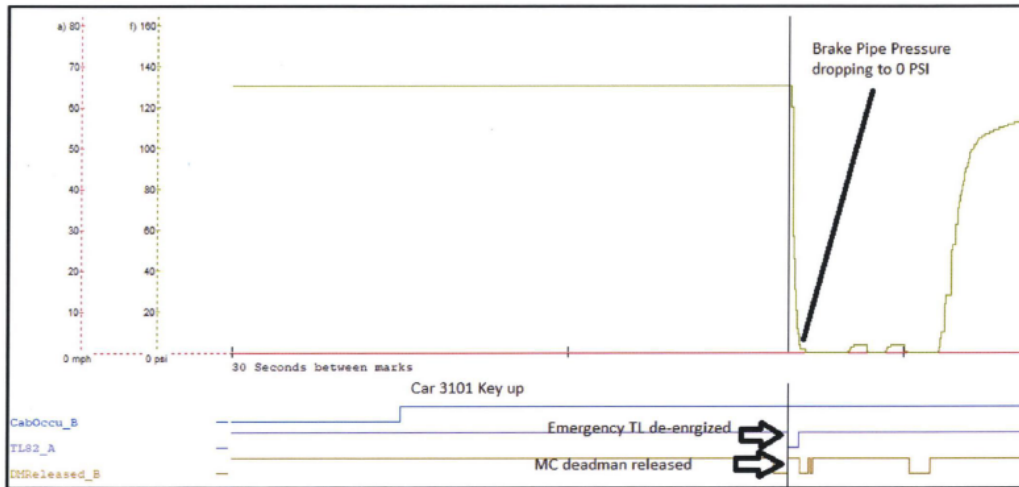
Figure 4. BPP dumping to 0 PSI

At the time of the main line incident, car 3101 was keyed up and the train length indicated a 6 car consist. The reverse and uncouple TLs (of car 3100) dropped momentarily, followed by the release of the MC Deadman and de-energization of the Emergency Brake TL (82), which caused the Brake Pipe to drop to 0 PSI.

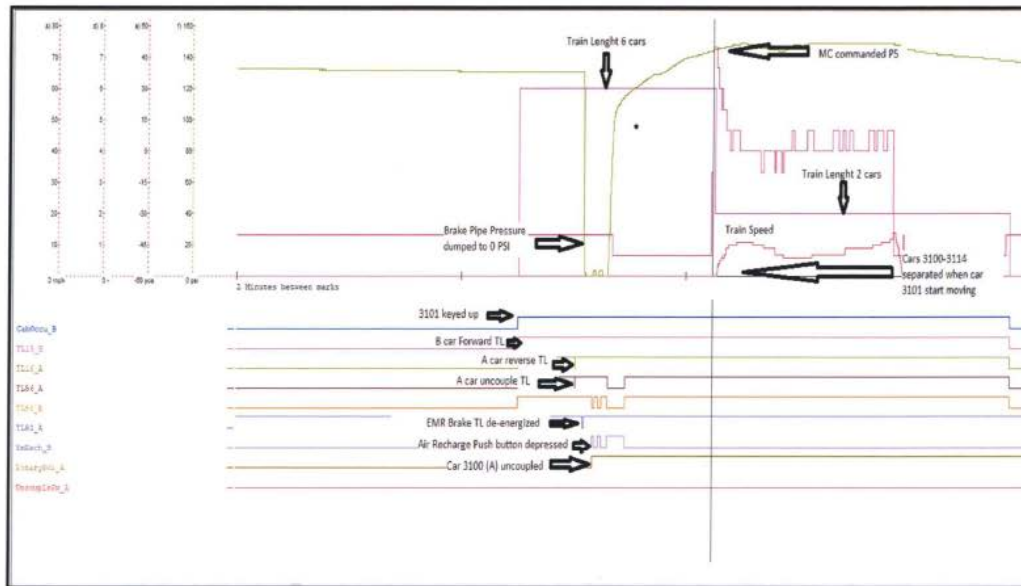
Figure 5. VMS Graph Analysis

Once the train started to move, the cars were separated, and the train length changed from 6 cars to 2 cars. Approximately 2.5 minutes after the undesired uncouple, cars 3101-00 stopped just beyond the Wiehle-Reston station.
