FINAL REPORT OF INVESTIGATION A&I E18476

October 31, 2018
Collision with object

W-0022

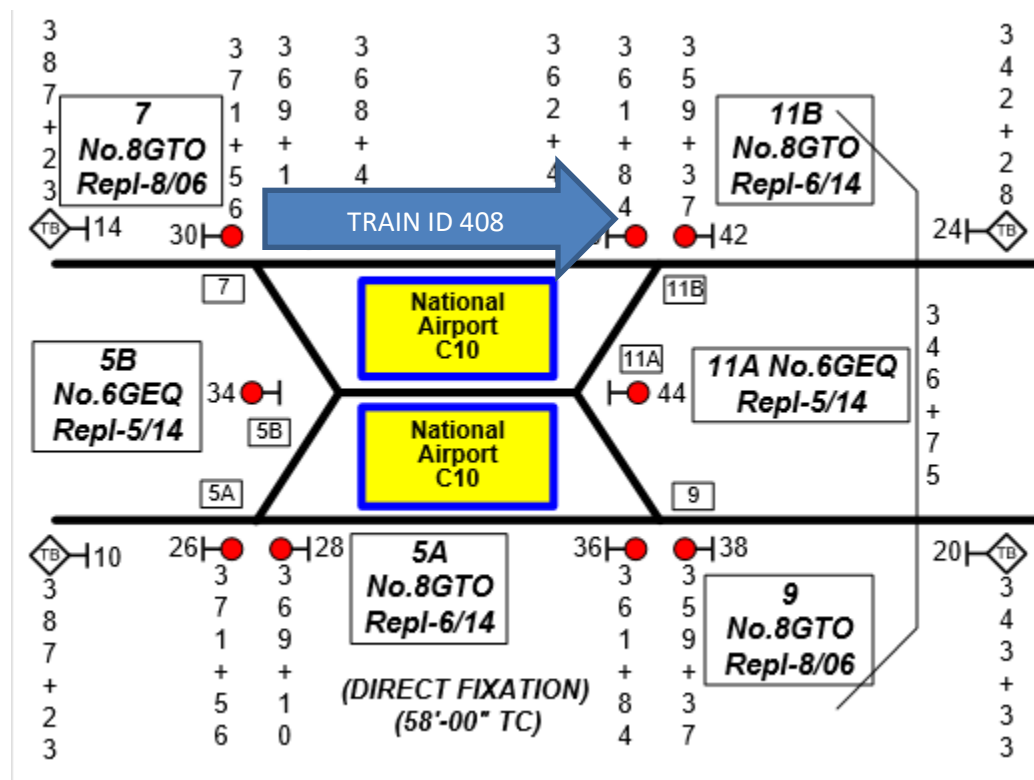
Field Sketch/Schematics

National Airport (C10) C2 364+50

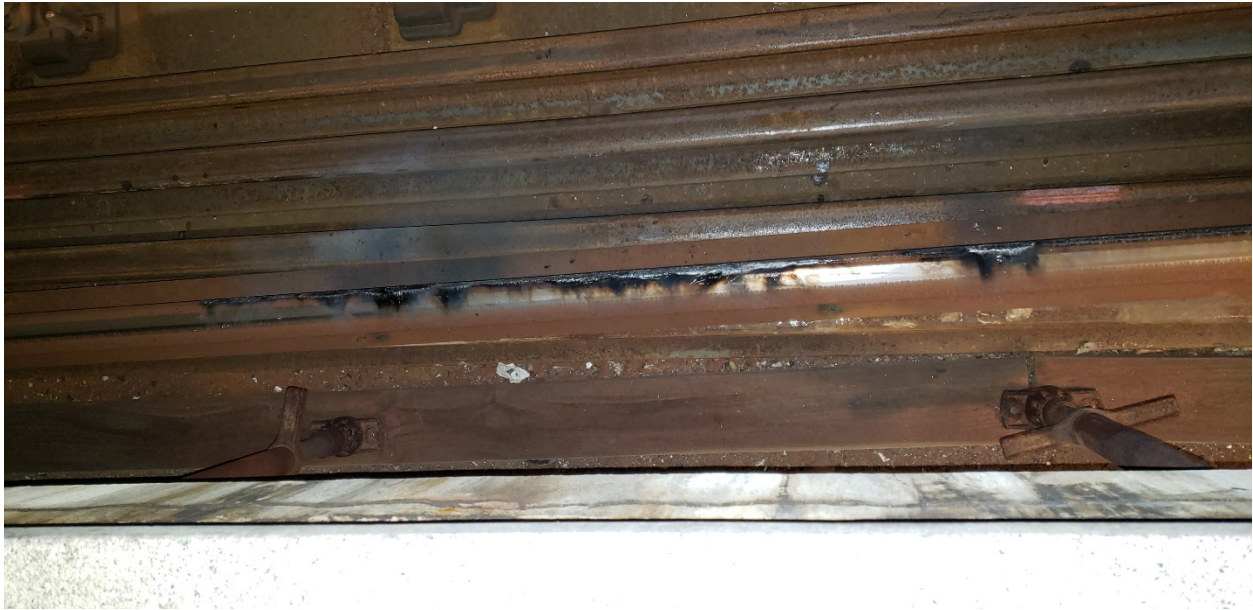
- One of the stored rails was sitting higher than the others
- When Train ID 408 entered C10 the collector shoes of car 3126, bridged the old unsecured rail

- When the collector shoe made contact with the old rail, it blew the collector Shoe Fuses on the left side of car 3126
- Train 408 operator reported the train was losing power and the Evaporator was inoperable.

in the track bed, however, the rails fouled the dynamic envelope of Train ID 408, therefore, when the train came into the station, the collector shoes came into contact with the rail. This contact caused the train to blow the Collector Shoe fuses and to break off a Collector Shoe Paddle, preventing it to move to its destination resulting in a delay of revenue service.

Photo 1 – Old rail that made contact with the collector shoe

1. Train Consist was removed from service
2. TRST cut the old rail and removed it to a secure area
3. The RWIC was counseled and re-trained in the proper inspection procedures of the work area at the end of the shift.

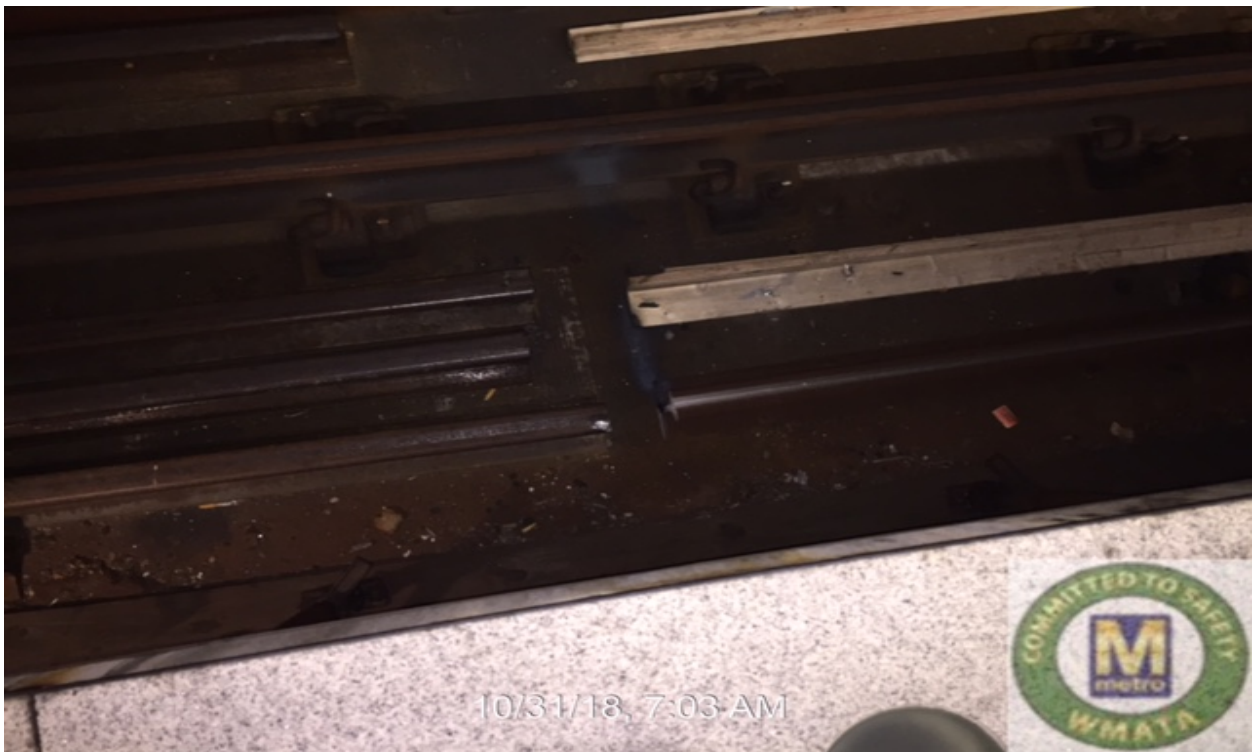
Photo 2 – Old rail was cut and moved

- The impeding rail was removed and stored at a safe location.
