Inspection Form

Washington Metrorail Safety Commission

Inspection Date	YYYY 2019	MM 10	DD 04	Report Number	20191004-WMSC-MAL-1		
Rail Agency Name	Washington Metropolitan Area Transit Authority			Rail Agency Department	CTEM	Sub- Department	New Carrollton Yard
Rail Agency Department Contact Information	Name		Email		Office Phone		Mobile Phone
	██████████		██████████		██████████		██████████
	██████████		██████████		██████████		██████████
Inspection Location	New Carrollton CTEM Shop - Railyard D99 4300 Garden City Dr Hyattsville, MD 20785

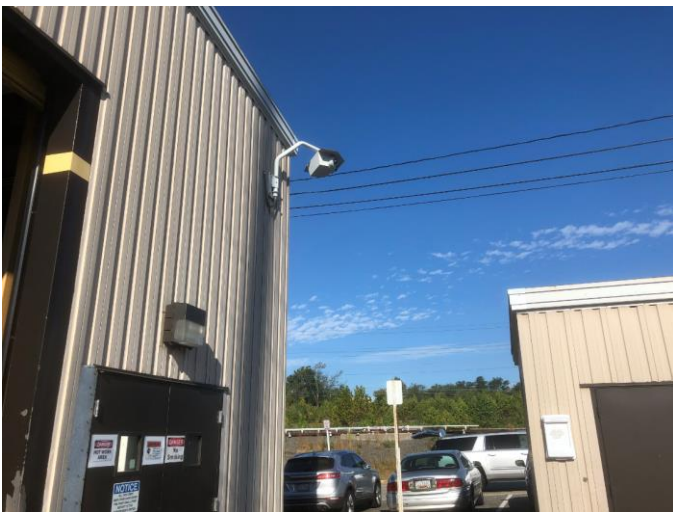
Photo 1 – The lighting outside the CTEM shop apron is poor

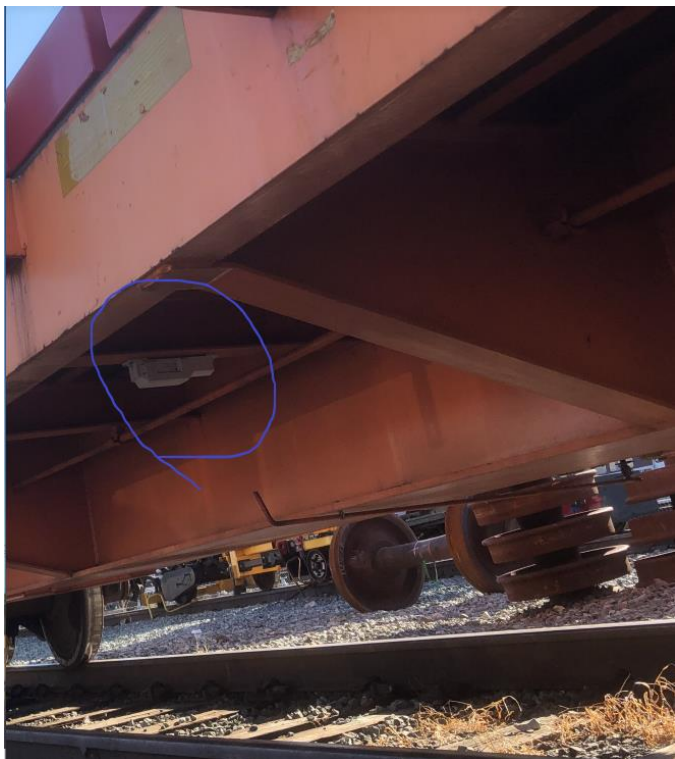
Photo 2 – CTEM management is installing transponders in all their equipment

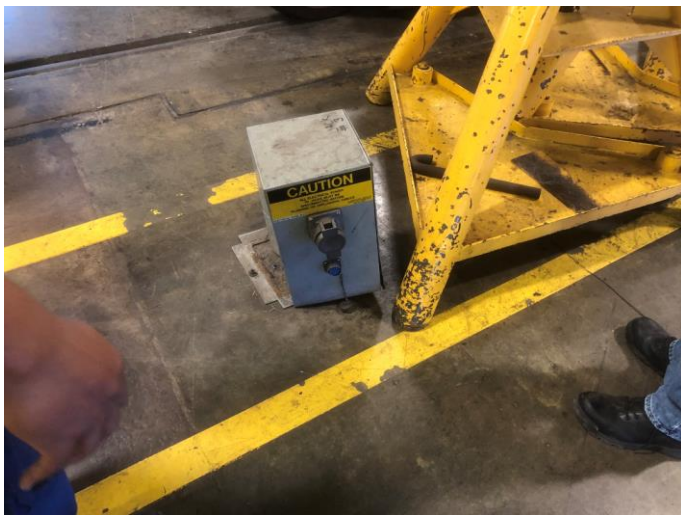
Photo 3 – CTEM floor electrical power units are loose, damaged, and create trip hazards

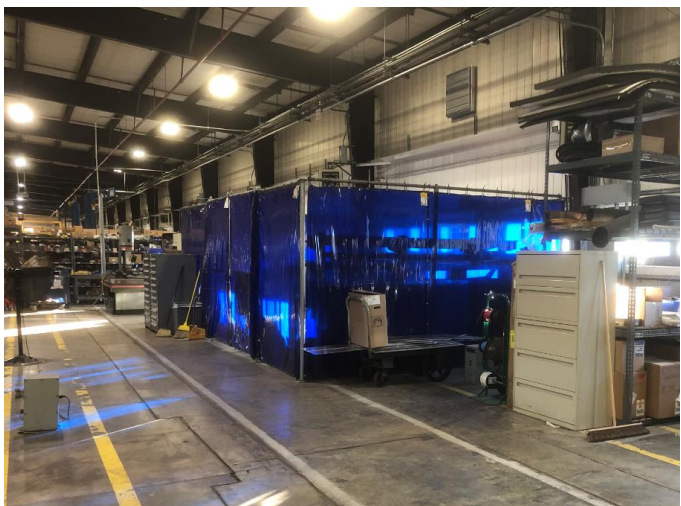
Photo 4 – A missing curtain barrier from the hot works area was installed

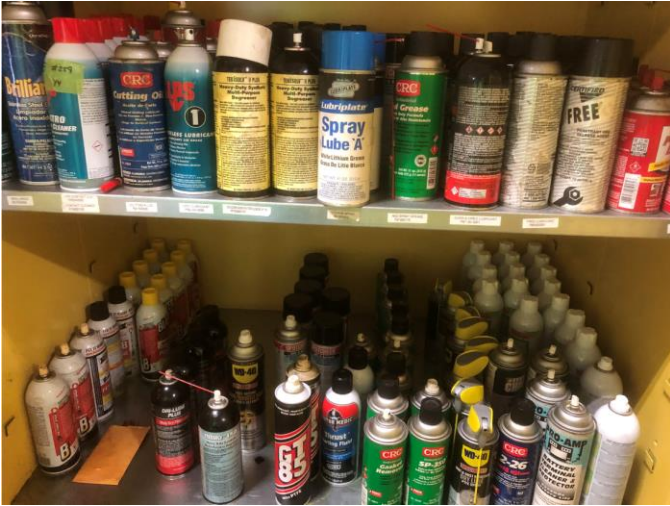
Photo 5 – Hazardous material labels have been added to storage cabinets

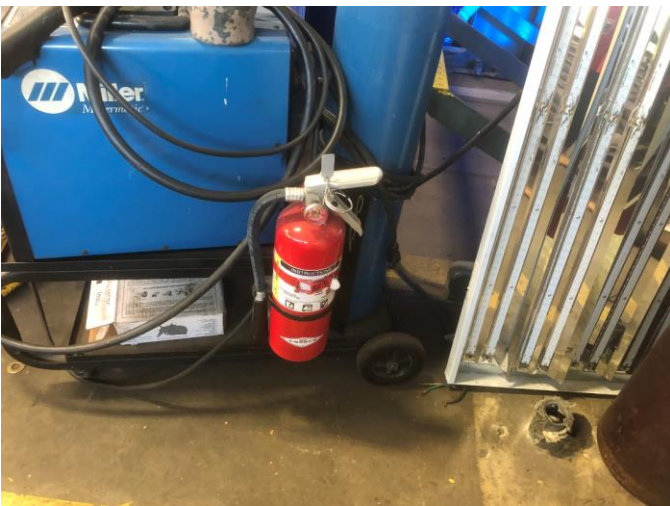
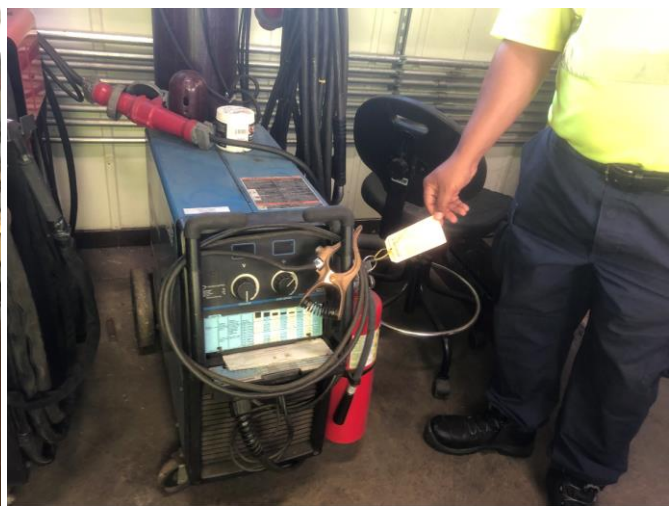
Photos 6 and 7 – Fire extinguisher inspection labels were missing from some fire extinguishers

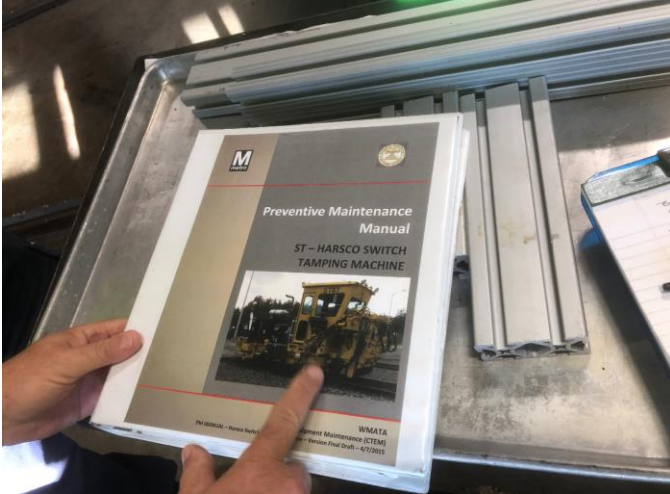
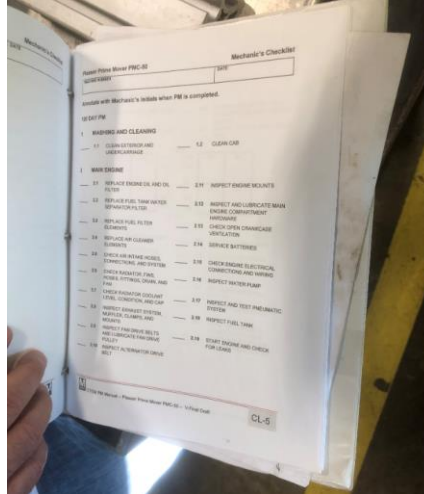
Photo 8 – Preventive maintenance manuals are available for each piece of CTEM equipment
