Washington Metrorail Safety Commission

Inspection Date	YYYY	MM	DD	Report Number	20191121-WMSC-MAL-1				
inspection bate	2019	11	21	Report Number					
Rail Agency Name	Washington Metropolitan Area T Authority		Area Transit	Rail Agency Department	CMNT	Sub- Department		Alexandria Yard	
	1	Name		Email	Office Phon	e	N	Mobile Phone	
Rail Agency Department Contact Information		 					N/A N/A		
Inspection Location		S&I Shop - R hower Avent VA 22314	•

Inspection Activity #	1	Insped	ction Sub	ject	Shop / Yard Inspection Observation		Activity Co	ode	VN	Л	WI	PI			
Job Briefing Employee Name/Title	WMATA Inspection		Accompanied Inspector?		Yes	Out Brief Conducted	Yes	Time 08:0			Outside Shift	No			
Related Reports	N/A			Related CAPS / Findings TOC-COL-15			-003-A								
	Ref Rule		Rule	Rule or SOP		Standard		Other / Title			Checklist Reference		ence		
Related Rules, SOPs, Standards, or Other	and P Hand	rocedu book (N	ifety Rule: res MSRPH). afety Rule		FTA S	afety Dire	ective 16-2								
Increation Location	Mai Trad		Yard	Stat	ion	осс	RTA Facility	WMSC Office	Track Trace	At-grade	At-grade Tunnel		Ele	evated	N/A
Inspection Location			х						Track Type						Х
Line/s)	Track		N/A		Chain Mai	rker

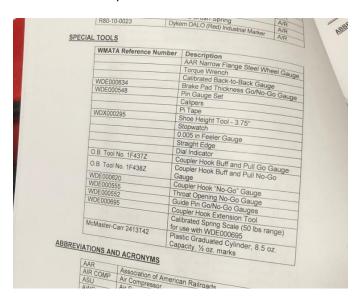
Photo 1 – Some special tools are listed in the PI manuals but do not have a WMATA part number

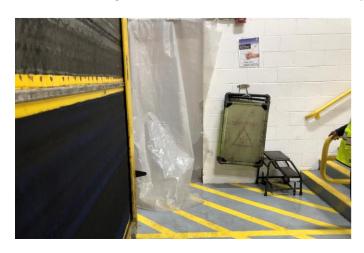
Photo 3 – Missing car wash access door inside the S&I shop

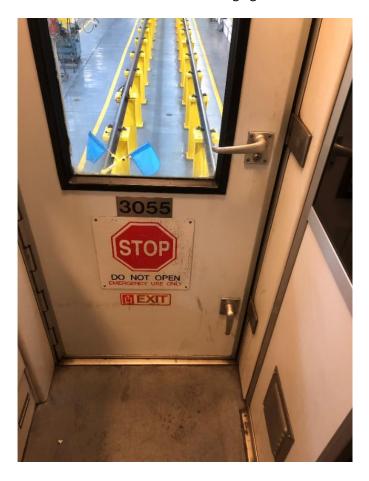
WMSC noted a safety sign on the wall of the S&l Shop that states "if you see a hazard report it". This is a good initiative to promote transparency and safety management systems (SMS) philosophy. Railcar Equipment WMSC inspector noted that a 2K3K bulkhead door on railcar 3055 was getting stuck. The door was rubbing against the threshold plate. See attached photo 5. This defect can have safety implications – this needs to be resolved. This door is an exit door for this train car, in the event of emergencies. This issue will be brought up at the WMSC/CMNT/CENV Monthly meeting. WMSC inspector noted that 7K railcar wheels are getting out of round every two months. Wheels on railcar 7655 were in the process of being cut. See attached photo 6. This issue will be brought up at the WMSC/CMNT/CENV Monthly meeting. Railcar collector shoe height and air bag/platform height are checked every two months. WMSC inspector provided an out-briefing to the Assistant Superintendent.

Photo 5 – Bulkhead door was rubbing against the threshold plate

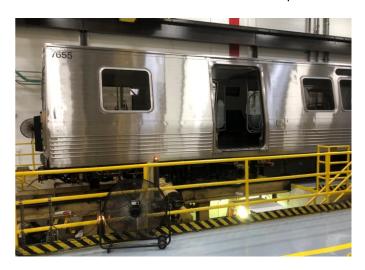
Photo 6 – Wheels on railcar 7655 were in the process of being cut
