FINAL REPORT OF INVESTIGATION A&I E19325
June 25, 2019
Doors Failed to Open

W-0023

FINAL REPORT OF INVESTIGATION A&I E19325**SMS 20190625#81026**

Date of Event:	06/25/2019
Type of Event:	Door Failed To Open
Incident Time:	06:26 hrs.
Location:	Smithsonian (D02), Track 2
Time and How received by SAFE:	07:00 hrs. On-Call Phone
Safety Officer Response:	No
Time of Safety Officer Arrival:	N/A
Time of Safety Officer Departure:	N/A
Rail Vehicle:	L3020-3021.3089-3088.3074-3075.3058-3059T
Injuries:	None
Damage:	N/A
Emergency Responders:	N/A

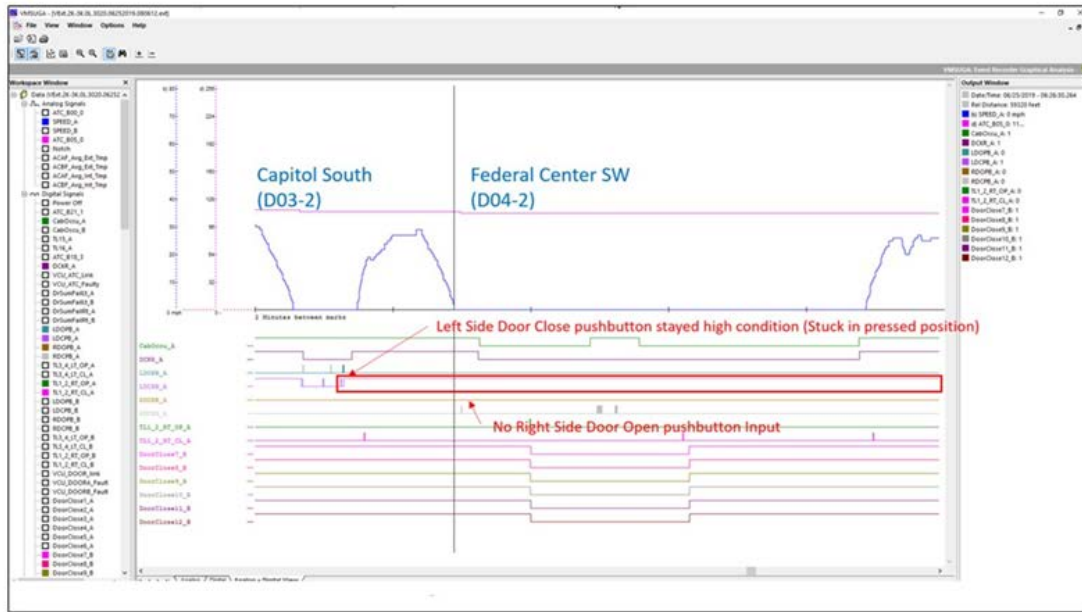
Based on salient facts identified as part of this investigation (ARS, CCTV, CENV data), SAFE is in concurrence with CMNT and CENV. Train ID 918 doors failed to open and close as a result of a defective close push-button on left door control panel which allowed a door close signal to remaining active (pushed in) position. This resulted in the train doors failing to open and close from the lead car while it was keyed up. When the T/O keyed down and went to the third car in the affected consist, there was no signal from the lead car preventing the doors to open or close. Therefore, upon open door push-button activation, in the third car, doors were allowed to open and later close without failure.

CENV analyzed the VMS for 3020-3021. According to the VMS, the Left Door Close push-button failure caused the reported incident. Seen below screenshot, left door close push button status was stuck in a High condition (pressed position) after operator closed the left side doors at Capitol South station the push-button never (released) recovered.

- Check the Left Door Close push button condition and R/R if necessary.

CMNT removed and replaced the defective left door control panel, operations test performed with no failures.
