FINAL REPORT OF INVESTIGATION A&I E19151, E19152, and E19159
March 25 and 28, 2019
Incorrect Route

W-0026

FINAL REPORT OF INVESTIGATION A&I**E19151, E19152, and E19159****SMS 20190326#78749****20190326#78750****20190328#78807**

D&G Junction (D98), Track 1, D98-36 Signal

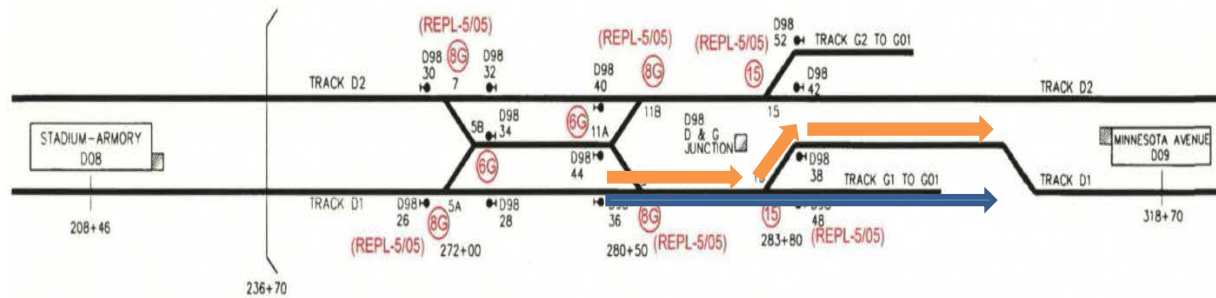
Field Sketch/Schematics

Key: The arrows are showing the direction of traffic on Track 1.

The Blue Arrow is showing the incorrect route the train took during the incidents.

The Orange Arrow is showing the correct route the train should've taken.
