FINAL REPORT OF INVESTIGATION A&I E18267

July 2, 2018
Smoke Event

FINAL REPORT OF INVESTIGATION A&I E18267**SMS # 20180705#72432**

Draft Final Report - Fire/Smoke at Capitol Heights
 E18267

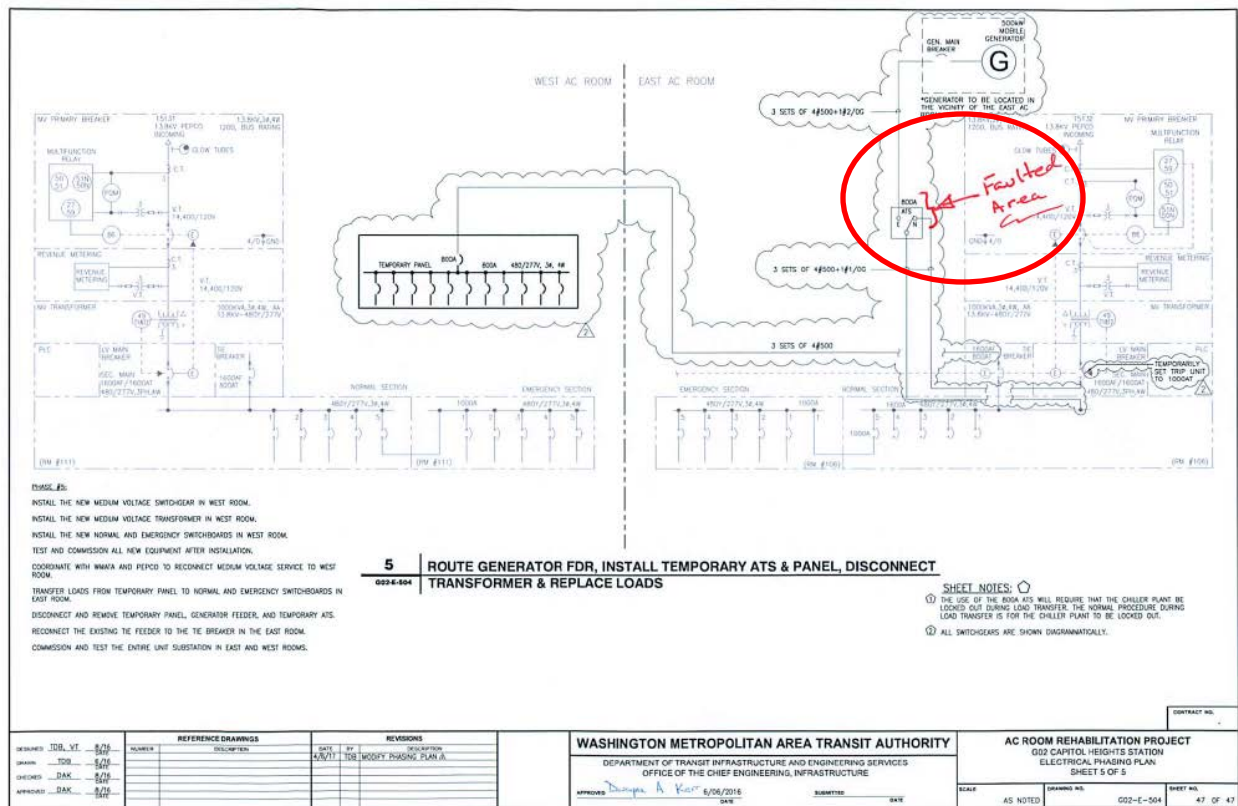
Above diagram is showing where it is believed the wiring caught fire.

a conclusion other than the insulation of the temporary cables at some point faulted, however, there is too much damage to pinpoint where. It appears that the cable faulted at the normal side of the transfer switch. The fault could have occurred in the insulation of the cable which was an aged cable. Also, the fault could merely have been chafed against the grounded enclosure [weight] to the point of a fault occurring. The installation of the materials along with the material itself was acceptable to standards of both National Electrical Code (NEC) and WMATA. The cables were not overloaded. The loads were known and checked before installation even began. It's important to note that while the fire occurred in the temporary generator system wiring, the generator itself and its operation had nothing to do with the fire. The sequence of events, abbreviated, indicate that the "normal side of the transfer switch" faulted causing the fire. The generator was not running. When Operations responded to the fire, their first order of business was to cut power which is typical. This in turn activates the generator. Later, the generator and output were de-energized as well. The load side wiring from the transfer switch was not damaged supporting the conclusion that there was no load issue. Due to an unknown root cause, SAFE has no further actions on this matter and recommends E18267 for closure.

1. POWER shall take the appropriate action deemed necessary to support prevention of repeated recurrence.
 - a. **For all future contracts or projects that require the use of a temporary generator, the electrical system supporting or tied into the generator system, including required equipment, such as the wiring system will now be installed in accordance with permanent procedures. Doing this eliminates the potential fault of exposed cables.**
 - b. **For new design requirements, all cable installed will be new stock to eliminate the possibility of using damaged or degraded cables.**
 - c. **POWER will conduct a bi weekly visual inspection of all associated equipment such as the transfer switch, disconnect switches, circuit breakers and cables. Every month a maintenance checklist and confirmation of the integrity of the system will be provided.**

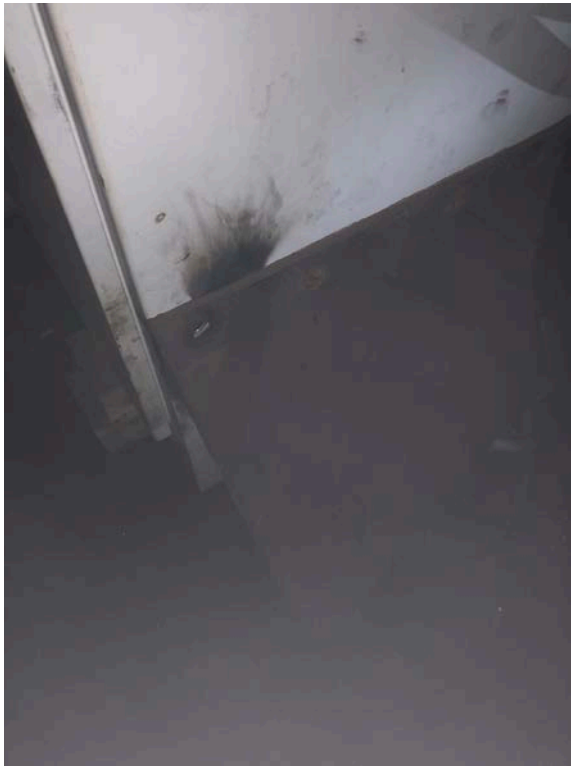
Photo 1 - Outside view of the switch gear controller

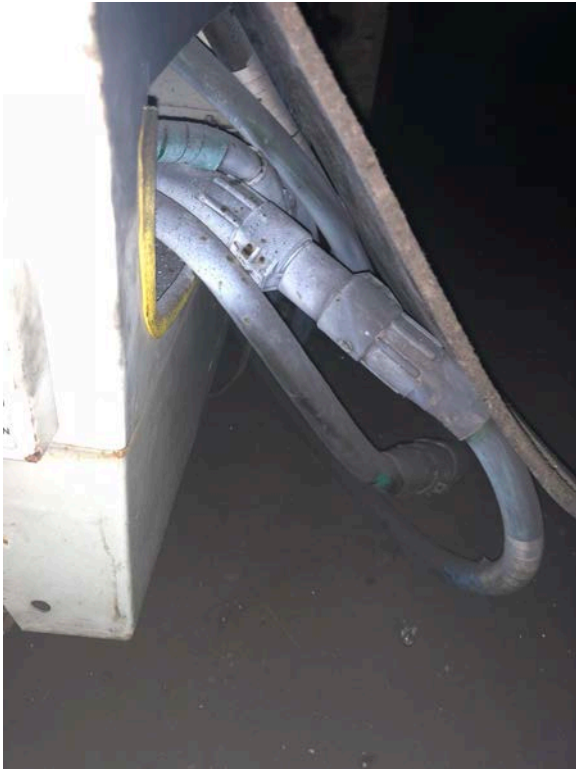
Photo 2 – Outside damage cables

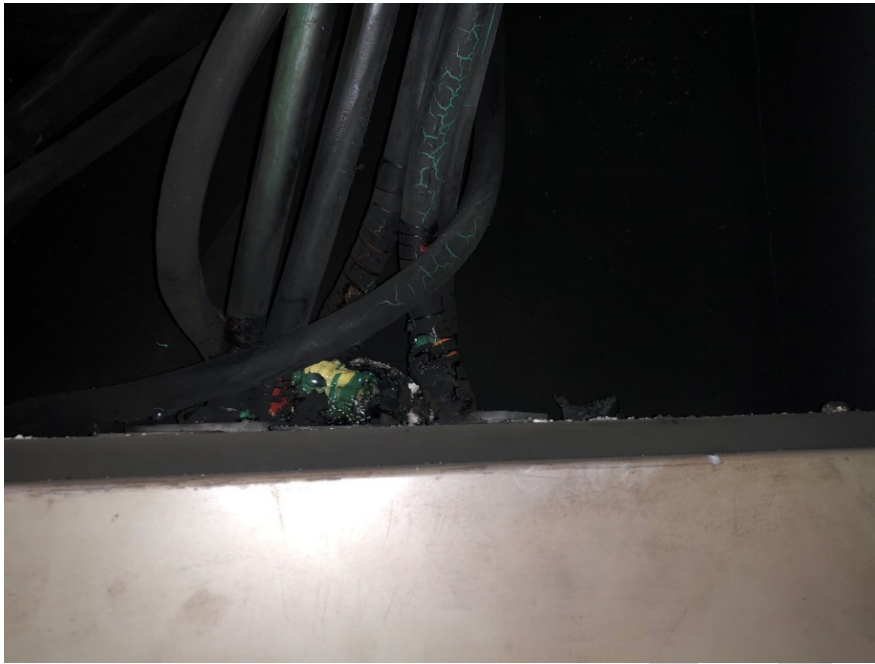
Photo 3 – Internal cable damage

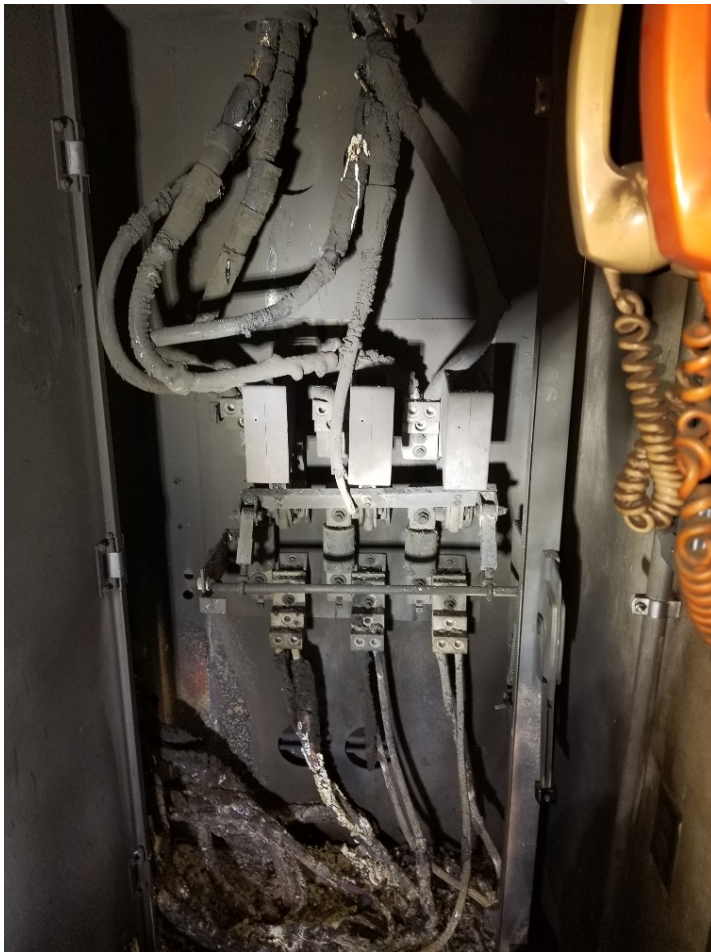
Photo 4 – Internal fire damage

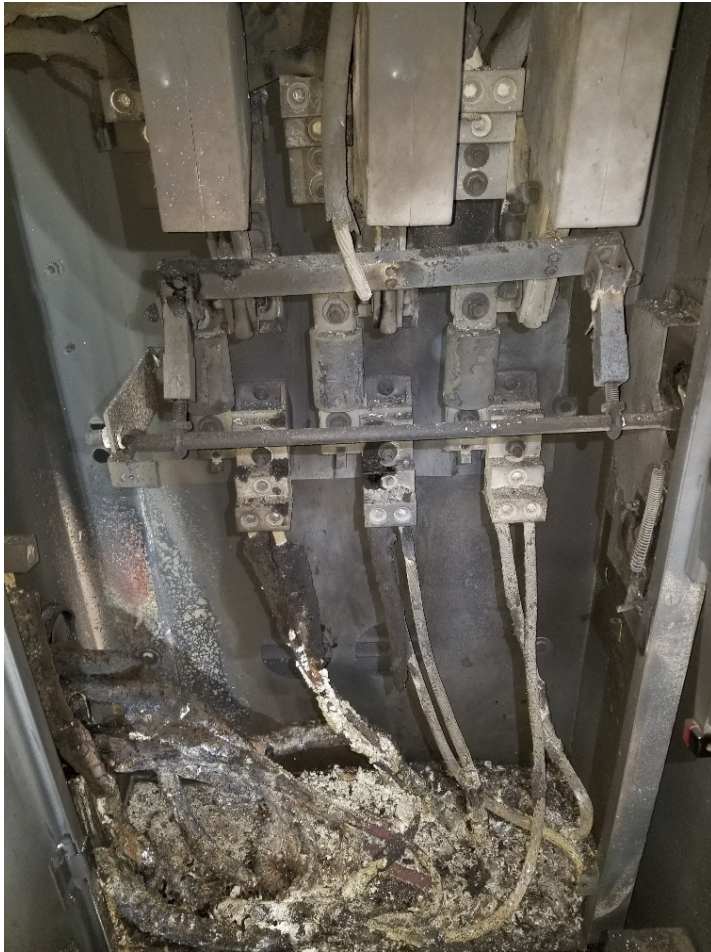
Photo 5 – Internal fire damage
