FINAL REPORT OF INVESTIGATION A&I E20130

March 9, 2020
Collision (Major)

W-0029

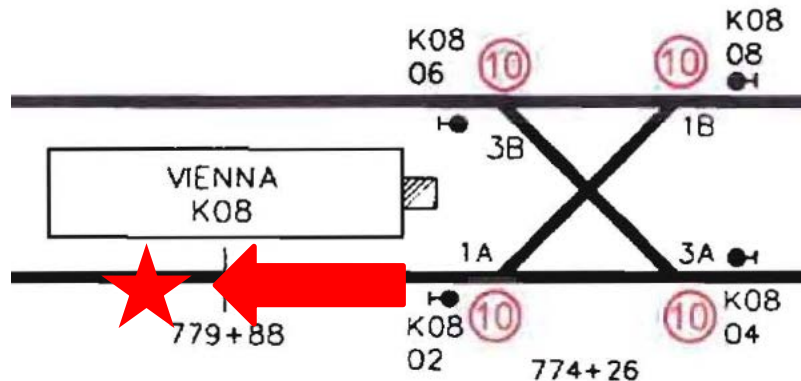
Field Sketch/Schematics

The incident area was located at the Vienna Station, Track 1
