FINAL REPORT OF INVESTIGATION A&I E19539

Collision

W-0030

SMS 20191007#83450

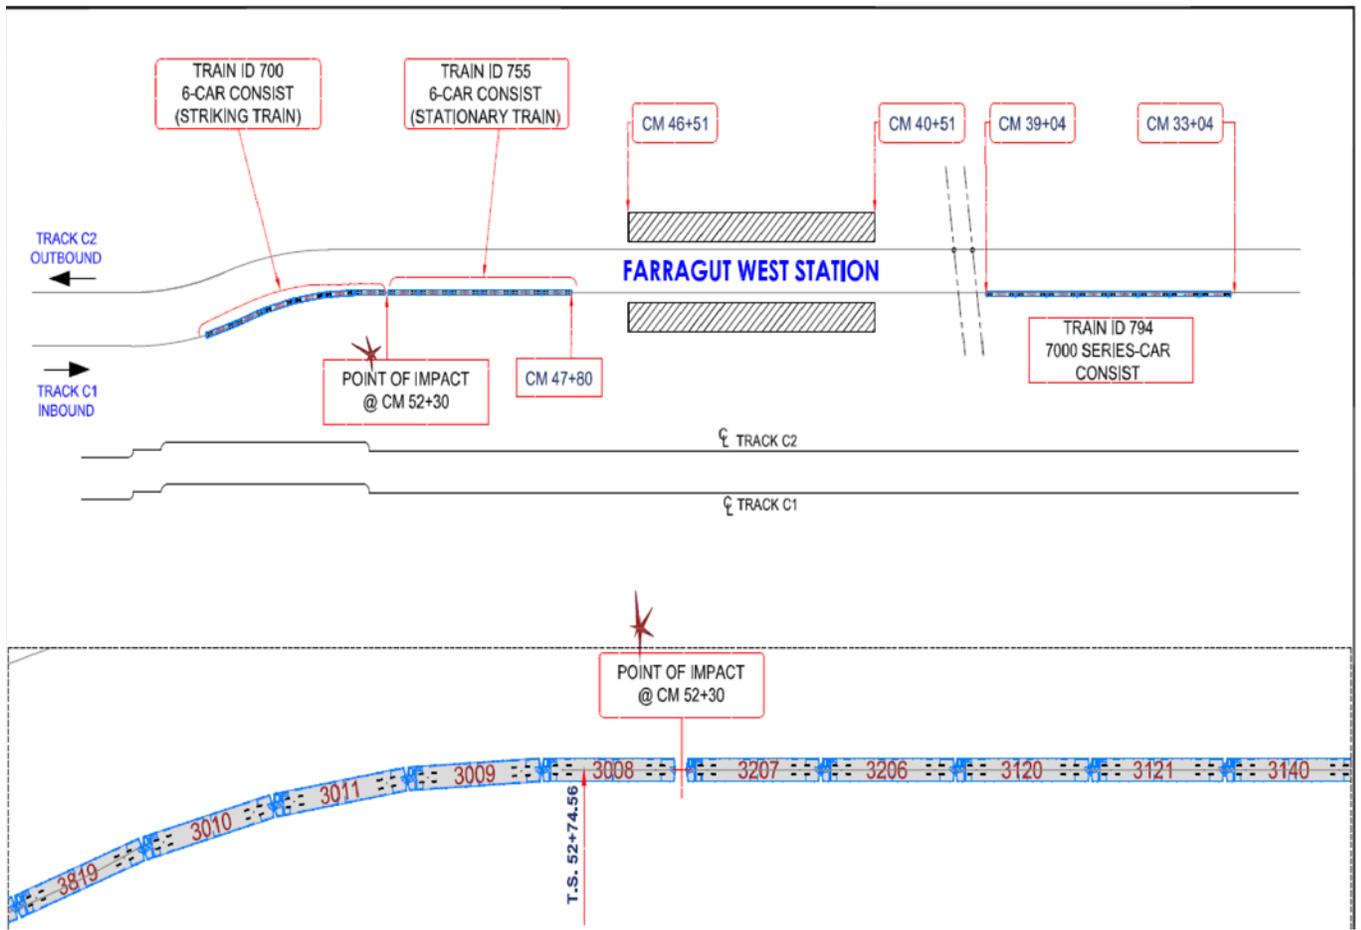
Figure 1 – Model of Incident Scene

At 00:45:55, Train 700 lost speed command signals. The train entered Stop and Proceed mode, without speed command signals. On three (3) separate instances, the speed (of Train 700) reached 15mph creating overspeed condition and application of Full Service Brake by ATC system. Train 700 was accelerating in P4 mode and collided with Train 755 at Chain Marker C1-52+30, at 00:48:11 while traveling at a speed of 11mph.

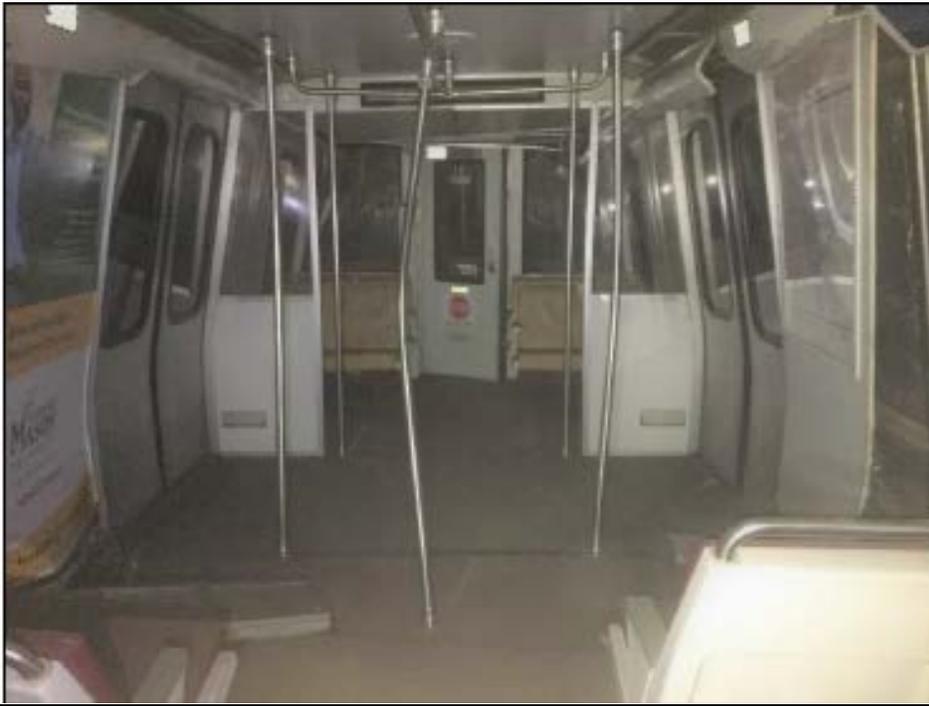
- No issues with night vision
- Was sitting upright and facing forward before collision event
- Upon impact with Train ID 755, the area was dusty and dark. Observed buckled seats and flooring in operating car.

Photo 1 – October 07, 2019, Car 3008 – Photo showing floor, stanchions and side décor panels buckled.

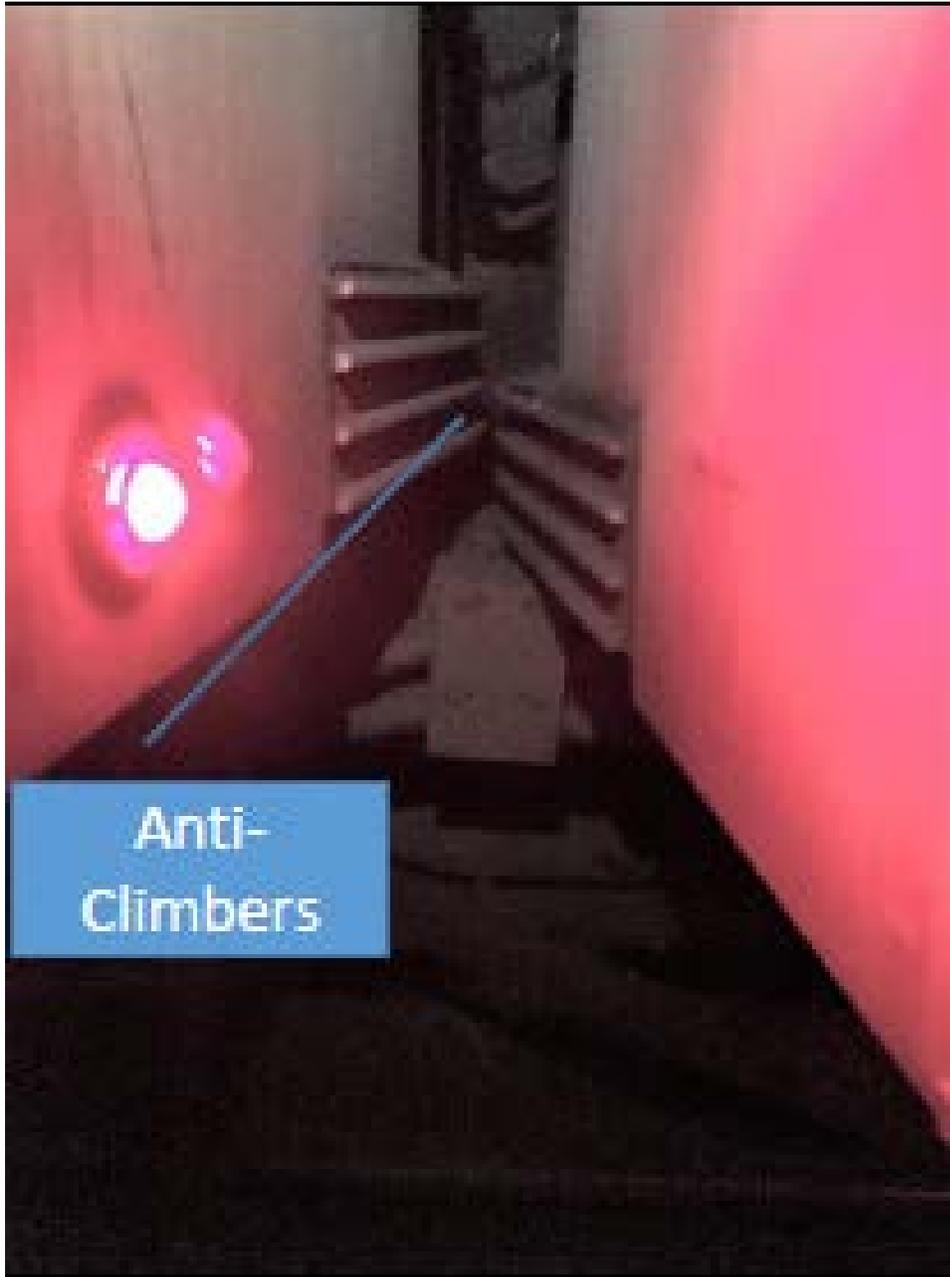
Photo 2 – October 07, 2019, Car 3008 – Photo showing Anti-Climbers made contact with each other.

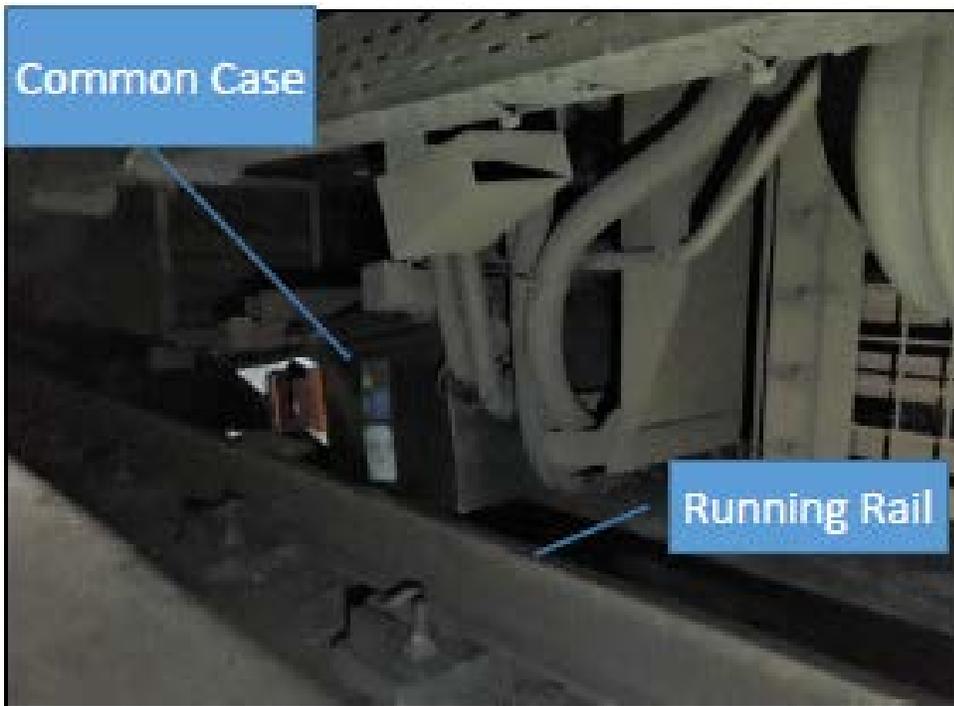
Photo 3 – October 07, 2019, Car 3008 – Photo showing Propulsion Common Case brackets broken and lying on top of the running rail.

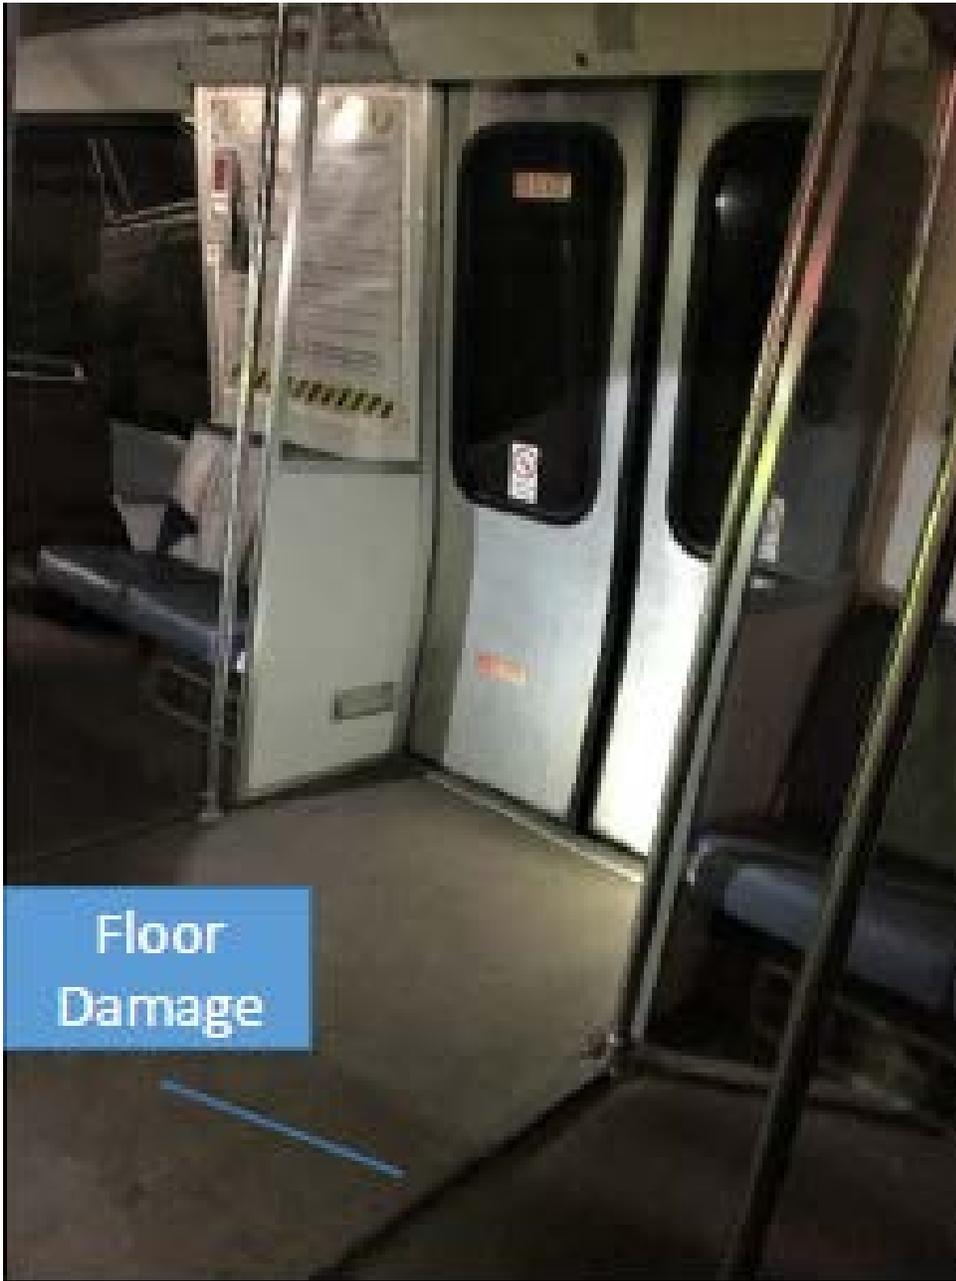
Photo 4 – October 07, 2019, Car 3007 – Photo showing floor, stanchions and décor panels buckled.

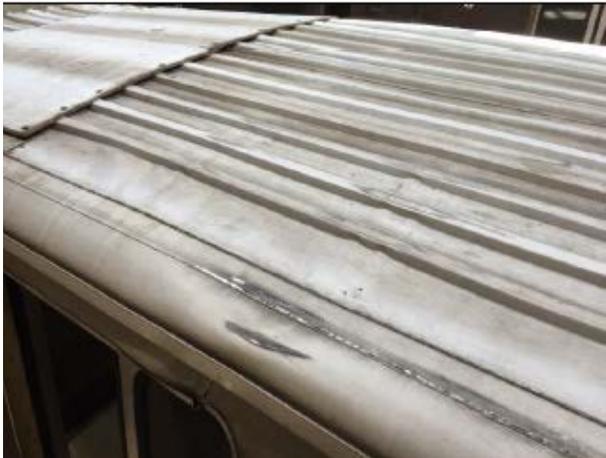
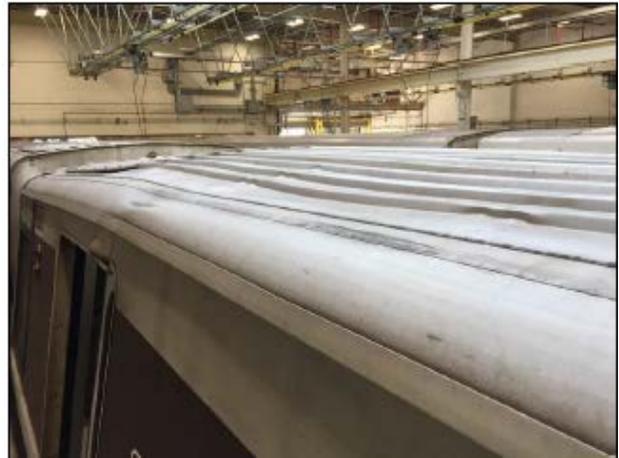
Photo 5 and 6 – October 09, 2019, Car 3008 – Photo showing roof buckled and sings of roof making contact with tunnel ceiling.

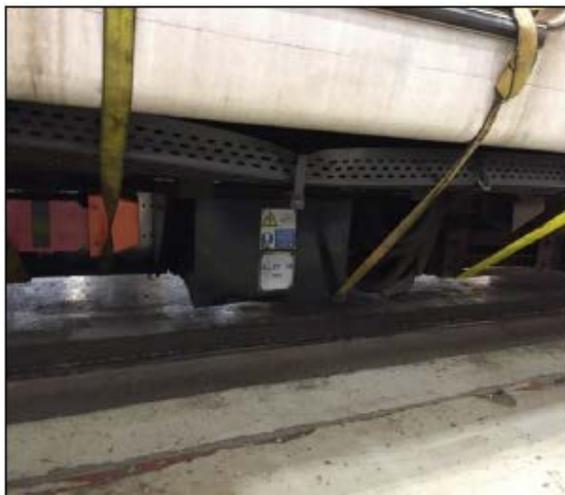
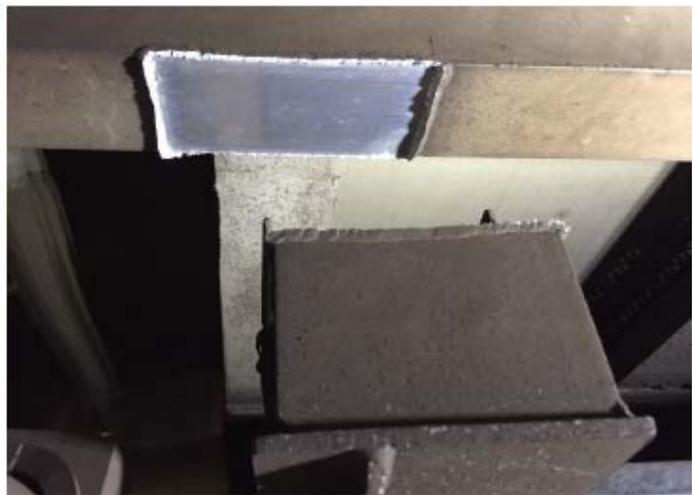
Photo 7 and 8 – October 09, 2019, Car 3008 – Photo showing broken Propulsion Common Case brackets.

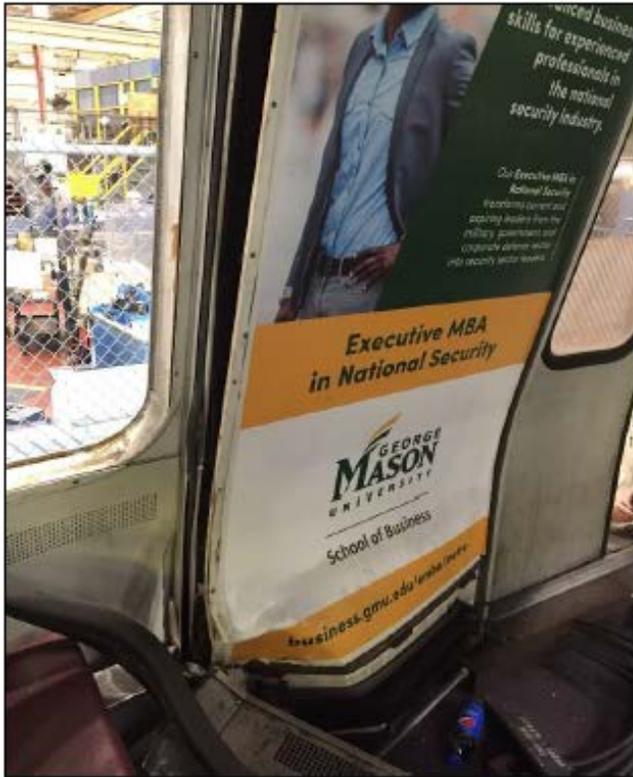
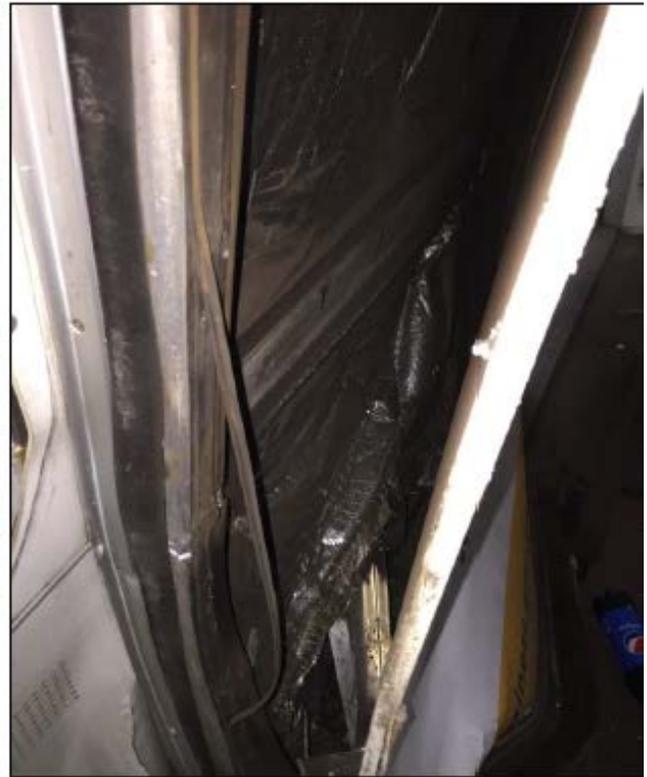
Photo 9 and 10 – October 09, 2019, Car 3008 – Photos showing damaged door pocket and décor panels.

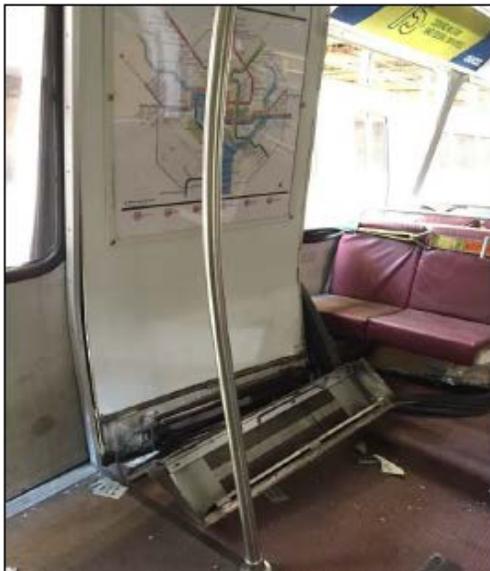
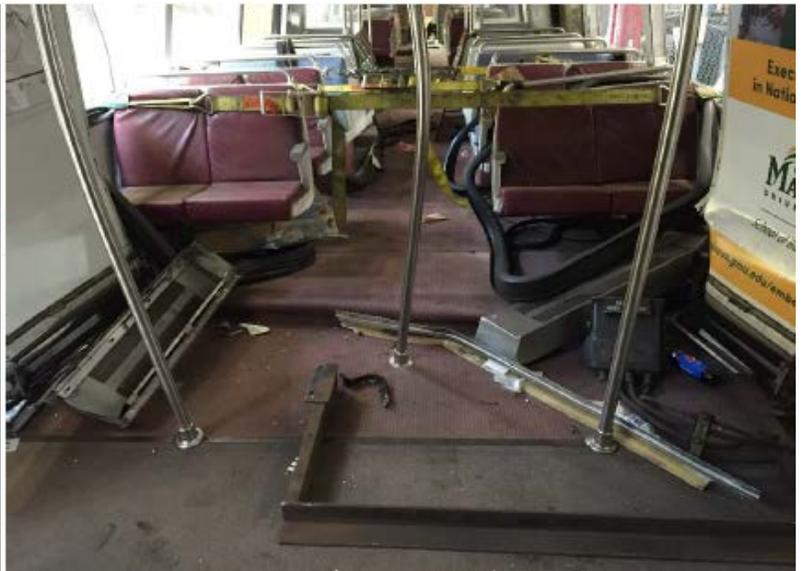
Photo 11 and 12 – October 09, 2019, Car 3008 – Damaged floor heat covers, stanchions, floor and décor panels.

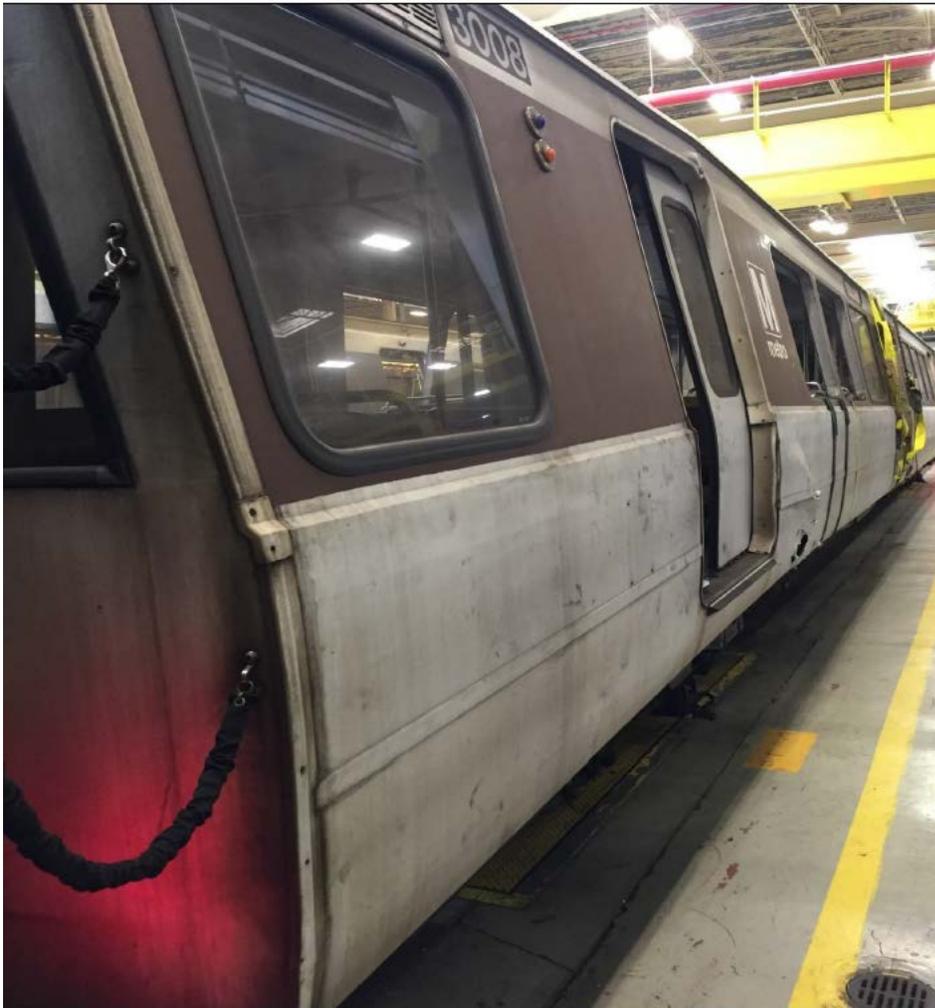
Photo 13 – October 09, 2019, Car 3008 – Photo showing exterior body panels buckled.

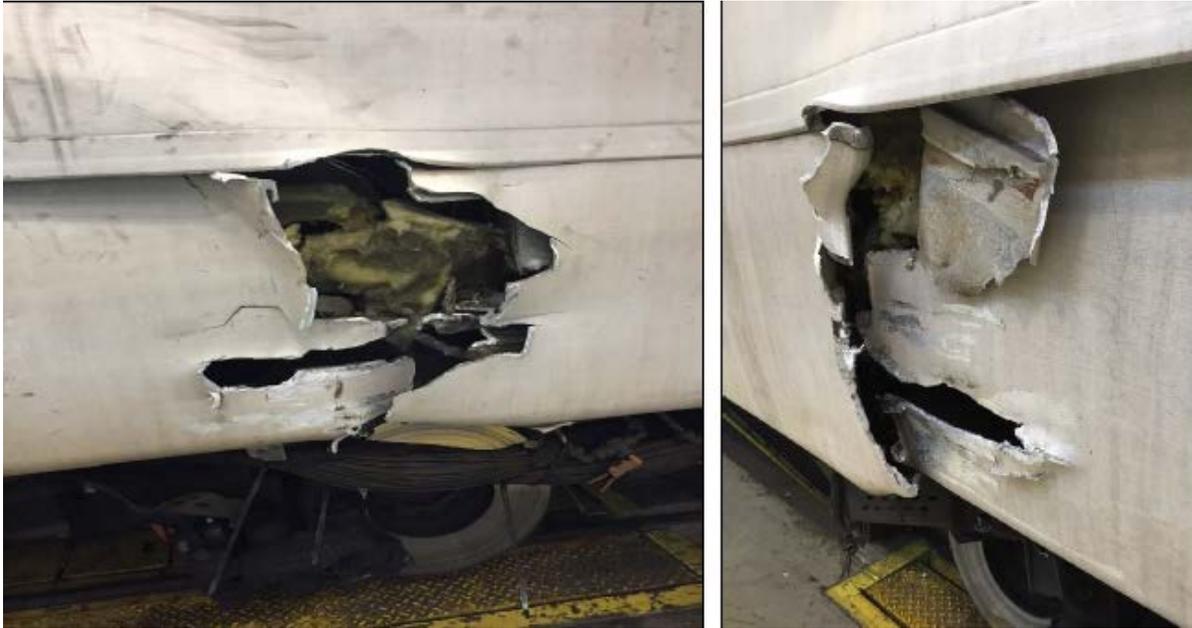
Photo 14 and 15 – October 09, 2019, Car 3008 – Photo showing exterior body panels buckled.

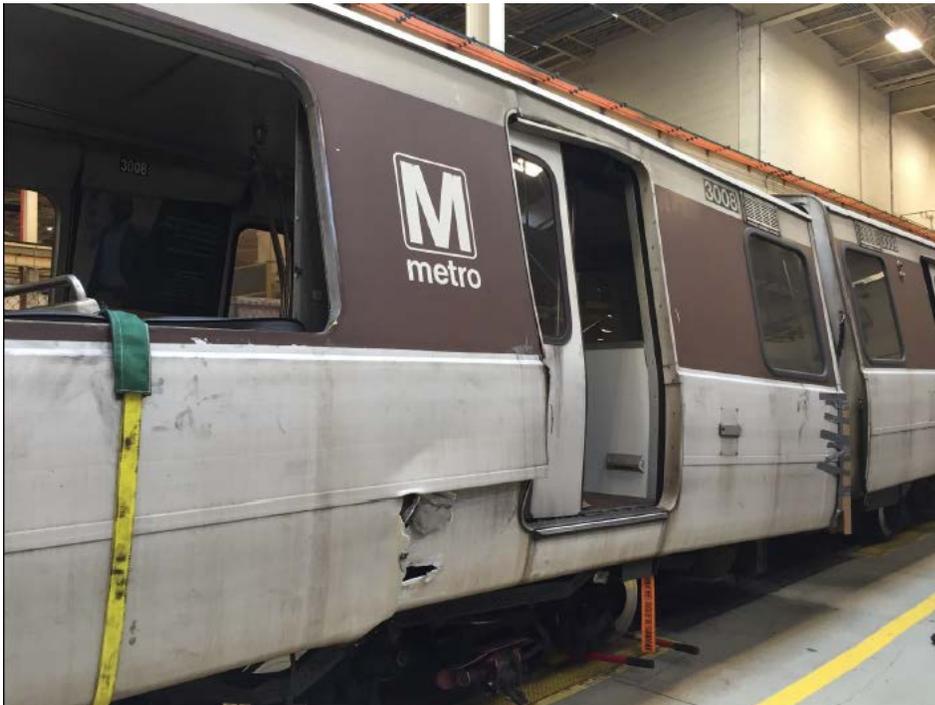
Photo 16 – October 09, 2019, Car 3008 – Photo showing exterior body panels buckled.

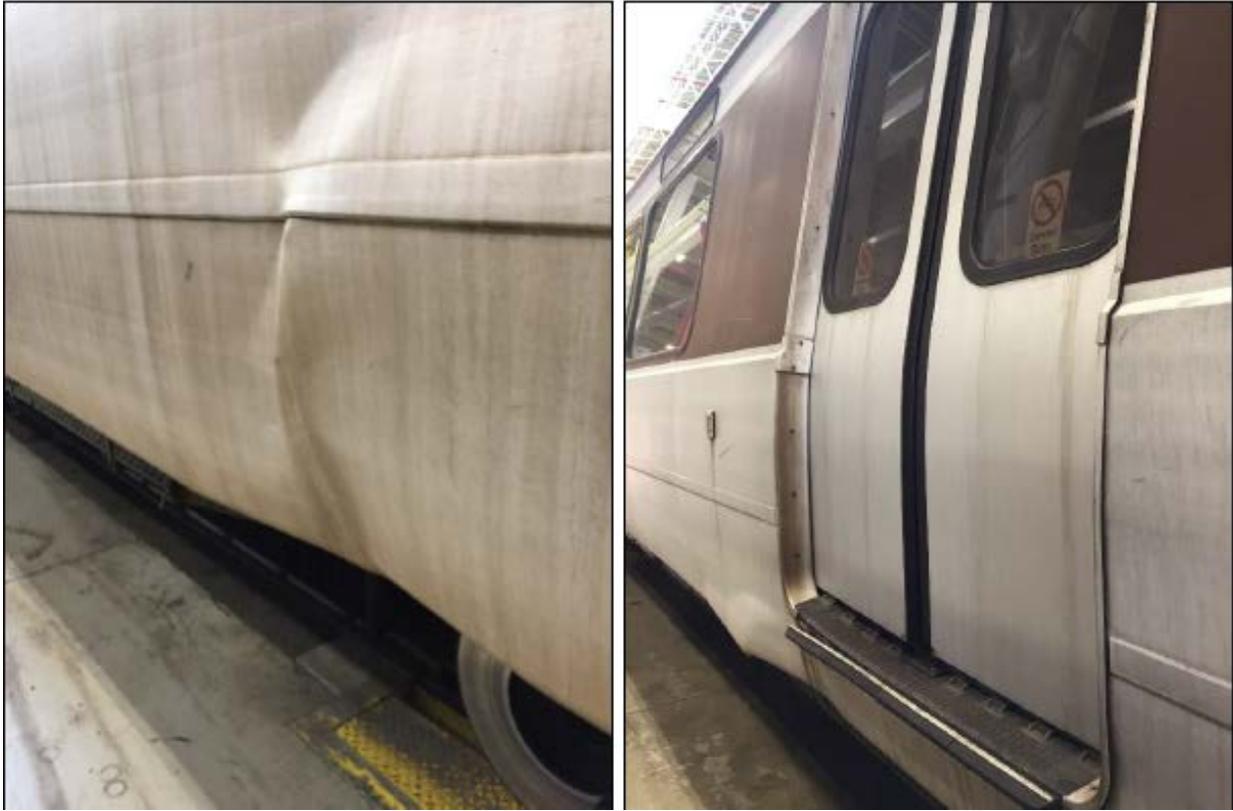
Photo 17 and 18 – October 09, 2019, Car 3009 – Photo showing exterior body panels buckled.

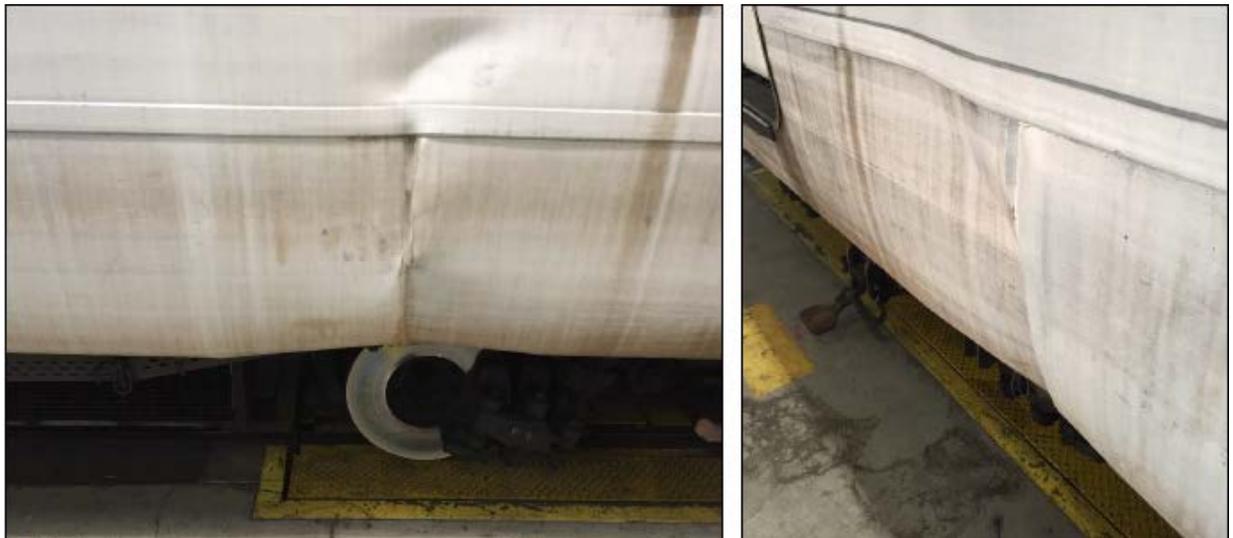
Photo 19 and 20 – October 09, 2019, Car 3206 – Photo showing exterior body panels buckled.
