**FINAL REPORT OF INVESTIGATION A&I E20085**  
February 14, 2020  
Derailment

W-0032

**SMS 20200214#86399**

<b>Date of Event:</b>	2/14/2020
<b>Type of Event:</b>	Derailment
<b>Incident Time:</b>	00:48 hrs.
<b>Location:</b>	Brentwood Yard, B99-62 Signal, Switch 65
<b>Time and How received by SAFE:</b>	01:00 hrs., On-Call Phone
<b>WMSC Notification Time:</b>	01:25 hrs. via Phone
<b>Responding Safety Officers:</b>	WMATA SAFE: Yes WMSC: No Other: N/A
<b>Rail Vehicle:</b>	HR 260 (Ford 750)
<b>Injuries:</b>	None
<b>Damage:</b>	No
<b>Emergency Responders:</b>	SAFE, RTRA, ATC, CTEM, PWR

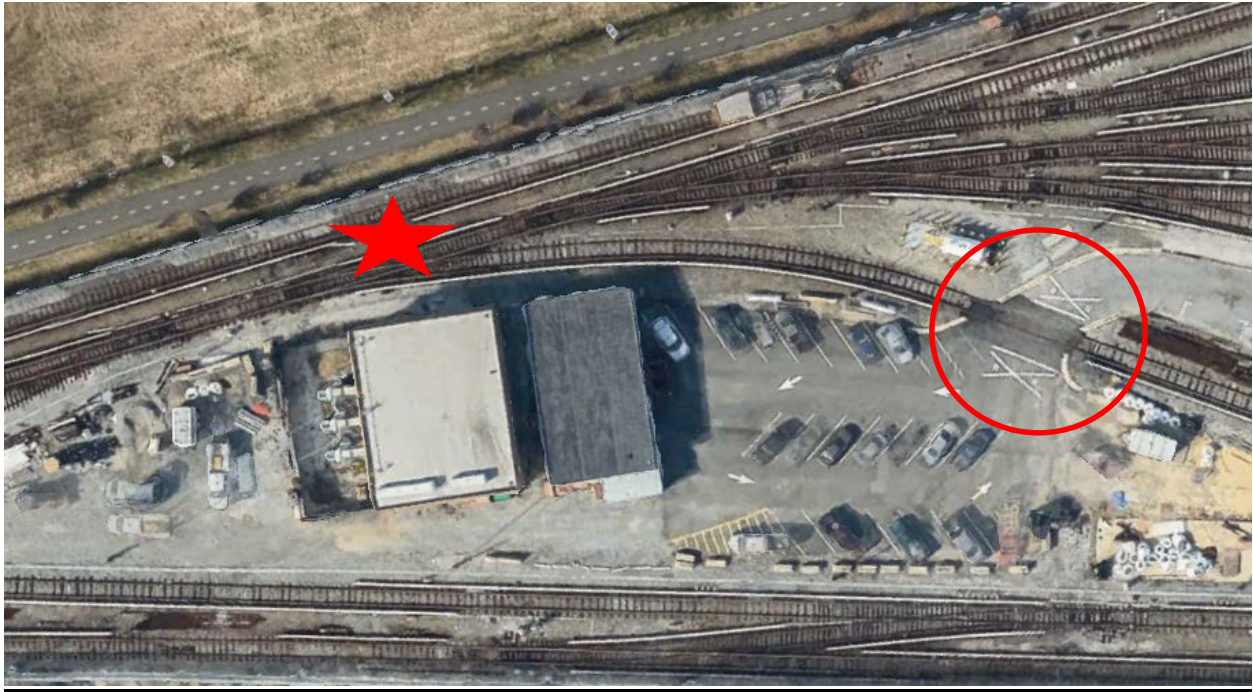
## Field Sketch/Schematics

HR 260 Mounted at Grade Crossing (Circle Indication) between B99-24 Signal and B99-66 Signal

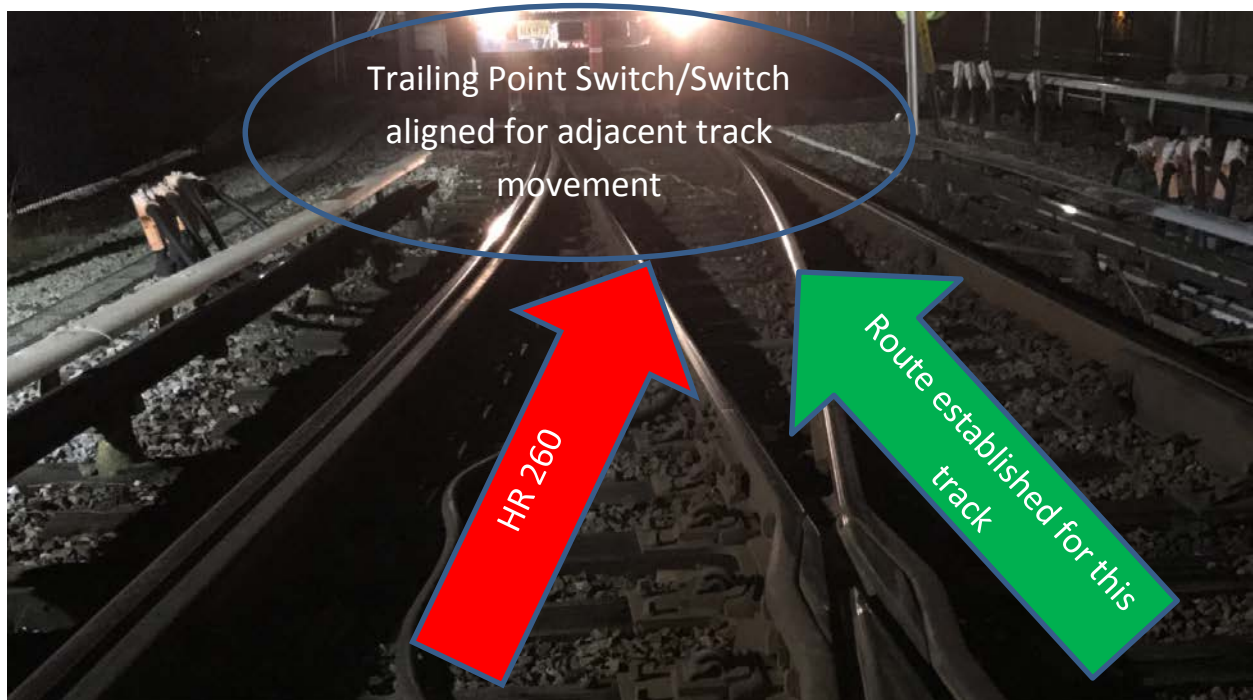
Photo 1 – Trailing point switch move shows alignment established for the vehicle depicted with a green arrow on the right side of photo.

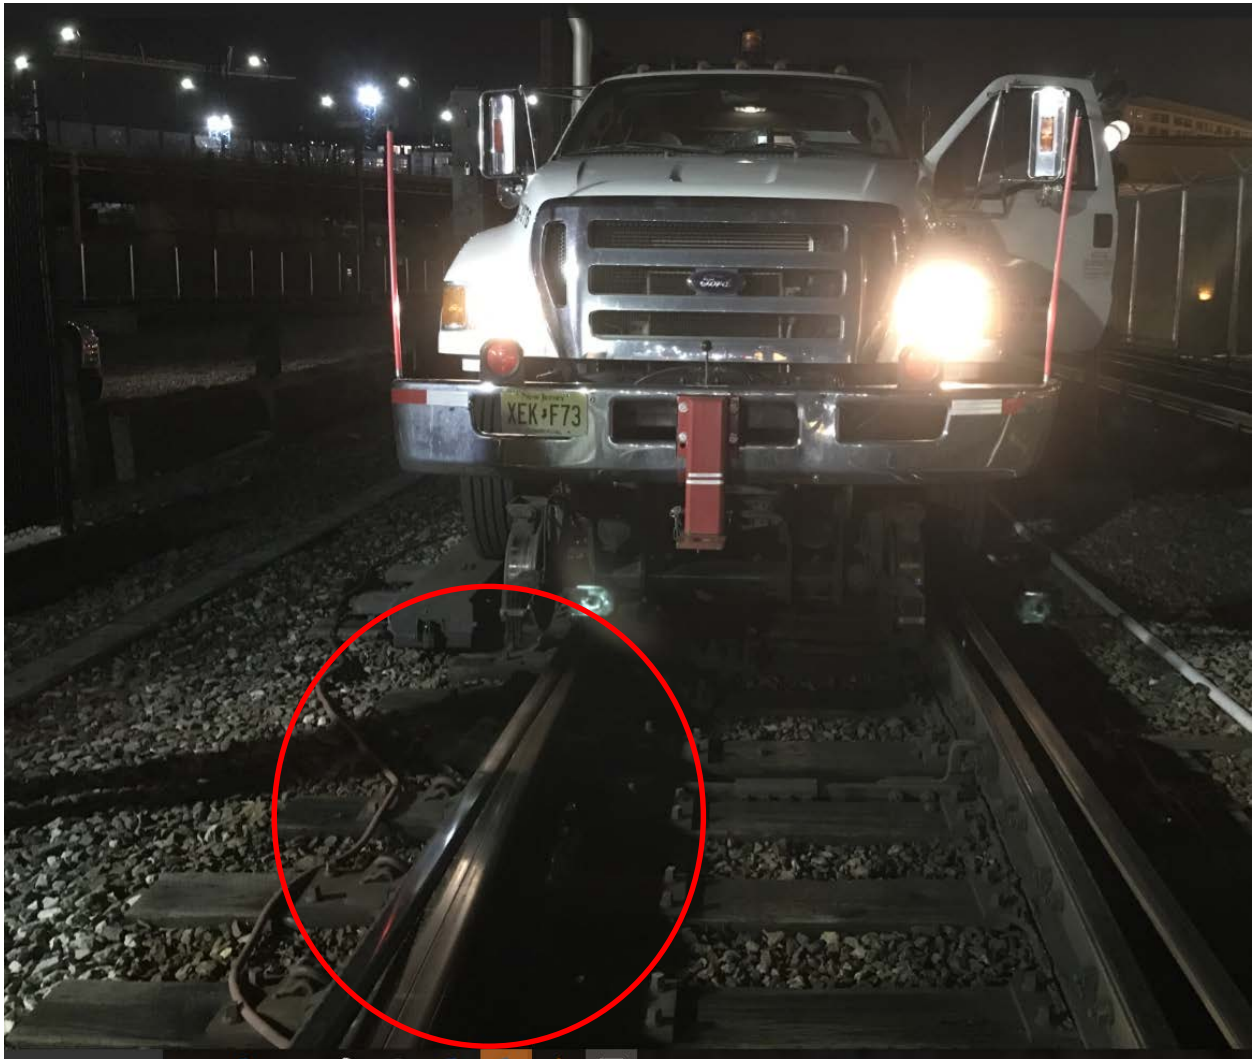
Photo 2 – Rail tucked on the left side of the rail indicating straight through move (Normal Position) for movement on adjacent track.

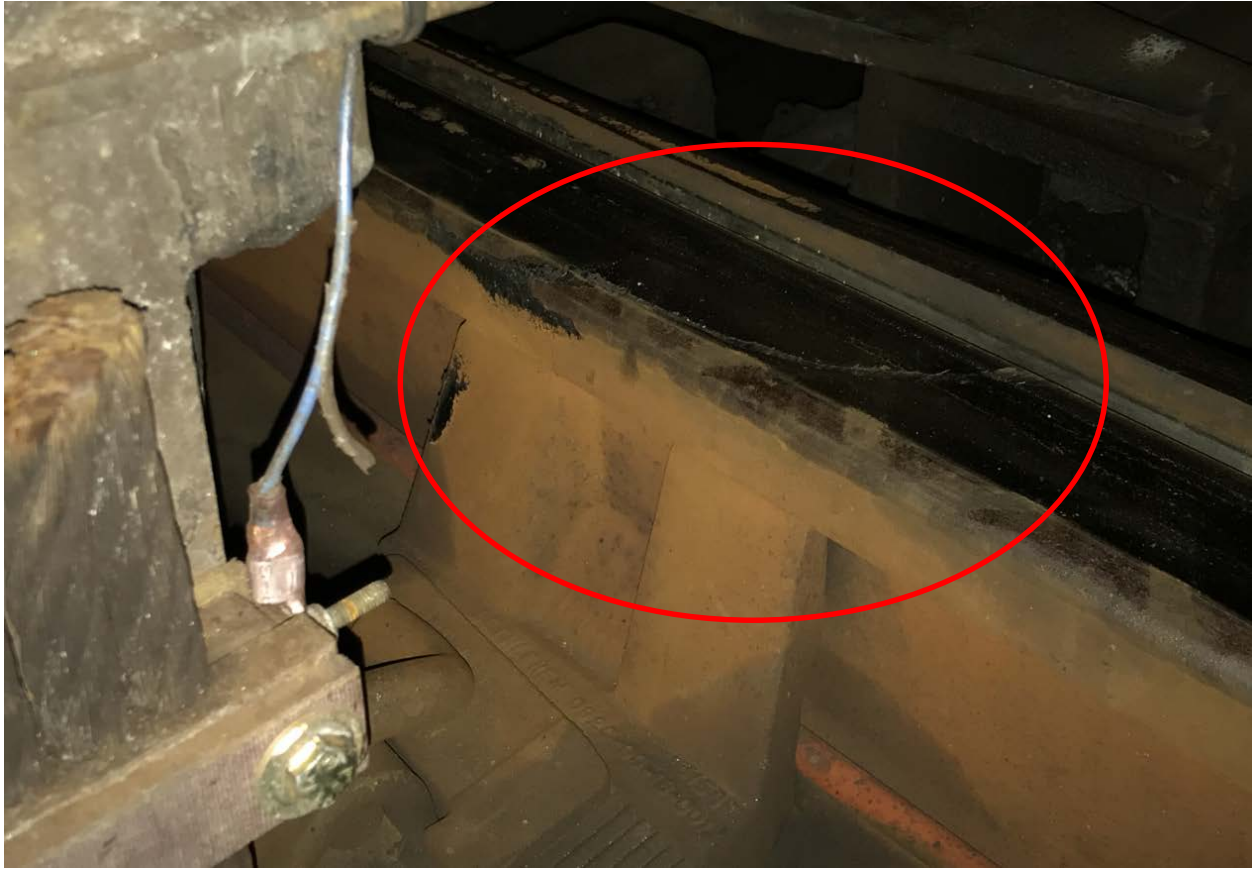
Based on field investigation, SAFE determined HR 260 derailed transitioning through B99-65 Switch. The rear axle's wheel flanges operated through the closed switch points. However, the front axle's wheel flanges climbed over the closed switch points and derailed. Based on observation of the position of the switch points in relation to secured HR 260, it was apparent that the rail vehicle traversed through the switch that was improperly aligned. Additionally, the switch was an interlocking tower-controlled switch and not manually set. HR 260 E/O failed-to verify alignment and subsequently derailed when traversing the trailing point switch alignment. Apparent rail markings indicate Point of Derailment (POD) occurred within the switch point while traversing B99-Switch 65. Refer to photo 3.

Photo 3 – POD markings on the head of the left side running rail with flange grease markings within the switch point.

1. RTRA Management shall take the appropriate action that includes but not limited to, retraining of RTRA personnel involved.
2. IRPG management shall take the appropriate action that includes but not limited to retraining of IRPG personnel involved.

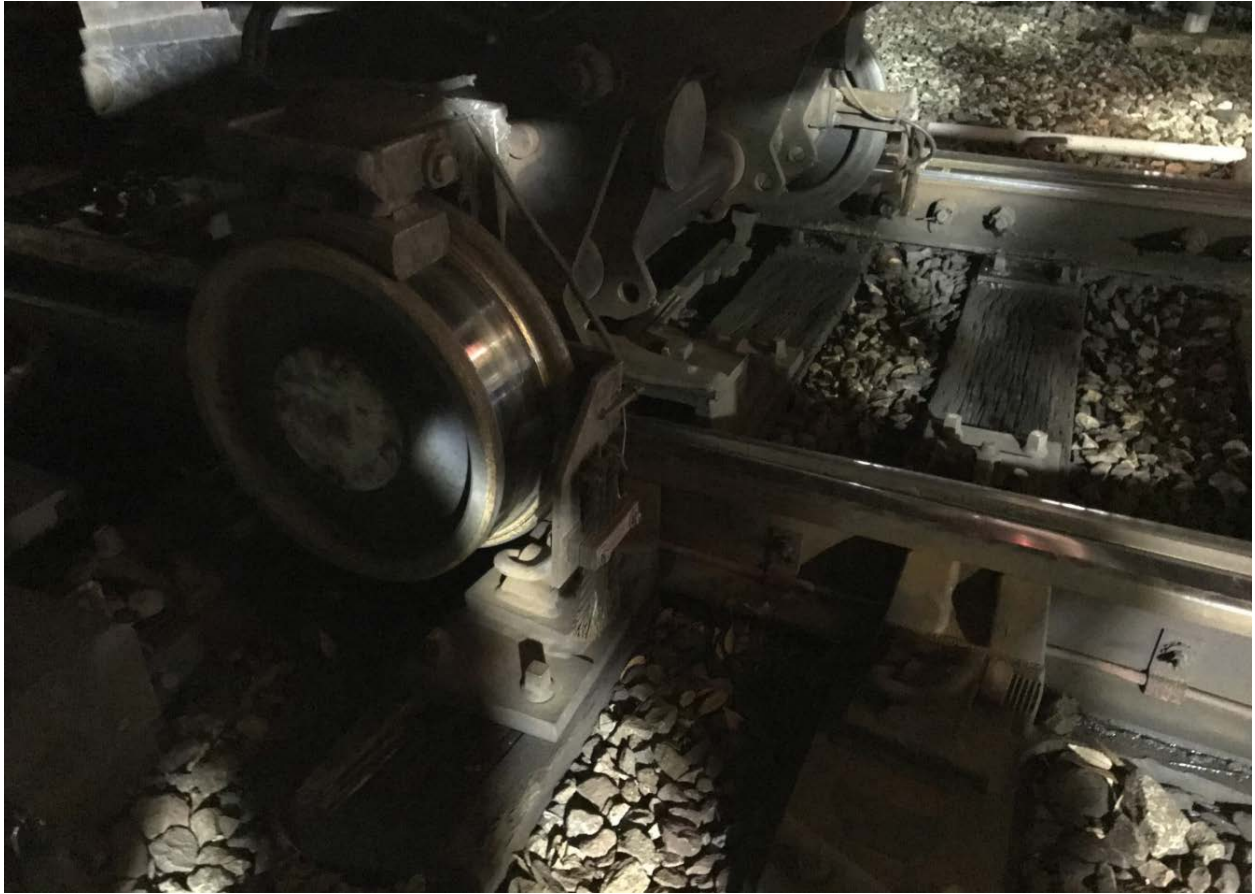
Photo 4 - Final Resting Point (FRP) 3-6 inches away from derailment location.
