#### WMSC Commissioner Brief: W-0034 - Fatality at Farragut West Station December 9,

2019 Prepared for Washington Metrorail Safety Commission meeting on August 4, 2020

#### **FINAL REPORT OF INVESTIGATION A&I E19675**

#### SMS 20191209#84904

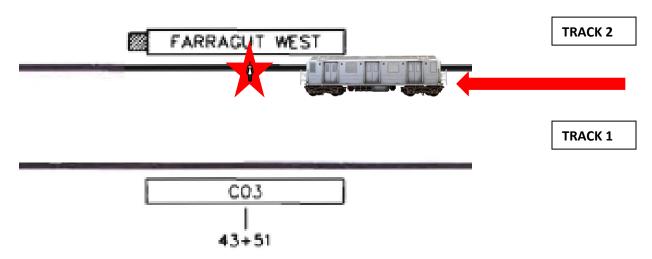
### **Field Sketch/Schematics**

The incident area was located at the Farragut West Station, Track 2.
