WMSC Commissioner Brief: W-0035 – Fatality at Capitol Heights Station December 3,

2019 *Prepared for Washington Metrorail Safety Commission meeting on August 4, 2020*

FINAL REPORT OF INVESTIGATION A&I E19661

SMS 20191204#84779

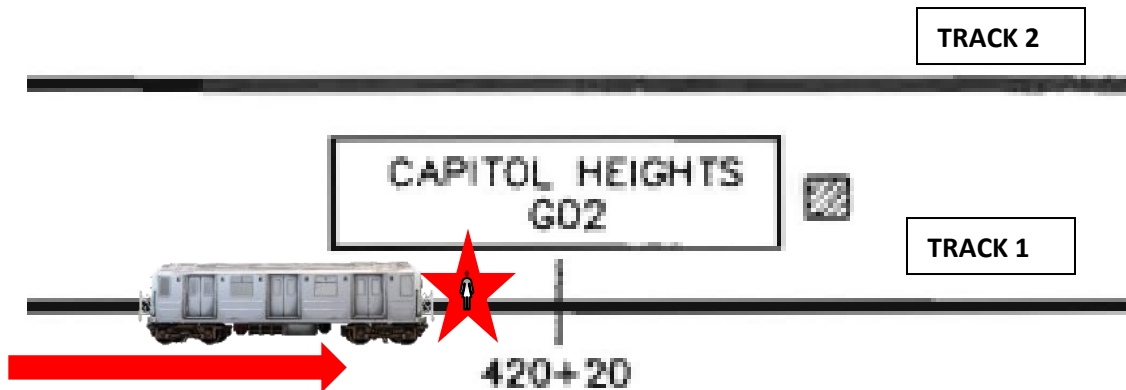
Field Sketch/Schematics

The incident area was located at the Capitol Heights Station, Track 1
