WMSC Commissioner Brief: W-0036 – Derailment at Van Dorn St. Interlocking July 8,

2019 Prepared for Washington Metrorail Safety Commission meeting on August 4, 2020

FINAL REPORT OF INVESTIGATION A&I E19354

Final Report – Van Dorn Interlocking Derailment Rev. 01
E19354

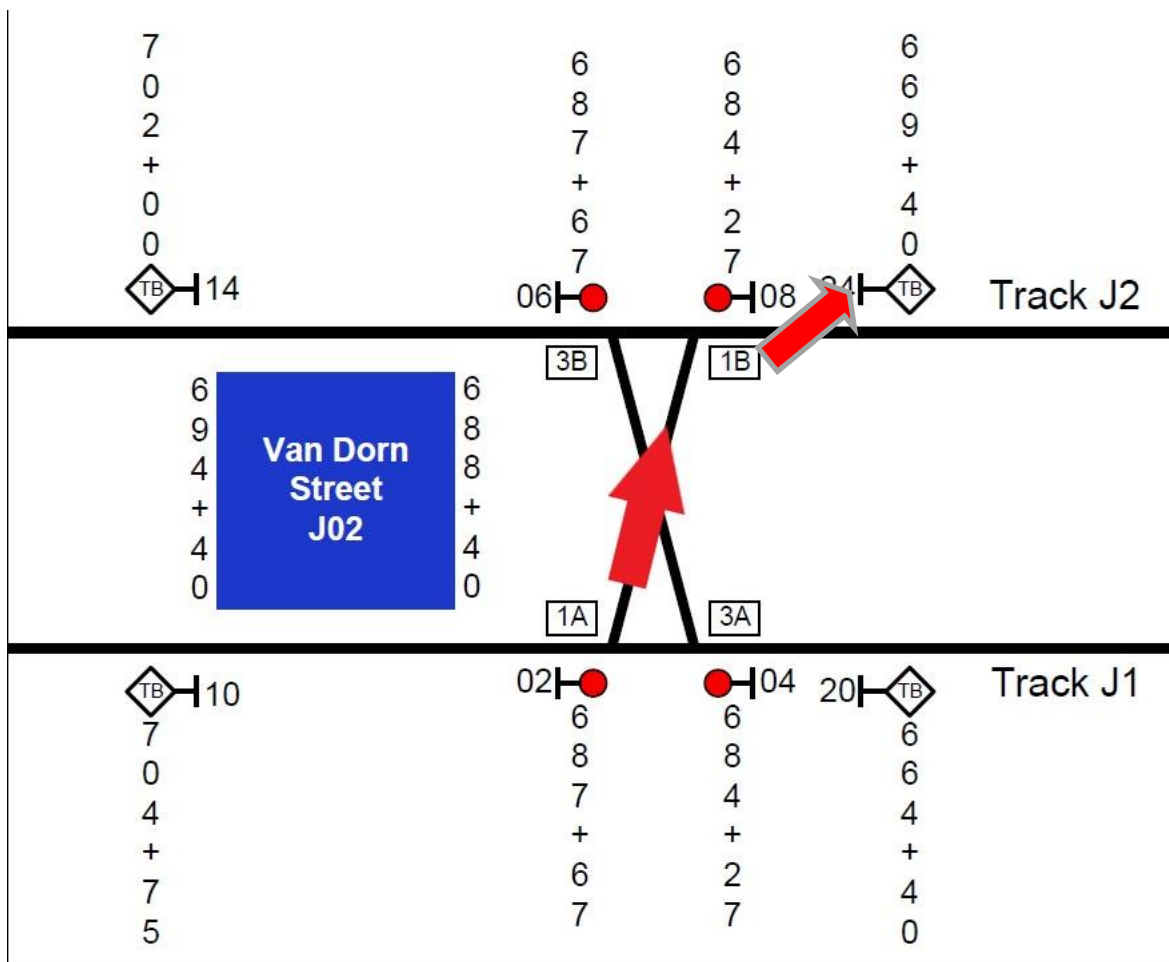
Field Sketch/Schematics

The incident area was located at Van Dorn interlocking at CM J1 687+20.

The HRU VD1 attempted a crossover move from the Track 1 platform to the Track 2 platform utilizing J02/1A, J02/1B and J02/3B switches when the unit's rear hi-rail truck derailed on the turnout side (left side) of the #8 guarded switch. The Point of Derailment (POD) determined to be at J1 687+20 about 20ft from the left-hand switch point near the heel block.

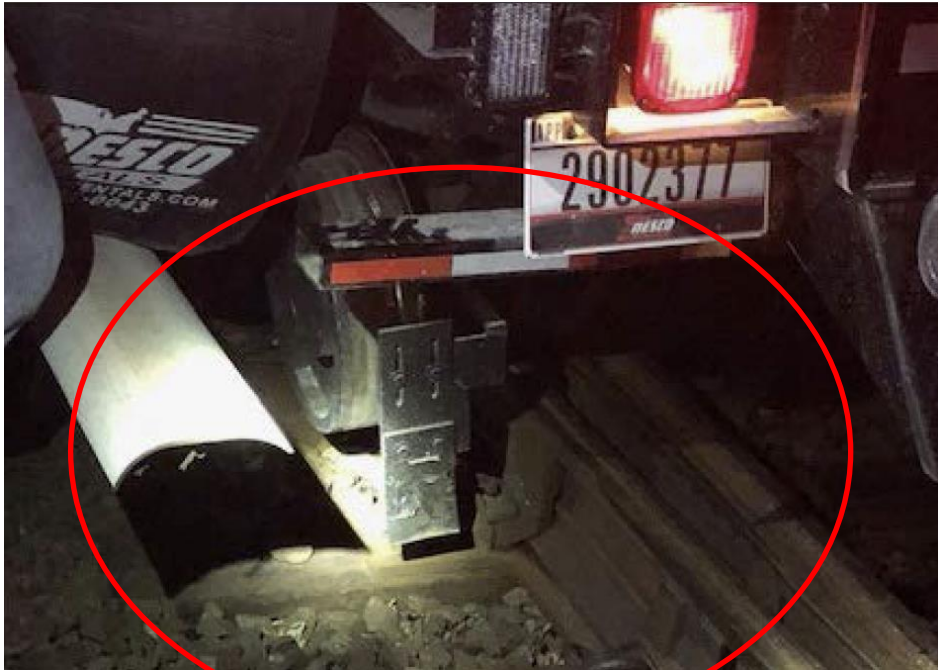
The Department of Transportation (DOT) inspection expires 4/2020, and WMATA inspection expires 9/2019. Based on preliminary findings, it is most probable that the rear road tires of the unit climbed on the guard rail and the Hi-rail gear wheels lost their normal relationship with the running rail and subsequently derailed.

1. Based on the contractor's post-incident inspection, an unidentified contractor personnel raised the pressure of the airbags to over 40 psi which should be under 20 psi. Only maintenance/qualified personnel should adjust the airbags.
2. The pre-move checklist did not require the CE/O to check the pressure of the HRU airbags.

Photo 1 – Left Rear of HRU Wheel Derailed

1. Contractor will implement the following measures to support the prevention of recurrence.
 - a. Include measuring the airbag pressure on the HRU pre-move checklist**
 - b. Contractor policy is to stop before crossing a switch/crossover and walk (not to exceed 3 mph) the vehicle to confirm that the Hi-rail gear does not climb/creep on the switch/crossover.**
 - c. Contractor Maintenance Personnel to correct the airbag pressure to the required 20 psi.**

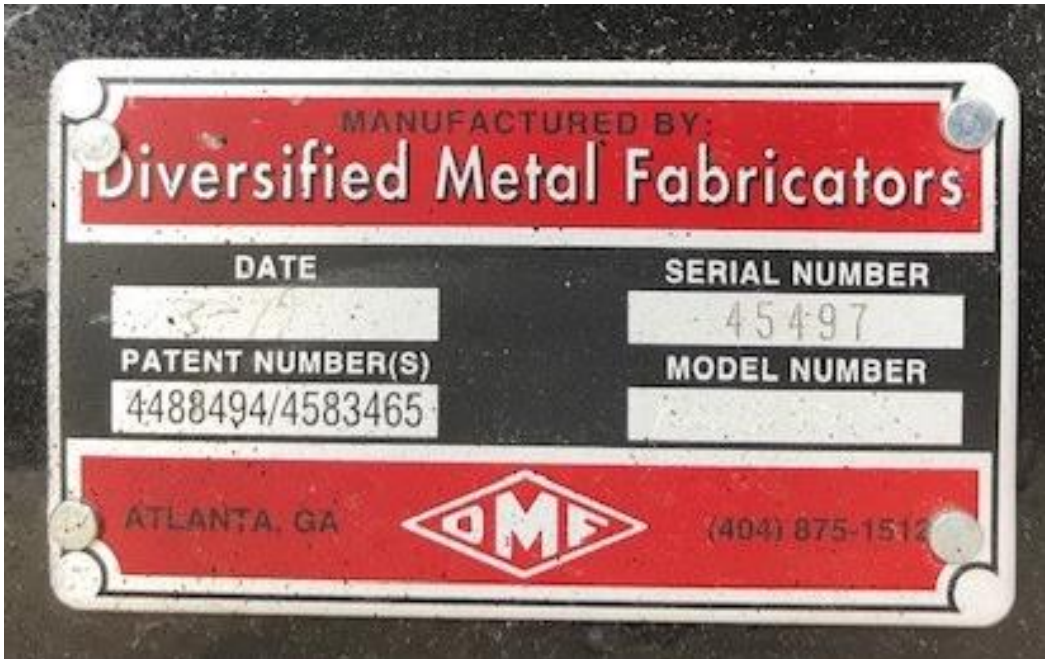
Photo 2 – HRU Serial Number

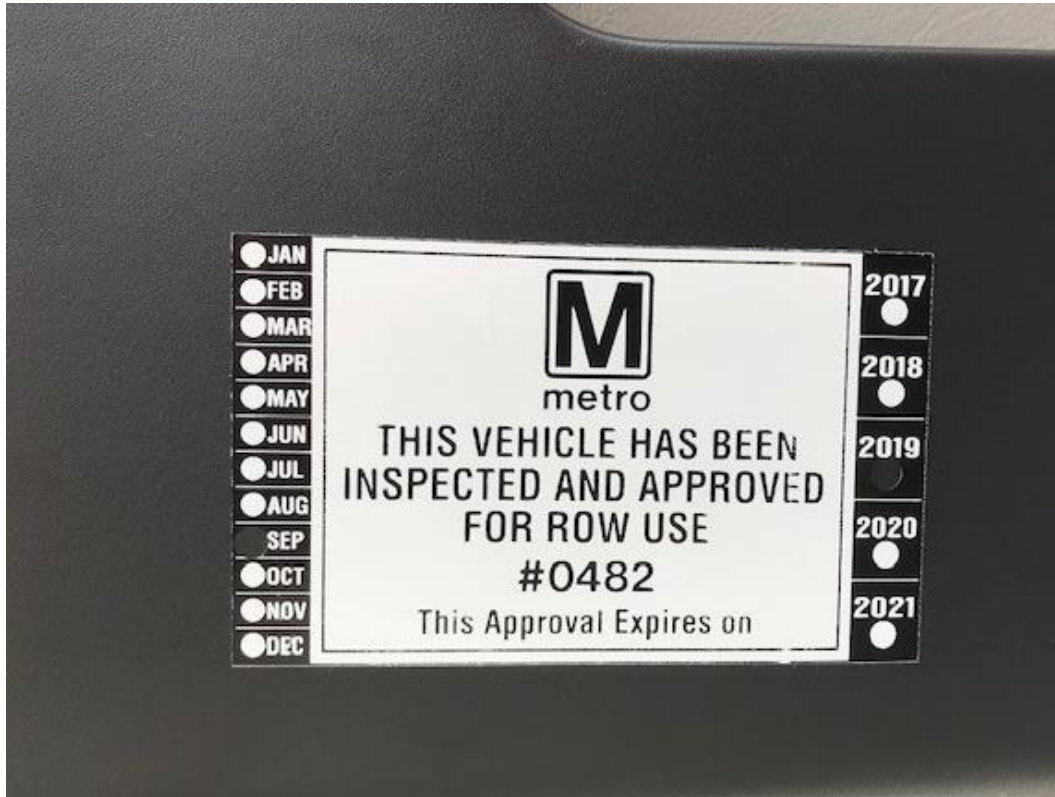
- This HRU has been inspected and approved for Right of Way (ROW) use. Approval expires in September 2019. See Photo 5
- Wester Star Vehicle, Manufactured by Daimler Trucks North American LLC

Photo 3 – HRU Certificate of Inspection. This Approval Expires September 2019
