WMSC Commissioner Brief: W-0038 – Derailment at Franconia-Springfield August 30, 2019

Prepared for Washington Metrorail Safety Commission meeting on August 4, 2020

FINAL REPORT OF INVESTIGATION A&I E19454

SMS 20190830#82612

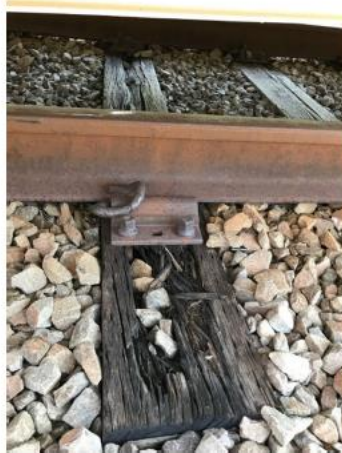
Reconstruction Photos:

While moving the rail equipment from Track 2 to Track 1, the rail cart derailed. The rail cart derailed due to a rotted tie. The track was 3/8" out from a standard track width. As can be seen from the photo, the rail cart derailed at the location of the bad tie as can be seen from the white paint on the rail where the cart derailed.

Details: At the location of the derailment there was a bad tie as can be seen in the picture below. The tie was rotted at the location of the plates.

- Walk track to inspect for rotted ties.
- Place spotter at potentially identified locations. In those areas go at a very slow pace.

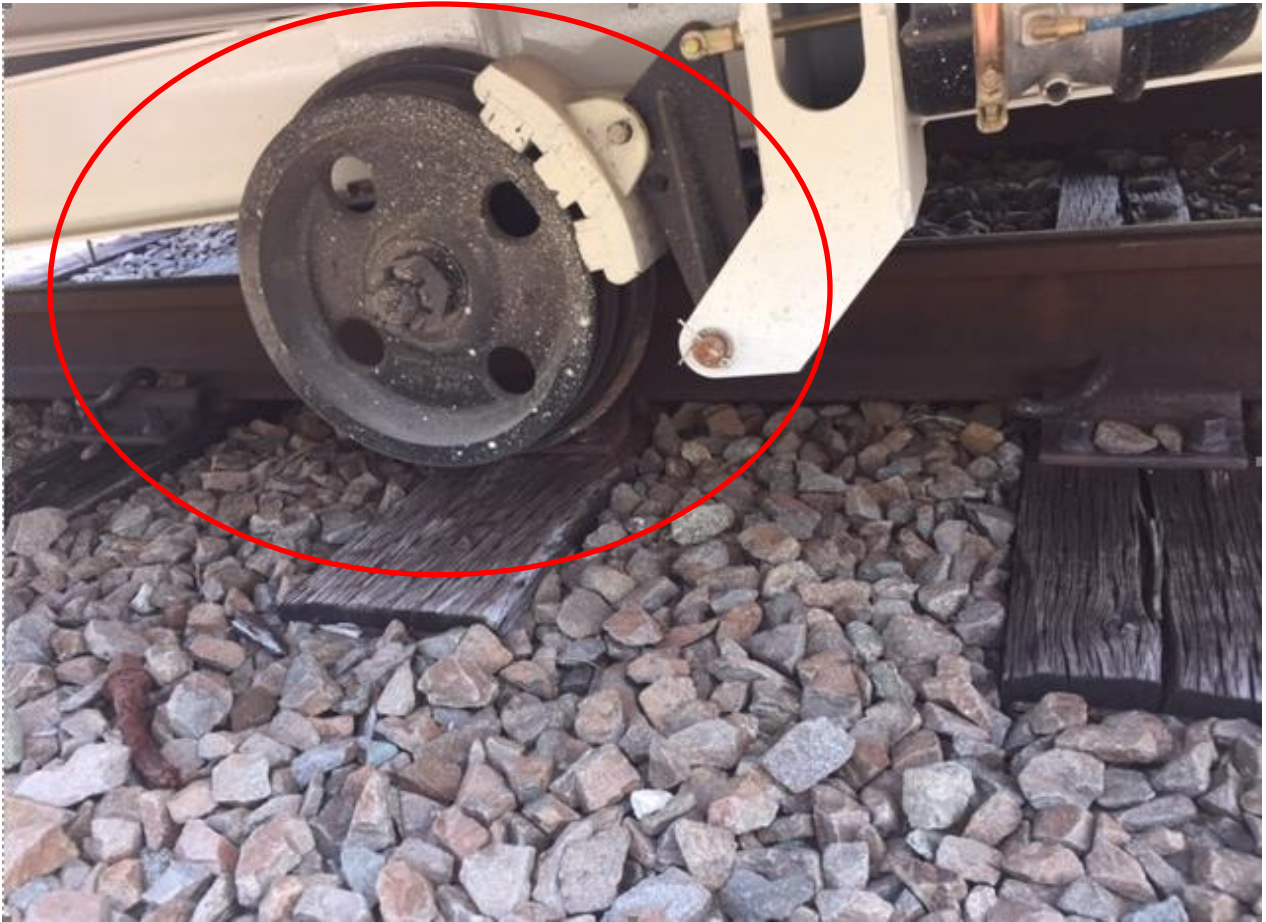
A Washington Metropolitan Area Transit Authority (WMATA) DECO / IRPG inspector within the ACS area informed SAFE that Unit #801 had been re-railed by the Contractor at 17:27 hrs., and stored at CM J3 884+00. The inspector reported that the Switches were in good condition, and all track components were present and appeared secured, except for the tie shown in photos 1, 2, and 4, which showed significant signs of deterioration.

Photo 1 – Rear axle derailed on the field side

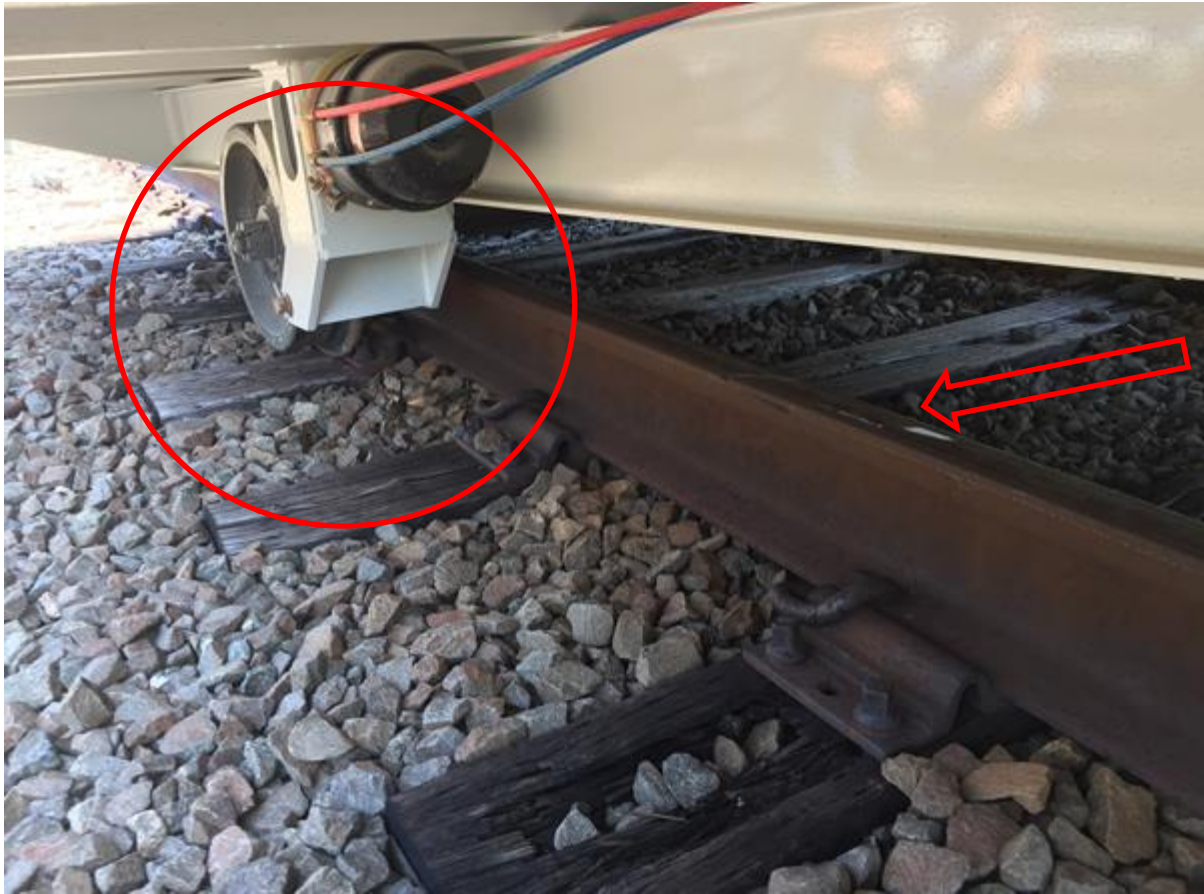
Photo 2 – Rear axle derailed on the field side during pushing (reverse) operation with POD markings

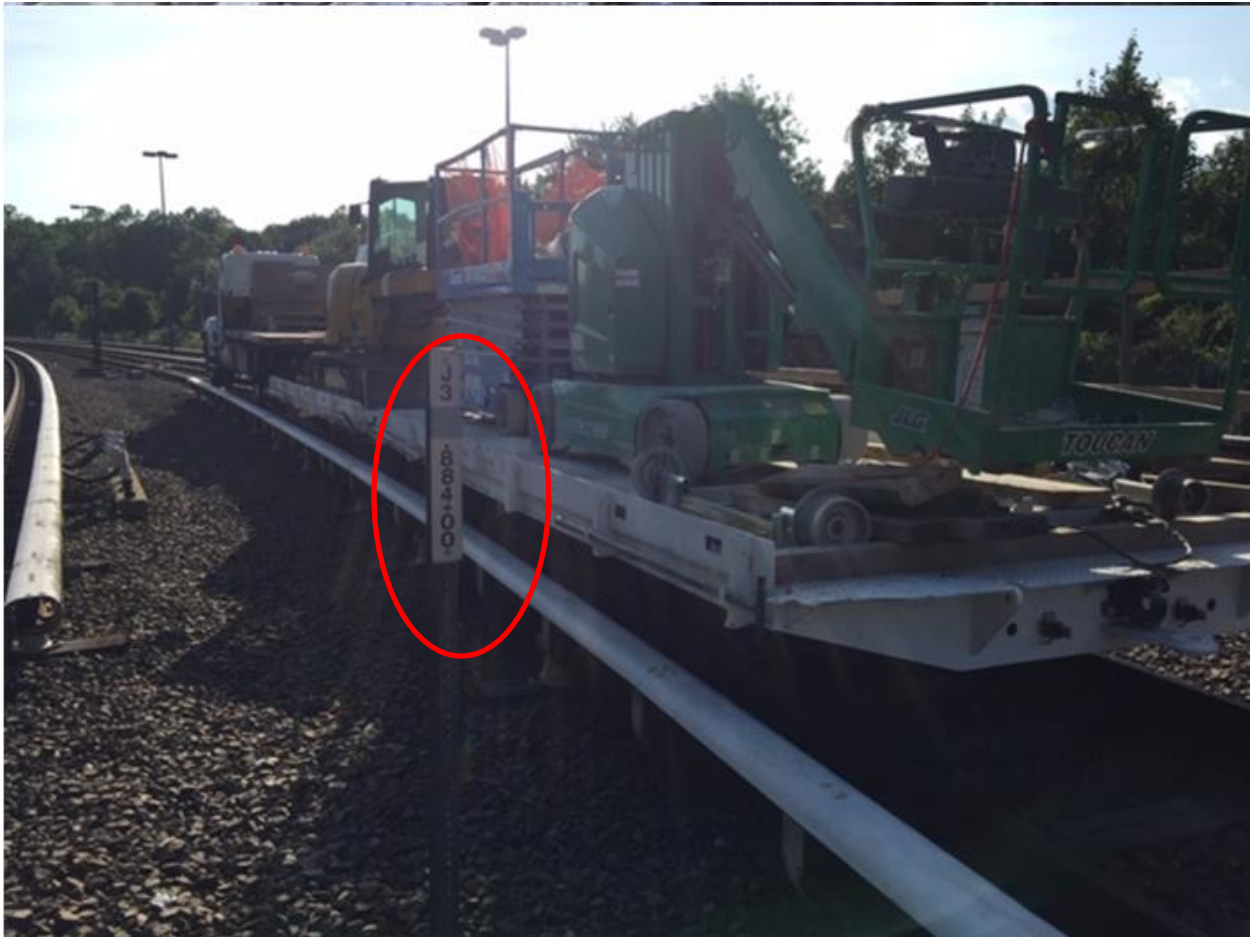
Based on POD, distance traveled, Point of Rest (POR), and operating speed was not a contributing factor. The most probable casual factors are track geometry, load distribution or load shifting, and a single axle rigid frame rail-car with no suspension.

Photo 3 – CM location, Unit #801 Derailment, the weight distribution of equipment on the flat car

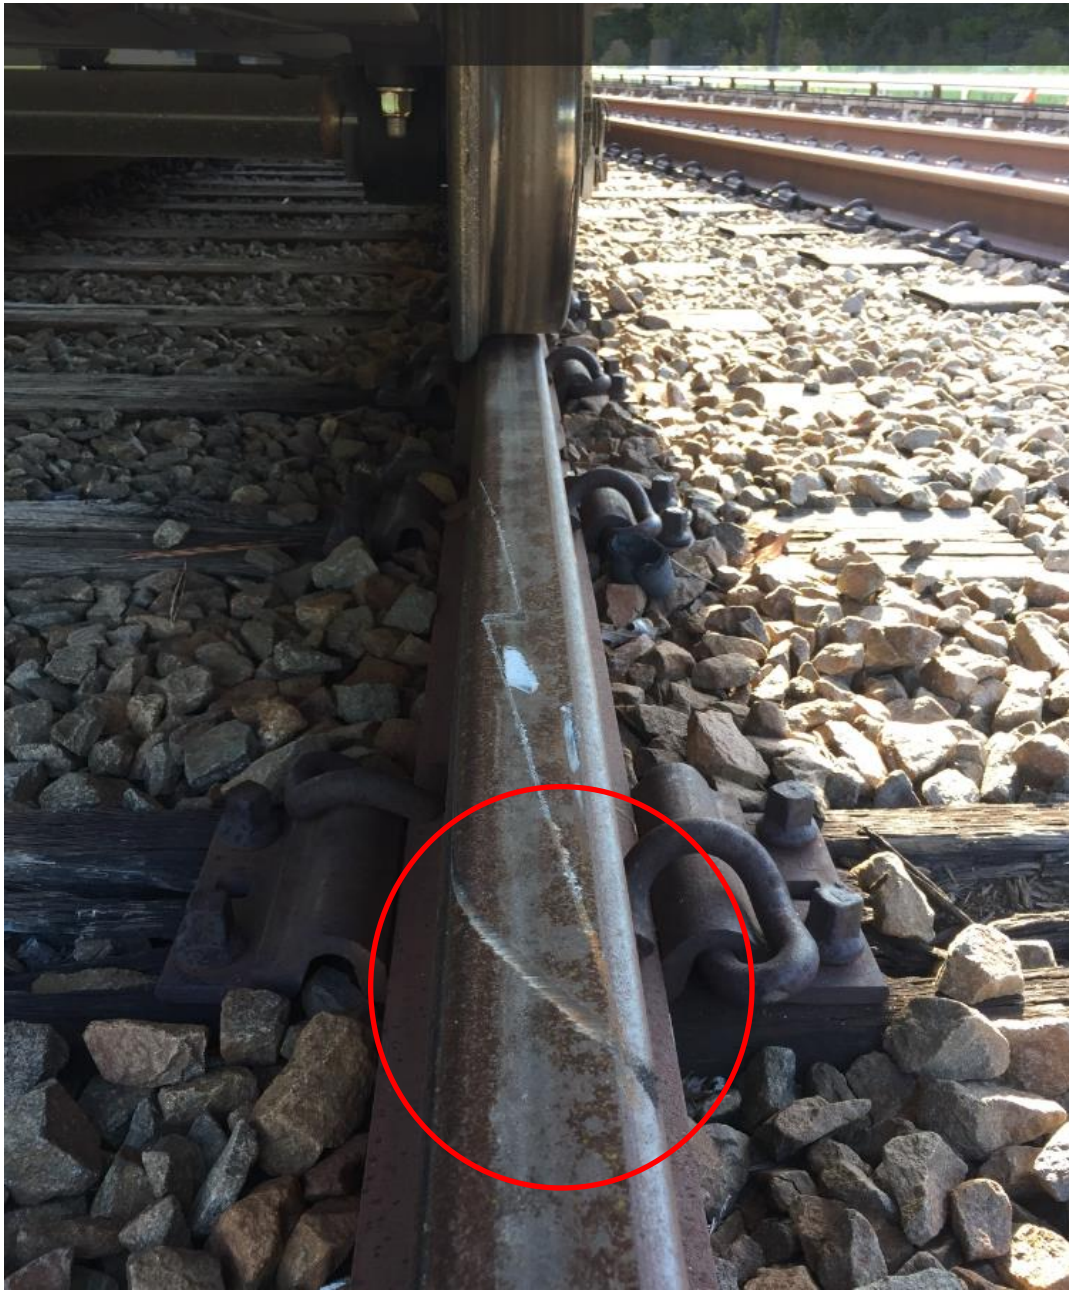
The Point of Derailment (POD) verified through rail markings was identified at CM J3 884+00. The POD was approximately one (1) foot from the location that the vehicle's wheels came to a complete rest. Refer to photo 4.

Photo 4 – POD markings
