WMSA Commissioner Brief: W-0039 – Derailment in West Falls Church Yard September 26, 2019

FINAL REPORT OF INVESTIGATION A&I E19509

SMS 20190926#83215

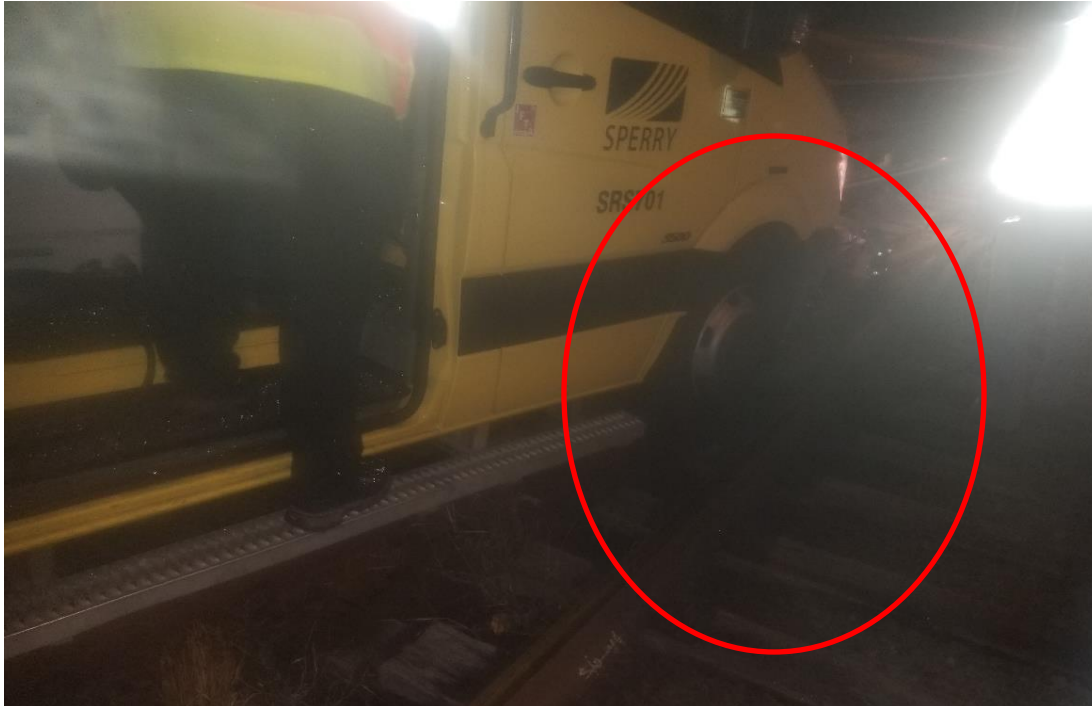
Photo 2 – Right front of HRU Wheel Derailed

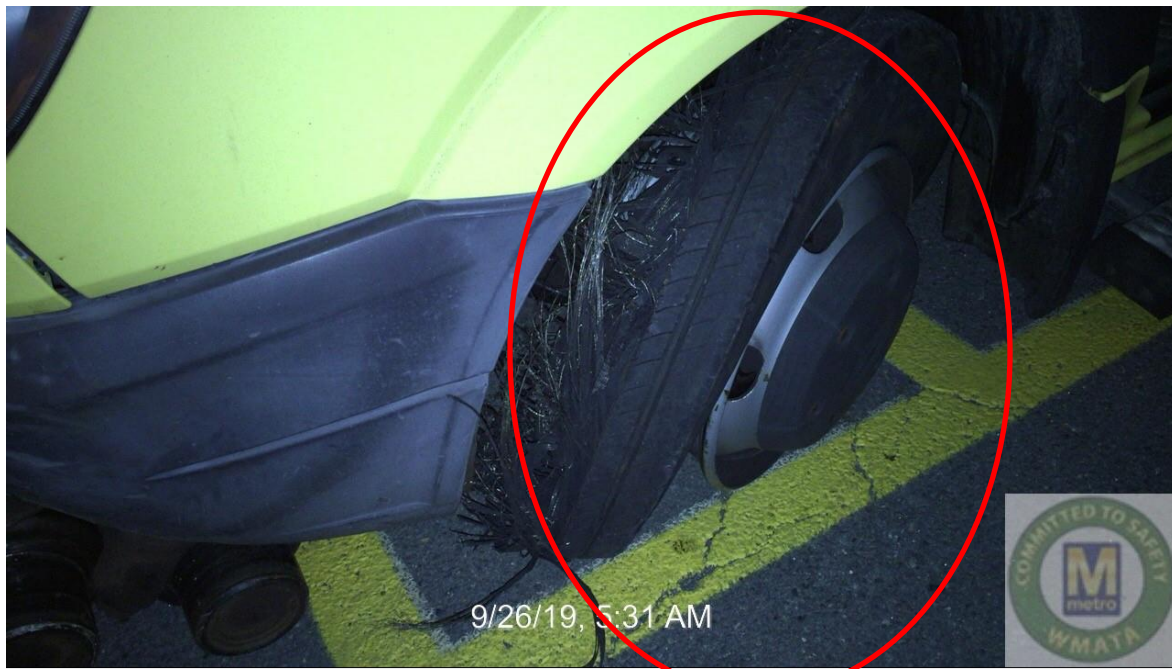
During overnight ultrasonic rail testing on mainline tracks, the work crew on board smelled burnt rubber and saw a road tire on the vehicle had become flat. The crew finished testing approximately 300 more feet of rail prior to moving the vehicle back to the West Falls Church Yard.

By the time of the derailment, the flat tire had been shredded and there was damage to the wheel rim. The flange on the hi-rail vehicle were found to be closed but under the condemning limit.

1. The HRU experienced a flat tire for an unknown reason while on the mainline, which caused the derailment. The work crew and the responding SAFE personnel inspected the area scene of the derailment. The flat tire was determined to be within the manufacturer and WMATA's specification. Reportedly, the Track Supervisor indicated that they did not remove personnel from service due to them having to monitor the flat tire during operation back to the yard. There was no operation corrective action required.
2. Additionally, the point of derailment showed significant side wear of the rail, which was also a contributing factor to the derailment. The defective rail was replaced.

Photo 3 – Damaged left front tire of HRU

The damaged vehicle tire and rim were repaired, and the vehicle was inspected and approved in October 2019 to return to Metrorail property.

Contractor has replaced the damaged rim and the flat tire. A re-inspection was conducted on 10/21/2019 for the SRS HRU. The vehicle passed Washington Metropolitan Area Transit Authority (WMATA) requirements, and sticker# 015 was issued. This sticker was placed on the operator's side. See photo 6. The flange was measured by Vehicle Program Services (CENV) prior to the post-incident Federal Railroad Administration (FRA) inspection and found to be closed but under the condemning limit. These measurements had to be done with calipers, and it was CENV's determination that the FRA inspection (performed by an authorized 3rd party) would validate that the wheel, as well as the rest of the rail gear, was indeed within tolerance. The tolerance sheet for the Zargo rail gear from their manual is attached (Attachment #2).

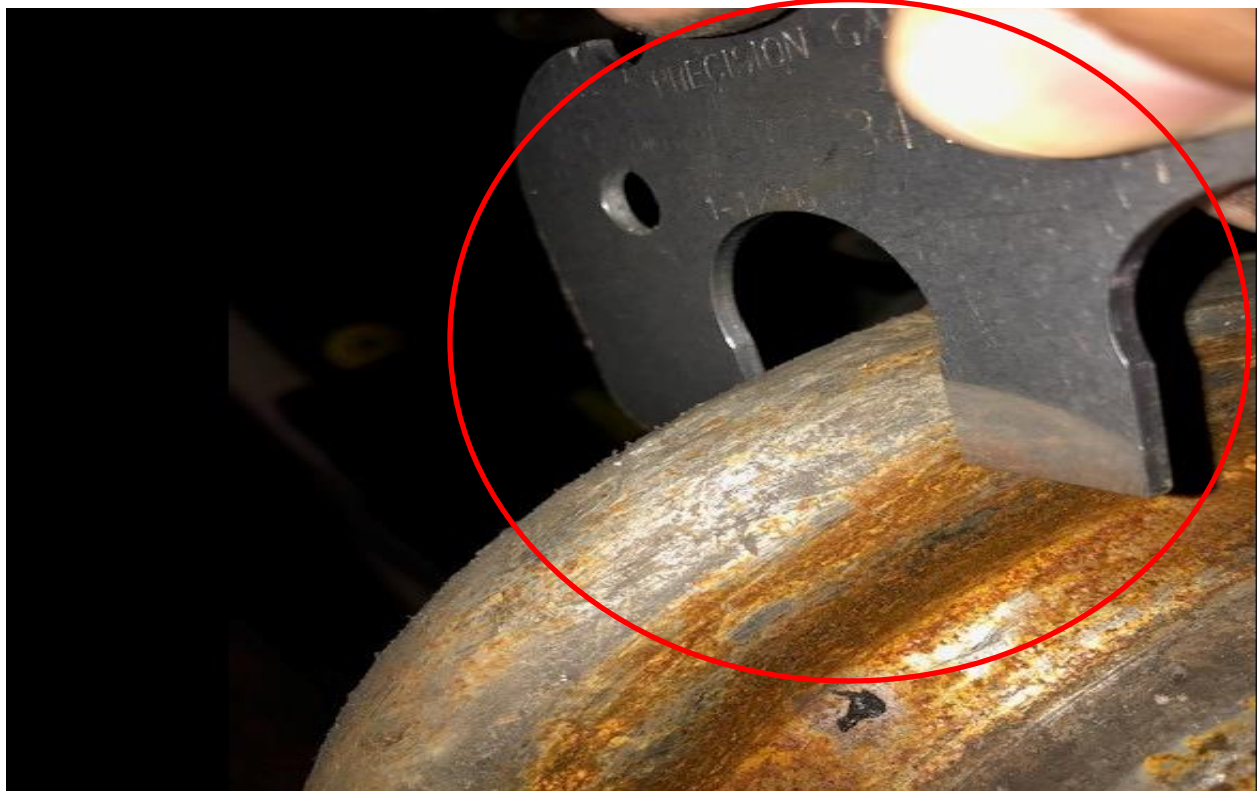
Photo 5 – SRS HRU Inspection includes inspection of the hi-rail wheels to validate they are within specification with a Caliper

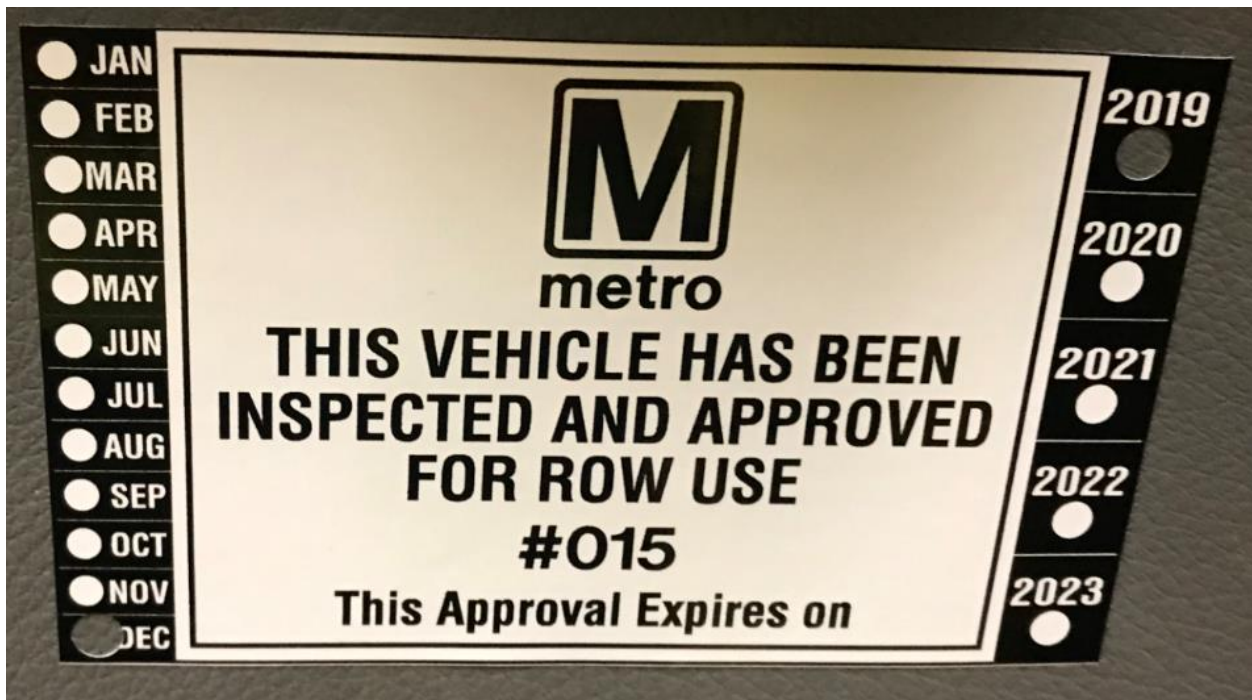
A re-inspection was conducted on 10/22/2019 for the SRS HRU. The SRS HRU passed WMATA's requirements, and sticker 015 was issued. See photo 6.

Photo 6 – HRU sticker# 015 was issued after re-inspection

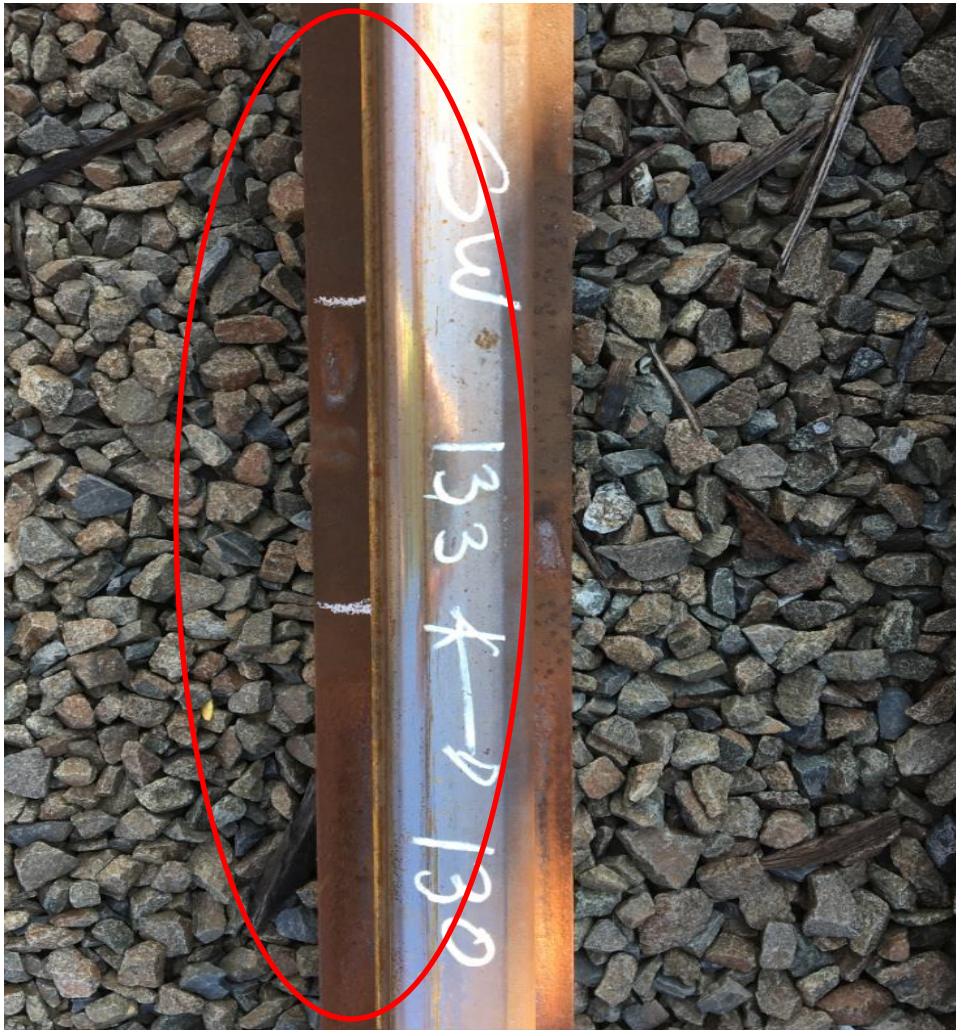
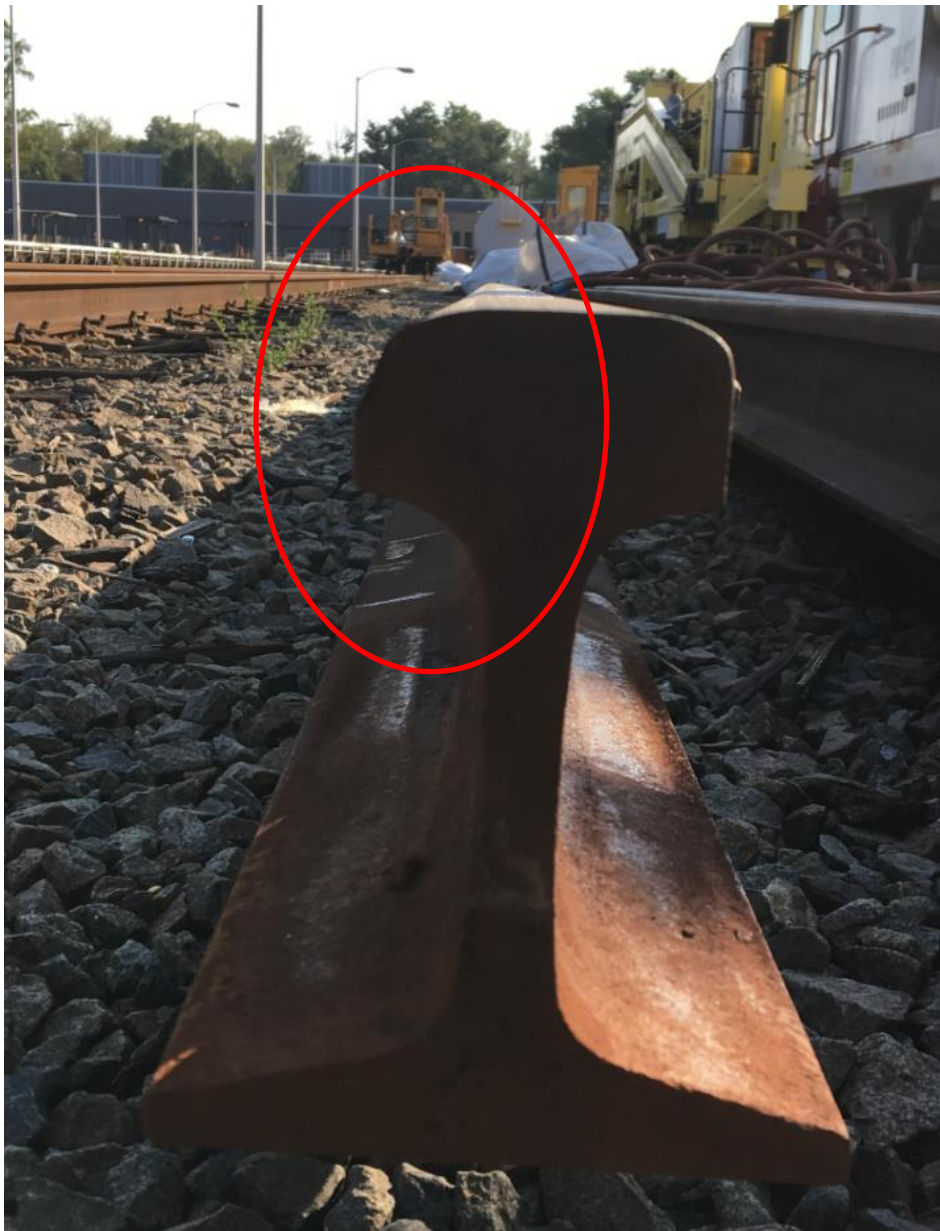
The rail at the point of derailment showed significant side wear.

Photo 7 – Significant side wear of the rail

Photo 8 – Significant side wear of the rail

The worn rail was replaced.
