## **WMSC Commissioner Brief: W-0041 – Collision in Shady Grove Yard Car Maintenance Shop January 4, 2020**

*Prepared for Washington Metrorail Safety Commission meeting on August 4, 2020*

**FINAL REPORT OF INVESTIGATION A&I E20007**

**SMS 20200107#85446**

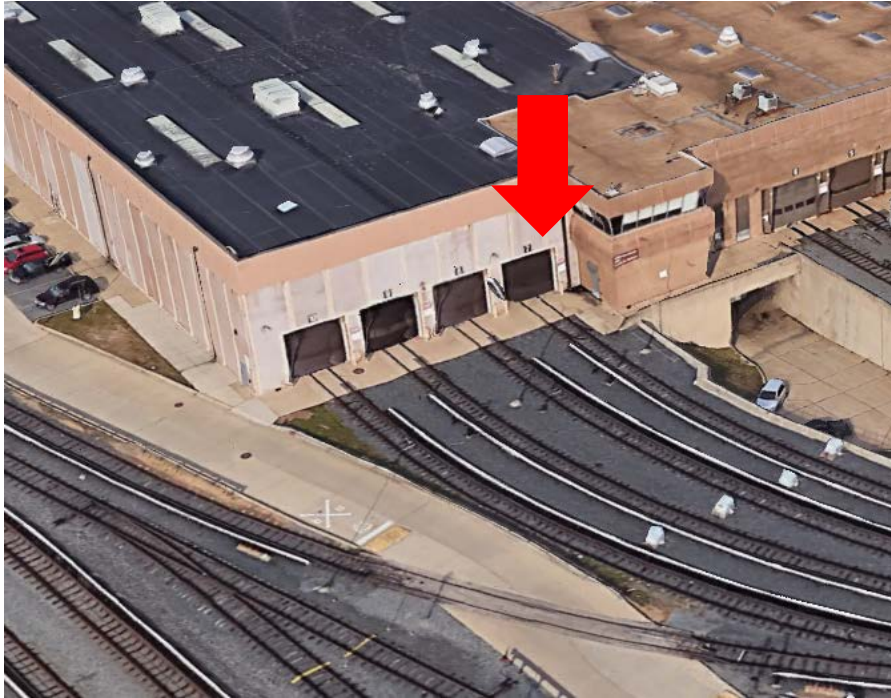
## Field Sketch/Schematics

Shady Grove Yard, 7 South

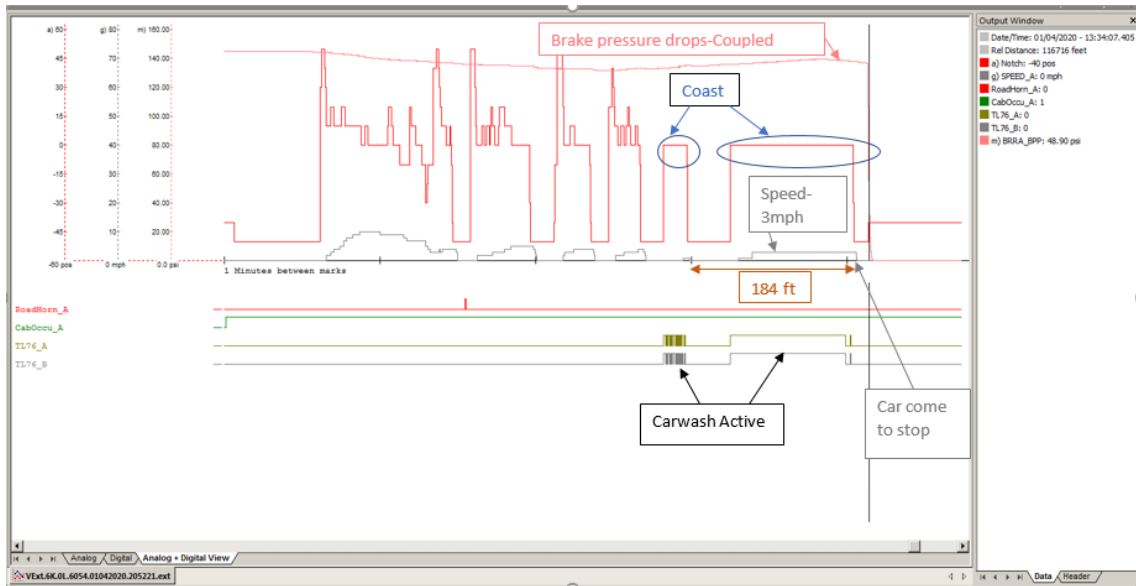
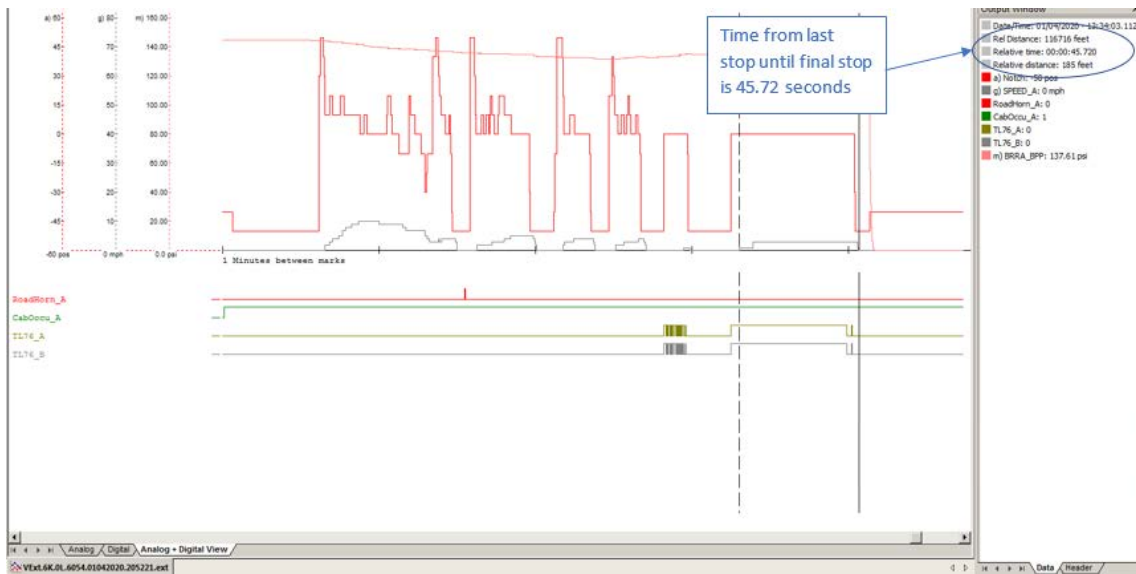
Vehicle Monitoring System (VMS) data revealed the following:

1. Speeds did not exceed three (3) mph
2. The train did not make any safety stops inside the S&I shop (Approximately 184 ft.)
3. Coast to Car Wash was the operating mode during the entire movement within the shop while under third car operation.

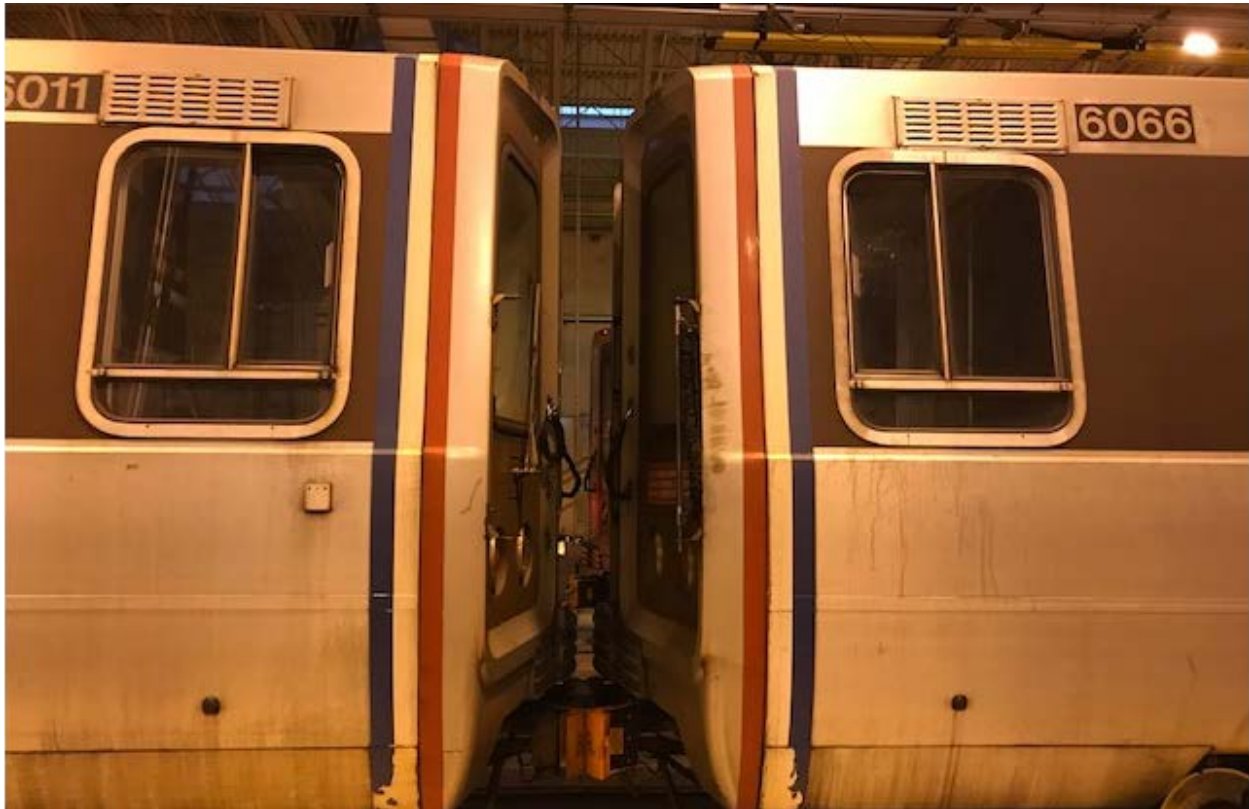
CMNT Supervisor notified the I/O of the event and redirected personnel accordingly. Upon arrival, CMNT and SAFE performed an inspection on both trains and did not find any damage resulting from the minor collision event. CMNT personnel performed an inspection of interior emergency intercom and car-borne radio, which determined there were no anomalies with equipment on cars 6011 or 6054.

Photo 1 – Car 6011 and Car 6066 after minor collision event
