## **WMSC Commissioner Brief: W-0042 – Collision on Largo Tail Track on August 15, 2019**

*Prepared for Washington Metrorail Safety Commission meeting on August 4, 2020*

**FINAL REPORT OF INVESTIGATION A&I E19431**

**SMS 20190816#82271**

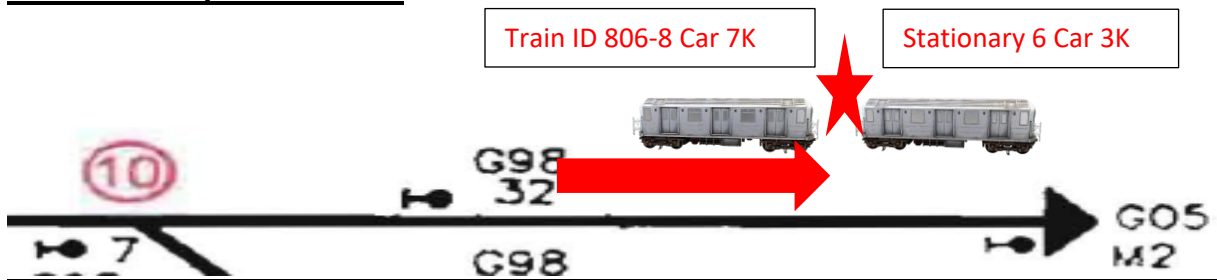
**Field Sketch/Schematics**

Largo Town Center Rear Interlocking, Tail Track 2

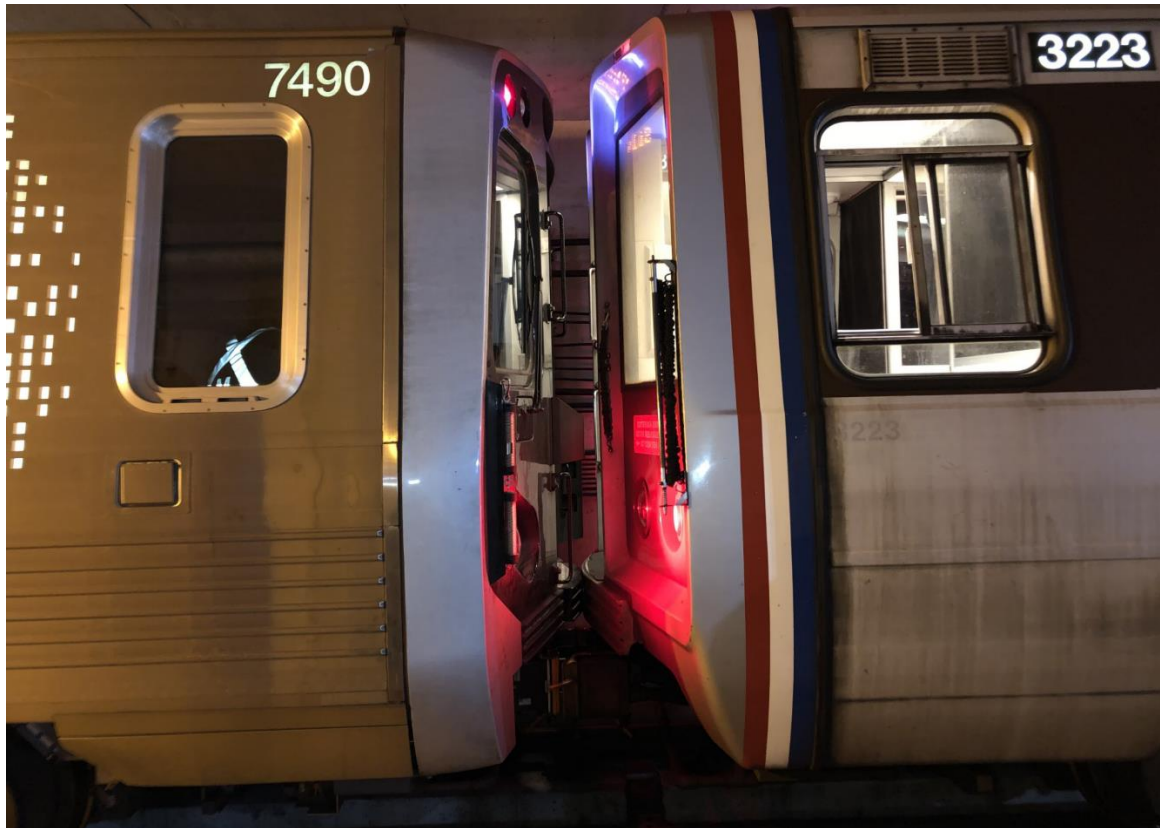
Photo 1 – Position of consist post-incident
