WMSC Commissioner Brief: W-0043 – Serious Injury (Employee) on Red Line on October 19, 2019

Prepared for Washington Metrorail Safety Commission meeting on August 4, 2020

FINAL REPORT OF INVESTIGATION A&I E19557

SMS 20191019#83739

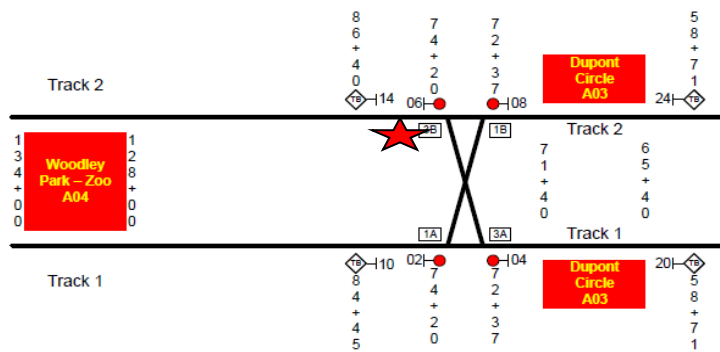
Field Sketch/Schematics

RPRC Location at time of Incident: CM A2-74+50 - A2-86+00

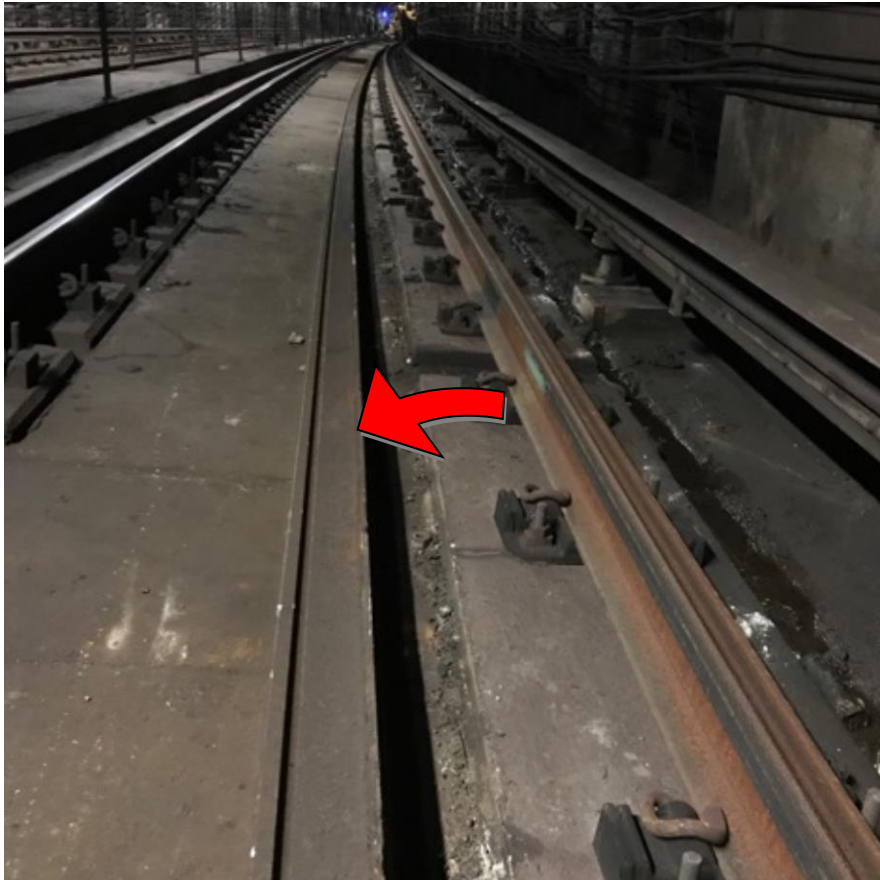
Refer to photo 1.

While the two RPRC personnel were installing fasteners, the old rail positioned near the newly installed rail, flipped on its side toward the RPRC crew, wedging their feet beneath the old rail. The RPRC personnel in the affected area assisted their

Photo 1 – Old running rail fall direction (Rail distance from the clips and fasteners varied at both ends of the work area).

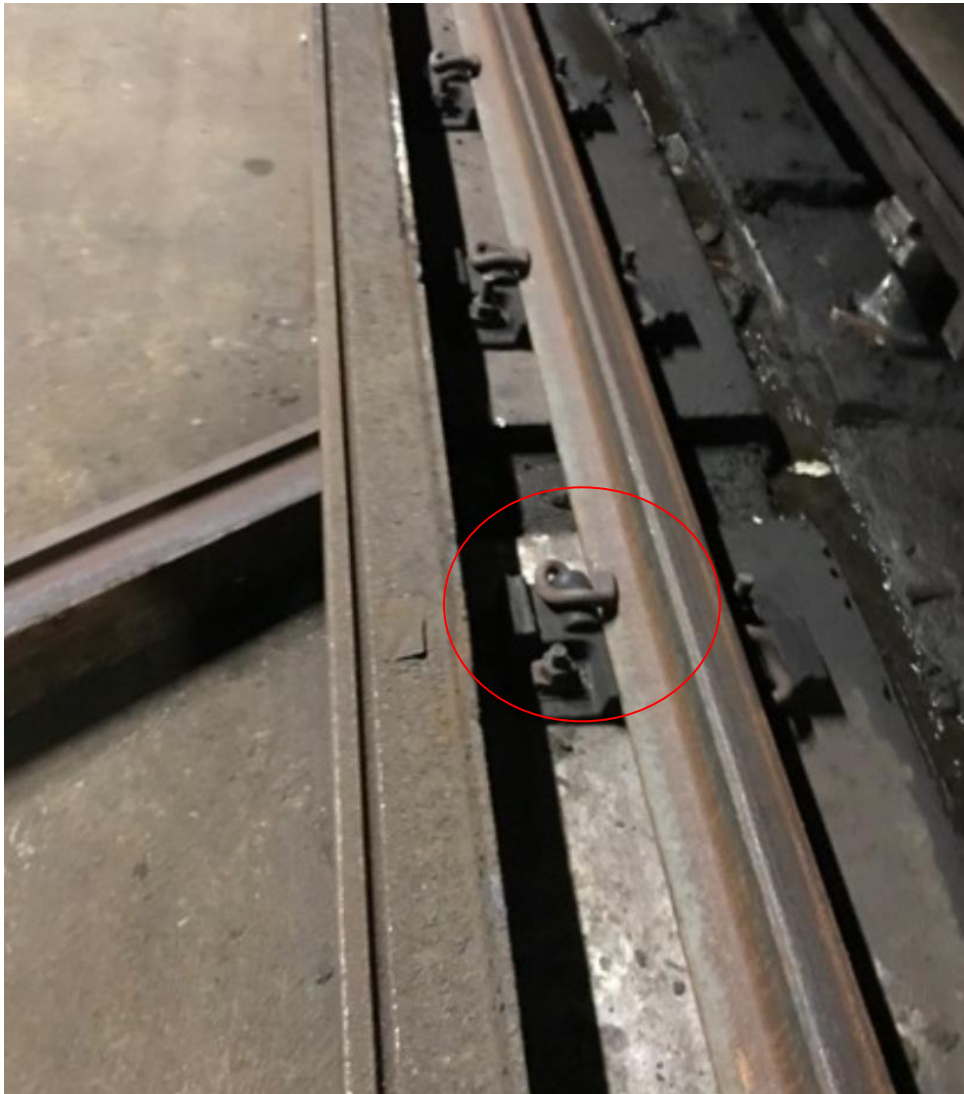
After employees began installing clips and fasteners on the newly placed rail, SM04 operated in the opposite direction threading the old piece of cut rail (positioned between the newly installed running rail and third rail) over to the center of the roadway closer to the newly installed rail. **Refer to Photo 2.** During this process, personnel moved to a place of safety until the unit passed their respective locations. Based on interviews, the injured RPRC personnel stated they began the clipping processes once the SM04 was out of their line of sight, which was later determined to be around a restricted view curve approximately 900 feet away from the injured employee location.

Photo 2 – Clips and fasteners installed on the New Rail

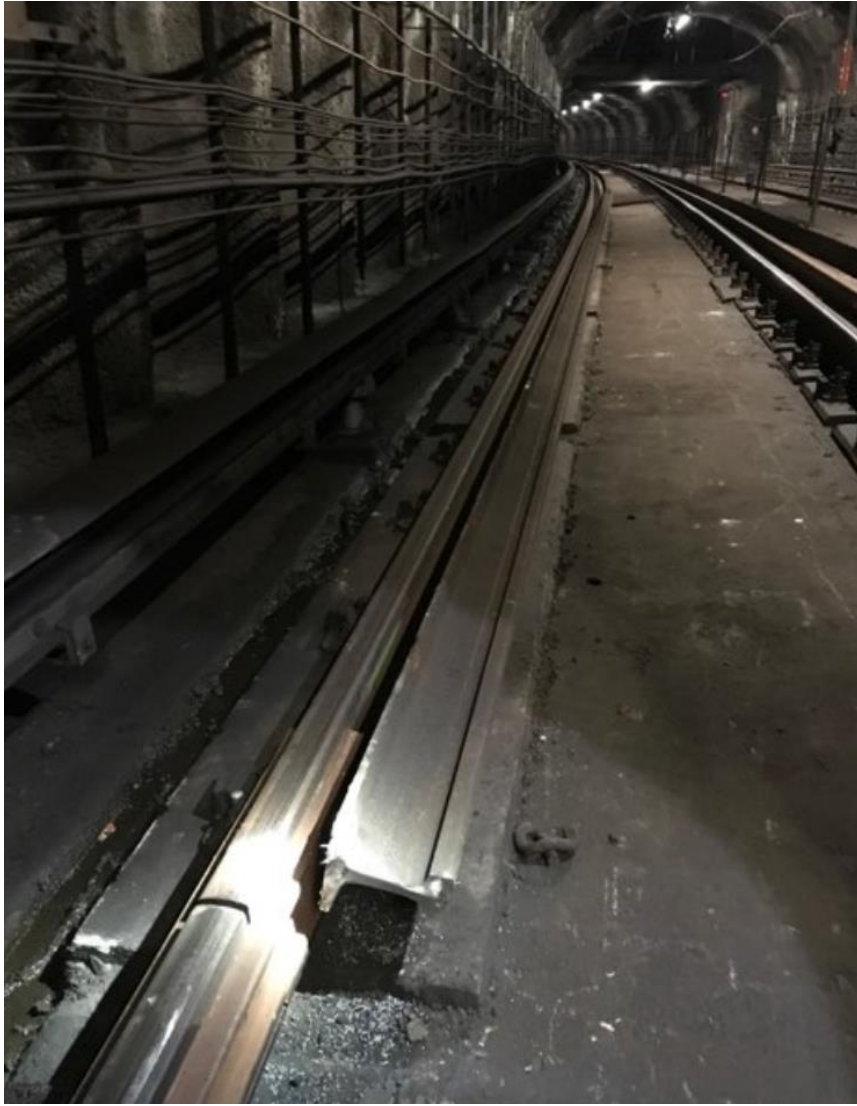
Photo 3 – Old stringer rail positioned on top of the clips and fasteners on arrival in the proximity of CM A2-084+00 (Ten) 10-feet away from SM04.
