WMSC Commissioner Brief: W-0045 – Serious Injury at Vienna Station May 1, 2020

Prepared for Washington Metrorail Safety Commission meeting on September 22, 2020

FINAL REPORT OF INVESTIGATION A&I E20181

SMS 20200504#87457

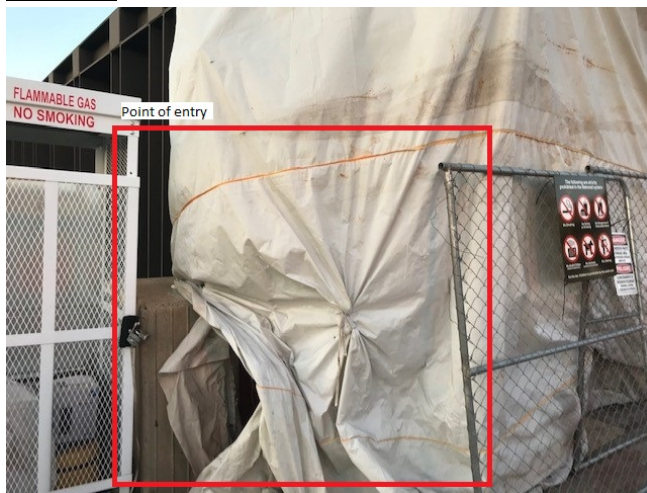
Photo 1 – Access point to enclosed work area

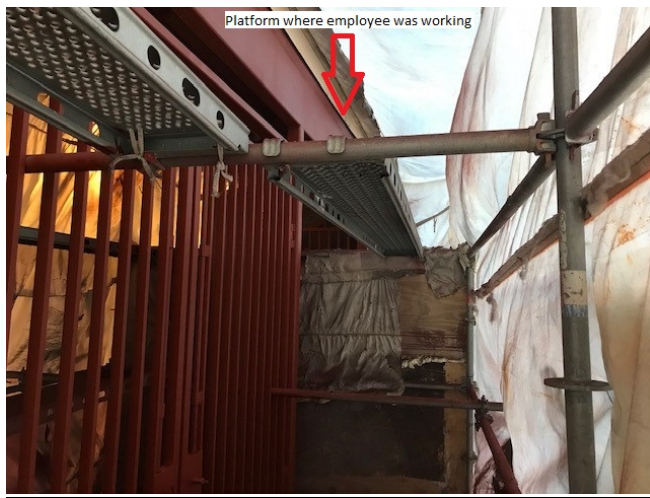
SAFE Construction personnel performed an inspection of the work location and concluded is most probable the injured contractor was using the scaffolding support arm to stand on to assist in reaching a higher part of the wall. While standing on the beam, the injured contractor lost consciousness, and while falling, the right side of their face came in contact with the upper metal decking of the scaffolding. The injured contractor had a noticeable cut underneath his right eye. Additionally, the right side of the middle torso also contacted the support beam adjacent to them as they fell. The Prime Contractor's report states the employee received a fractured collar bone as the result of the fall.

Photo 2 – Approximate area where injured contractor was standing before falling.

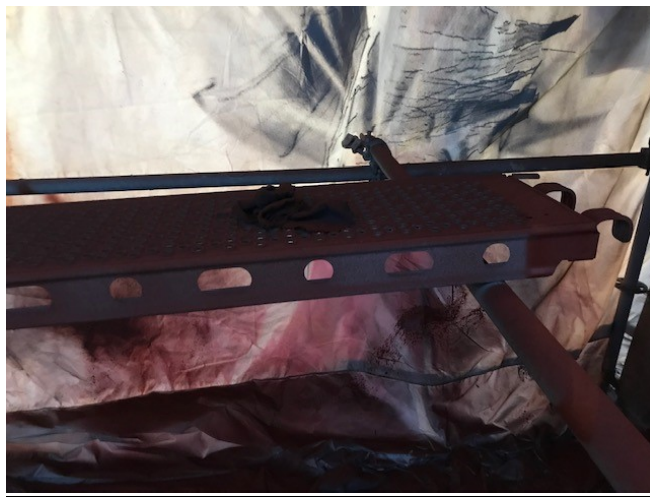
- Scaffold platform on all working levels were noticed not fully planked or decked between the front uprights, not in compliance with OSHA 1926.451(b)(1) and 1926.451(b)(1)(i)
- End plank of scaffold were only cleated or restrained by hooks at one end, not in compliance with OSHA 1926.451(b)(4)
- Scaffolds ends were observed extended over its support more than 12 inches, not in compliance with OSHA 1926.451.(b)(5)(i)
- Scaffold platforms were more than 2 feet above a point of access without a portable ladder, hook-on ladder or attachable ladder, not in compliance with OSHA 1926.451(e)(1) and 1926.451(e)(2)
- Scaffolds and scaffold components were not inspected for visible defects by a competent person before the start of work shift, not in compliance with OSHA 1926.451(f)(3)

- Scaffolds were erected, moved, dismantled, or altered without the supervision or direction of a competent person qualified in scaffold erection, not in compliance with OSHA 1926.451(f)(7)

Photo 3 – Scaffolding platform area.

- The worksite was closed until the contractor can correct all discrepancies found during SAFE Construction post-incident site inspection.
- Contractor corrected all scaffolding and ventilation-Engineering Control discrepancies as required by OSHA.
