WMSC Commissioner Brief: W-0046 – Collision in Alexandria Yard February 10, 2020

FINAL REPORT OF INVESTIGATION A&I E20071

SMS 20200210#86262

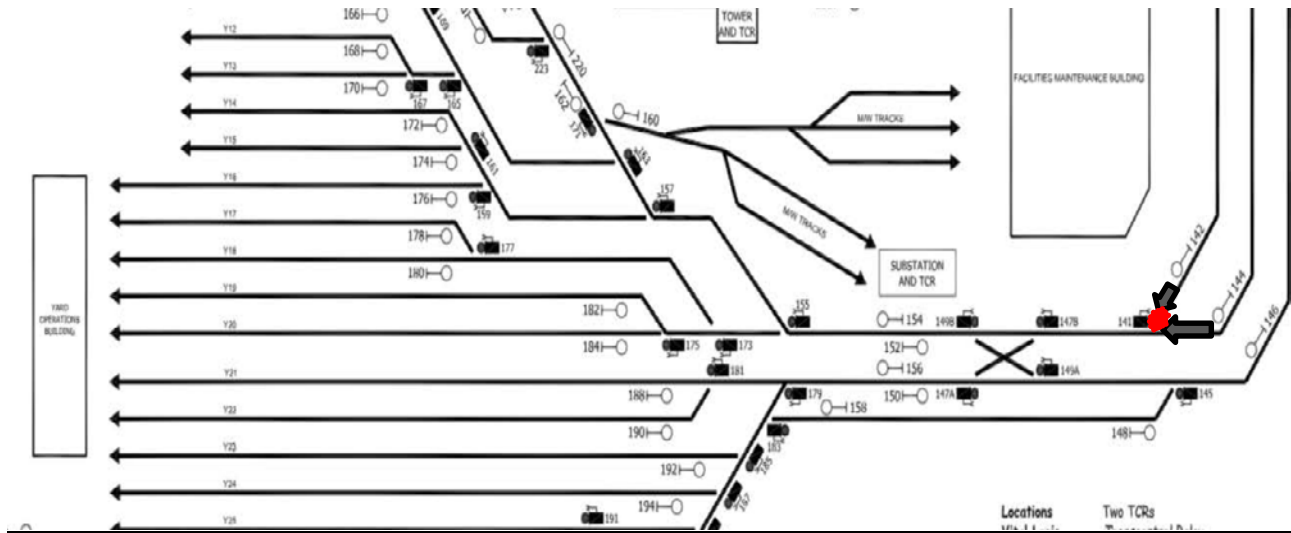
Field Sketch/Schematics

- Track Unit RSW3 was located on the inner loop ~90 feet past signal C99-142. As seen in the yard CCTV video footage, the work crew was standing on the roadway.
- VMDS data from Car 3204 shows that Car 3205 was the lead car.
- The consist was on the Rail Yard Middle Loop. VMDS data shows the train was traveling at ~10 MPH and began to slow as it approached RSW3 but continued to move past RSW3.

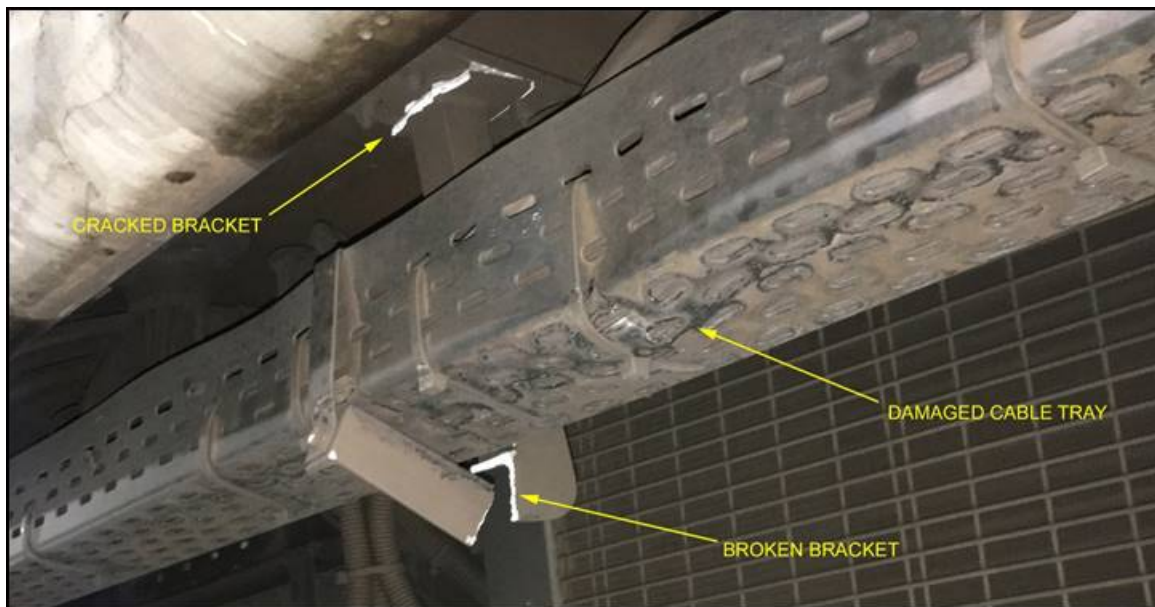
- The CMNT personnel performed an exterior and interior inspection of the affected car and found damage to Car 3205. Details of the damage are as follows:
 - Broken Cable Tray Bracket
 - Broken Weld to Car Body
 - Damaged and Bent Cable Tray

- A 3D laser scan of the front truck pin shows the truck center pin was slightly bent. See inspection analysis below.
 - Since this truck was lifted approximately 10-12" off the rail, the right side was held by the safety cable.
 - This still placed stress on the center pin, due to the entire weight of the car being placed on truck wheels 2 and 4.
 - The truck wheel bearings were also under significant stress as a result of the car weight.
 - Front and rear sides of the center pin showed normal wear at approximately 0.008" wear.

1. CMNT shall perform the following actions on car 3204-05 prior to its return to revenue service (**completed March 11, 2020**):
 - Inspect cables in damaged cable tray
 - Weld broken bracket to the car body
 - Weld the broken hanger bracket
 - Replace both trucks
 - Due to stress placed on the center pins, both pins should be Magna-Fluxed using an outside Lab to ensure the welds around the bearing slide pads, and center pin are not cracked.

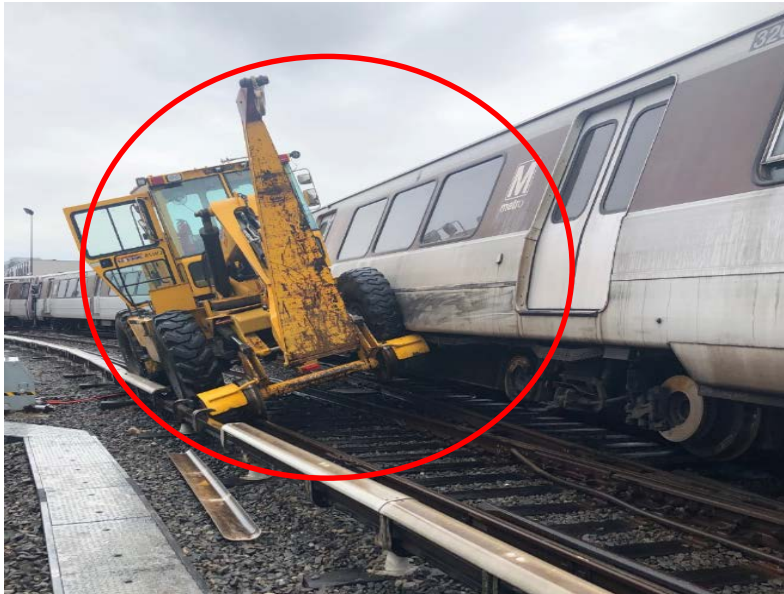
The lead car, 3205, struck the work unit. Four wheels of the train and all hi-rail wheels of the work unit derailed. The wheels of two trucks on the work vehicle remained about eight inches off the rail as it was wedged up by the rail car. At least one truck on Car 3205 was lifted approximately one foot off the rail.

- Based on the video:
- The consist traveled 8-10 feet past RSW3 when the front left tire came into contact with the side of the consist, just past doors 1 & 2, and traveled approximately another 6 feet dragging RSW3.
- This resulted in the right side of the consist being lifted ~10" off the track. Wheel 2- and 4-Wheel flange kept the truck on the rail.

Photo 2 - This collision resulted in both vehicles' wheels losing contact with the rails.
