**WMSC Commissioner Brief: W-0047– Collision, train routed onto dead rail during response
at Minnesota Ave. Station February 14, 2020**

Prepared for Washington Metrorail Safety Commission meeting on September 22, 2020

FINAL REPORT OF INVESTIGATION A&I E20087

SMS 20200216#86428

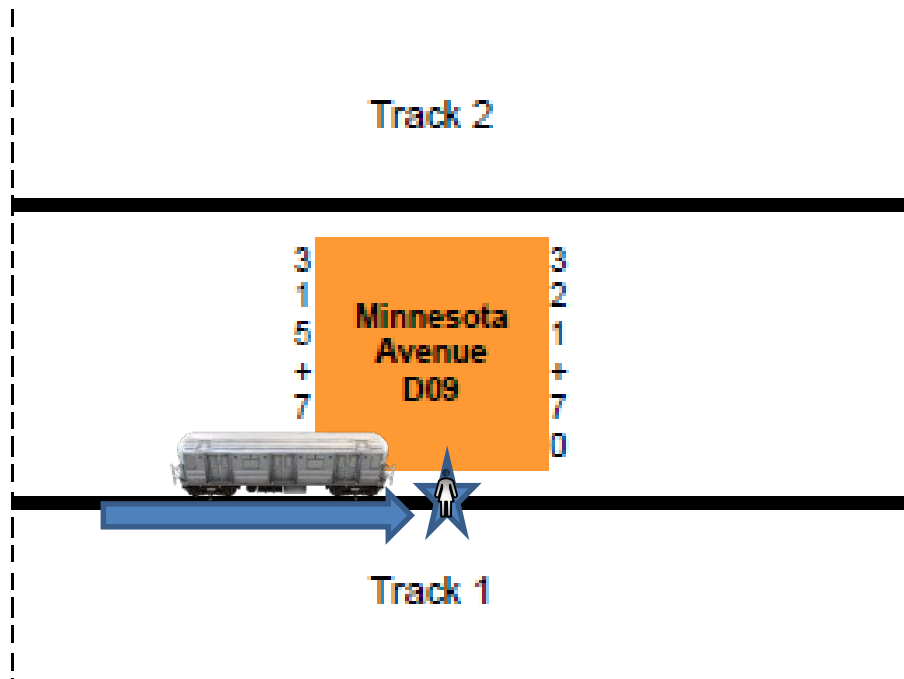
Field Sketch/Schematics

The incident area was located at the Minnesota Avenue Station, Track 1

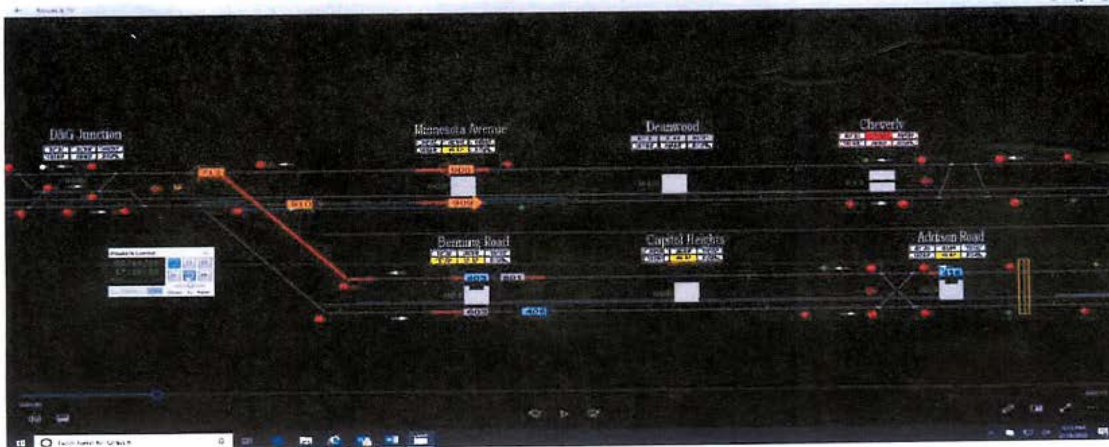
Train Routed into De-Energized 3rd Rail Power

- 1.4.12 The ROCC Supervisor shall have knowledge of track switches and interlocking operating procedures and other interlocking features
- On February 14, 2020 approximately 5:10pm, Train operator on 909 track # 1 Minnesota Avenue reported a customer was struck by his Train. 3rd rail power was de-energized; a ground walk around was performed; the operator reported the trailing 2 cars were off the platform. The following Train 910 was routed onto de-energized 3rd rail power with customers aboard. ROCC restored 3rd rail power to move Train 910 back to the D&G. AIM indicated the trailing car was on energized track.

- ### Root Cause
- Once notified of the emergency condition, the ROCC Supervisor failed to protect the incident area, by removing the automatic routing from D98-36 signal and placing a prohibit exit on D98-38 signal. As a result, Train 910 was routed onto de-energized 3rd rail. The ROCC Supervisor failed to immediately make blanket announcements informing all operators of the emergency and location. The announcement could have alerted the operator on Train 910 from accepting the alignment. Prior to restoring power to move Train 910 from the incident area, ROCC failed to verify, the Safety of WMATA's employee doing the ground walk around and the customer under Train 909 which was reported showing signs of life.

- ### ROCC Responsibility
- When notified of an emergency condition, the ROCC Supervisor shall be responsible for coordinating all activities to alleviate the condition. The ROCC Supervisor's primary concern shall be the Safety of customers and employees and the protection of property and equipment.

- ROCC shall cancel all automatic signals. If any interlocking of any diverging, universal or pocket track is contained within working limits.
