**WMSM Commissioner Brief: W-0048 – Fatal Collision, Self-Evacuation, Evacuation – Red Line – March 14, 2019**

Prepared for Washington Metrorail Safety Commission meeting on September 22, 2020

FINAL REPORT OF INVESTIGATION A&I E19135**SMS 20190315#78457**

Date of Event:	March 14, 2019
Type of Event:	Collision
Incident Time:	22:18 Hrs.
Location:	Between Takoma (B07) and Fort Totten (B06), Track 2 Chain Marker (CM) B2-290+00
Time and How received by SAFE:	22:18 hrs., SAFE on Call Phone
Safety Officer Response:	Yes
Time of Safety Officer Arrival:	23:10hrs.
Time of Safety Officer Departure:	02:34hrs. 3/15/19
Train Consist:	L7252-53x7213-12x7282-83x7263-62T
Injuries:	1 - Fatality, 1 - Customer reported injury during evacuation via roadway
Damage:	None
Emergency Responders:	MTPD, DCFD, SAFE, CMNT, PLNT, ATC, TRST

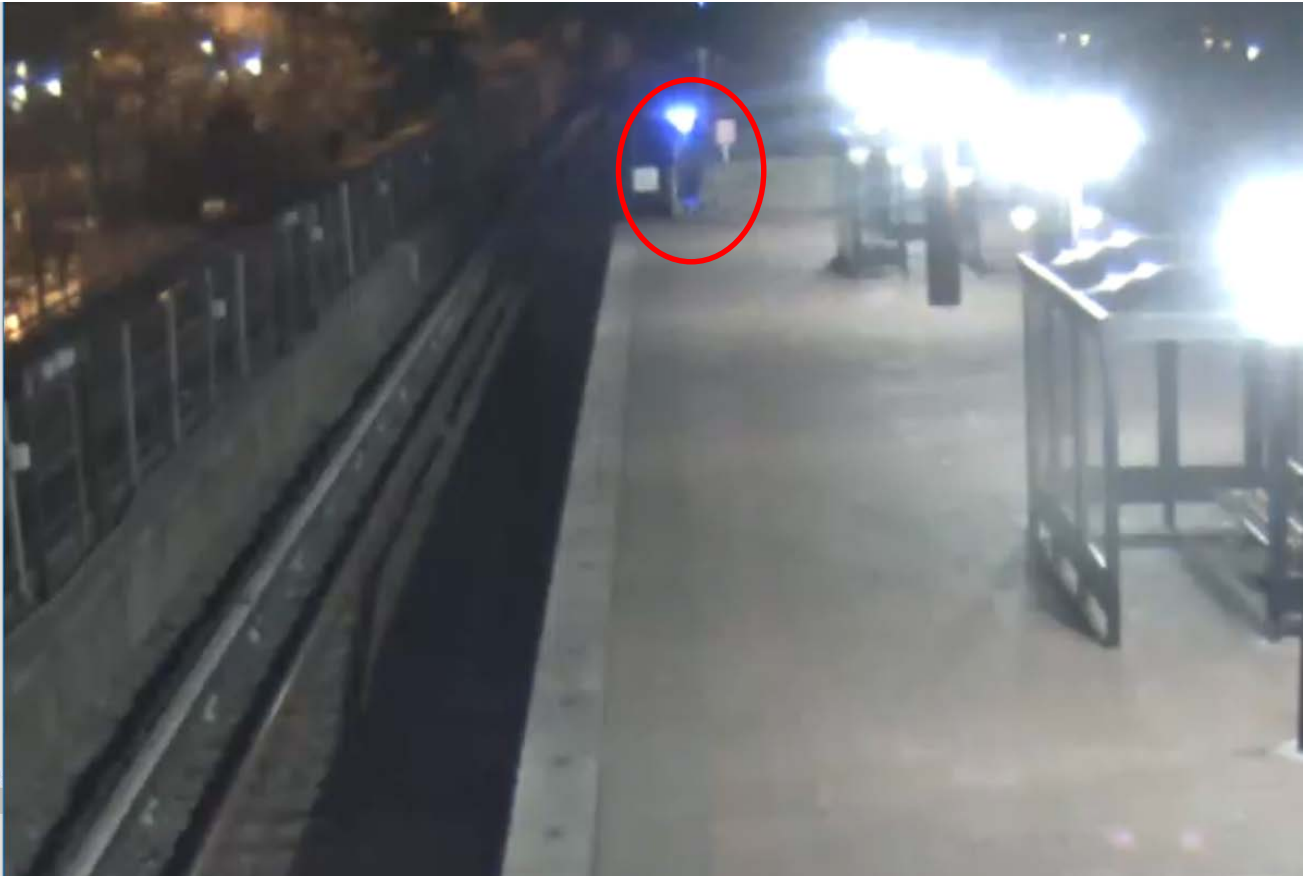
21:54 hrs. – The decedent enters the roadway via end gate Track 2 at B06 Station Via CCTV

Photo 1 – 21:54:46 the customer enters the roadway via end gate Track 2 at B06 Station

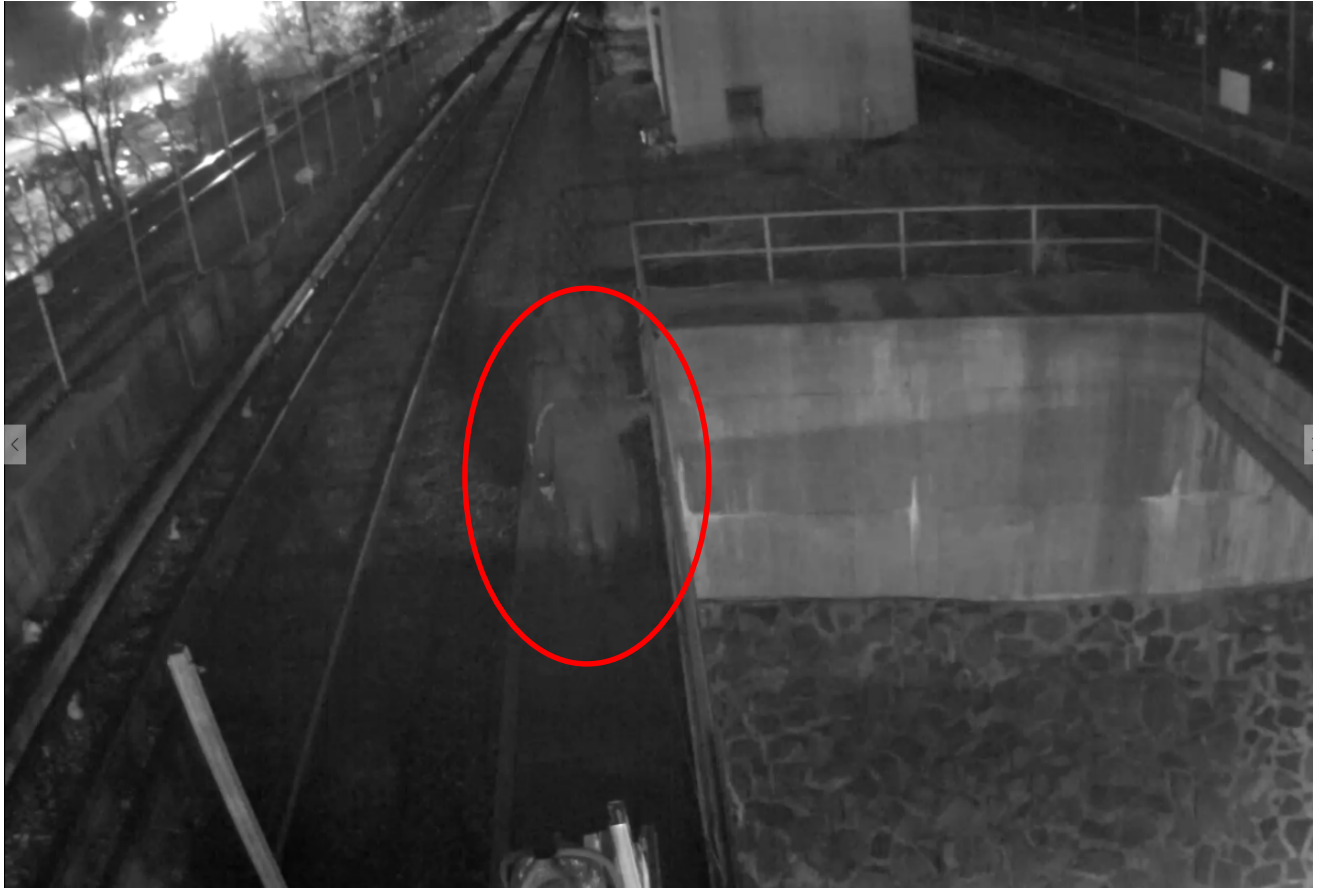
21:55 hrs. – The decedent was seen entering the roadway unauthorized on Track 2 in the direction of B05 Station via CCTV

Photo 2 – 21:55:20, the customer seen entering the roadway unauthorized on Track 2 in the direction of B05 Station

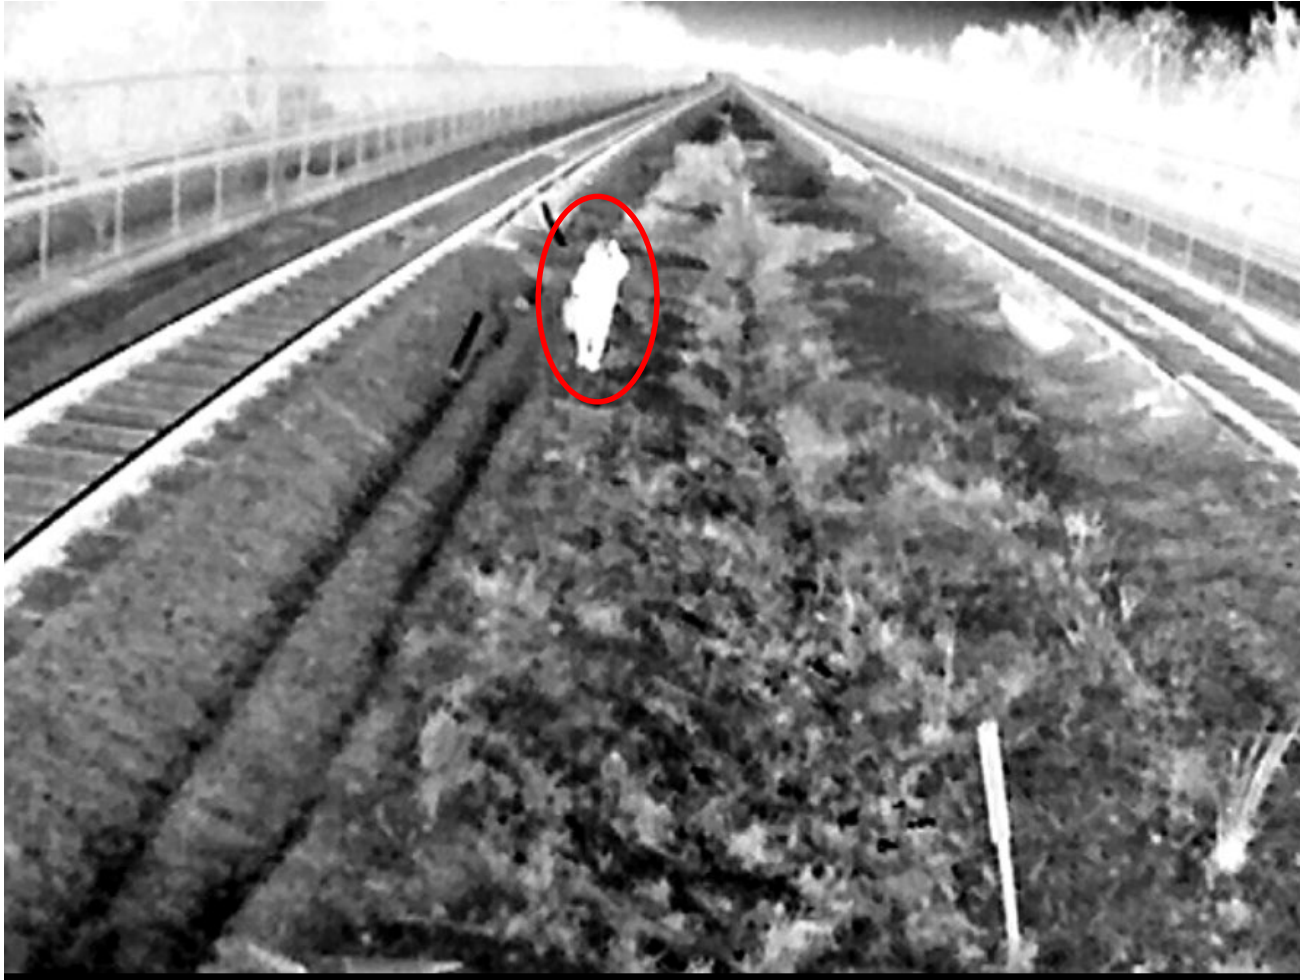
21:58:00 hrs. – The decedent was in between Track 1 and Track 2 walking in the direction of B05 Station Via CCTV

Photo 3 – 21:58:00 hrs., the customer was in between Track 1 and Track 2 walking in the direction of B05 Station

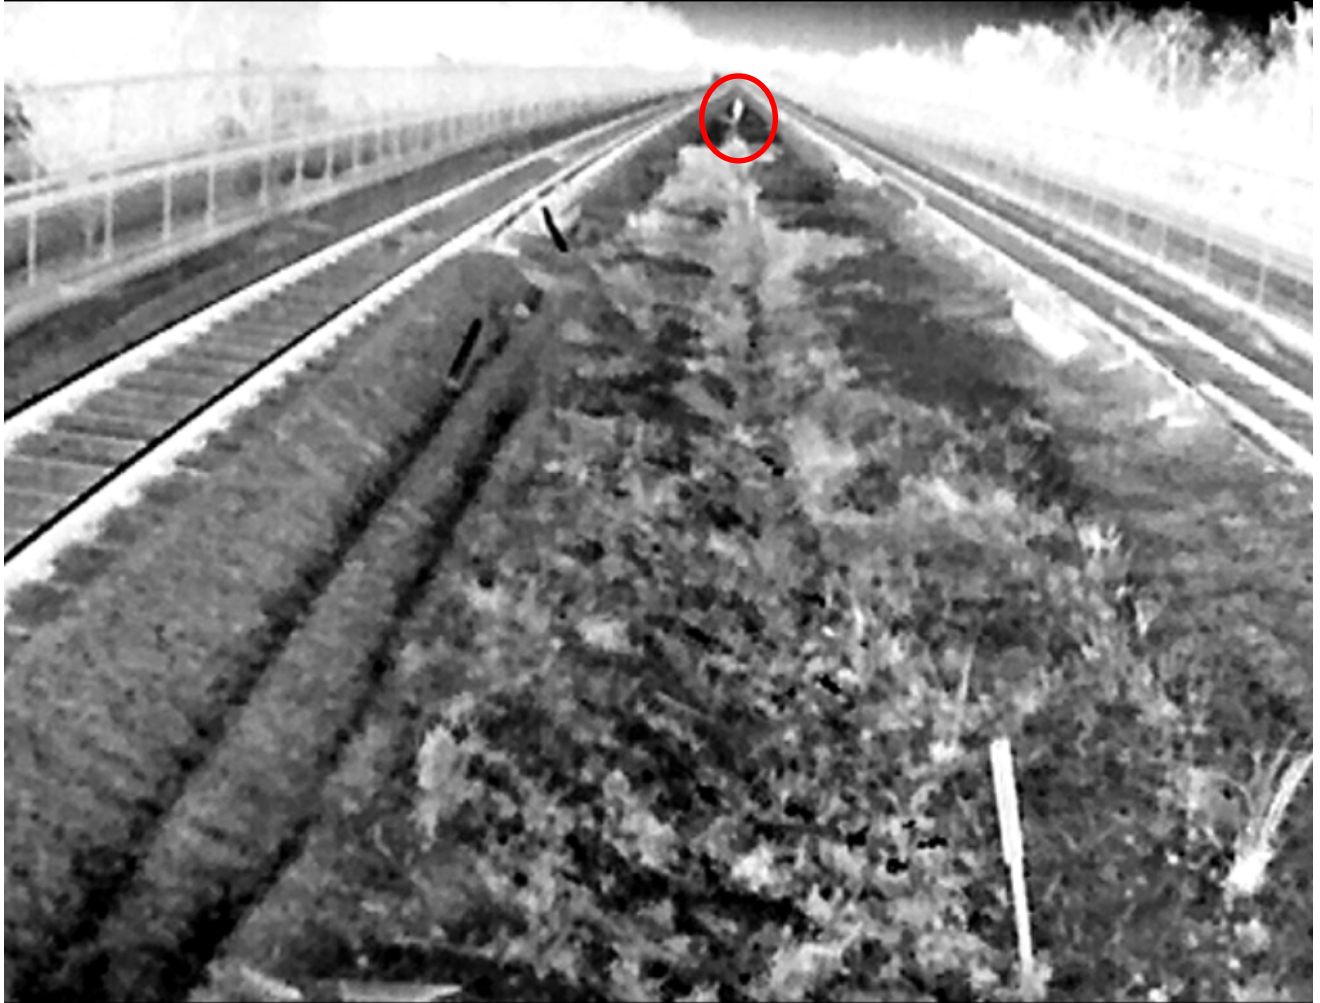
22:04 hrs. – The decedent eventually disappears from camera view 4 seconds after the above screenshot of the camera footage while walking between tracks 1 and 2

Photo 4 – 22:04 hrs., the customer eventually disappears from camera view 4 seconds after the above screenshot of the camera footage while walking between tracks 1 and 2

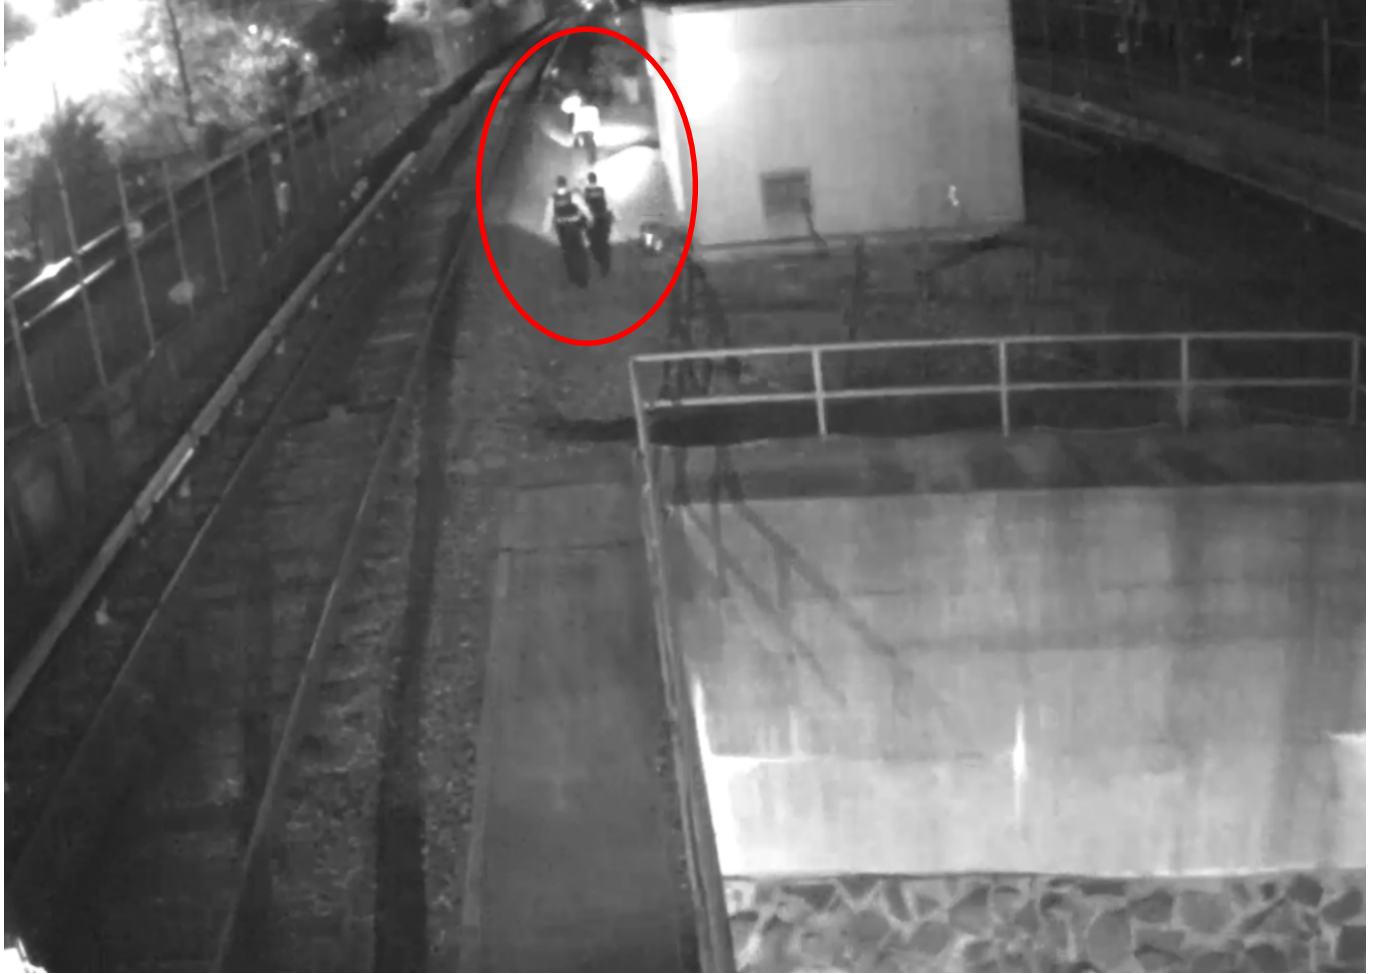
Photo 5 – 22:33 hrs., MTPD initial contact with first 2 self-evacuated customers

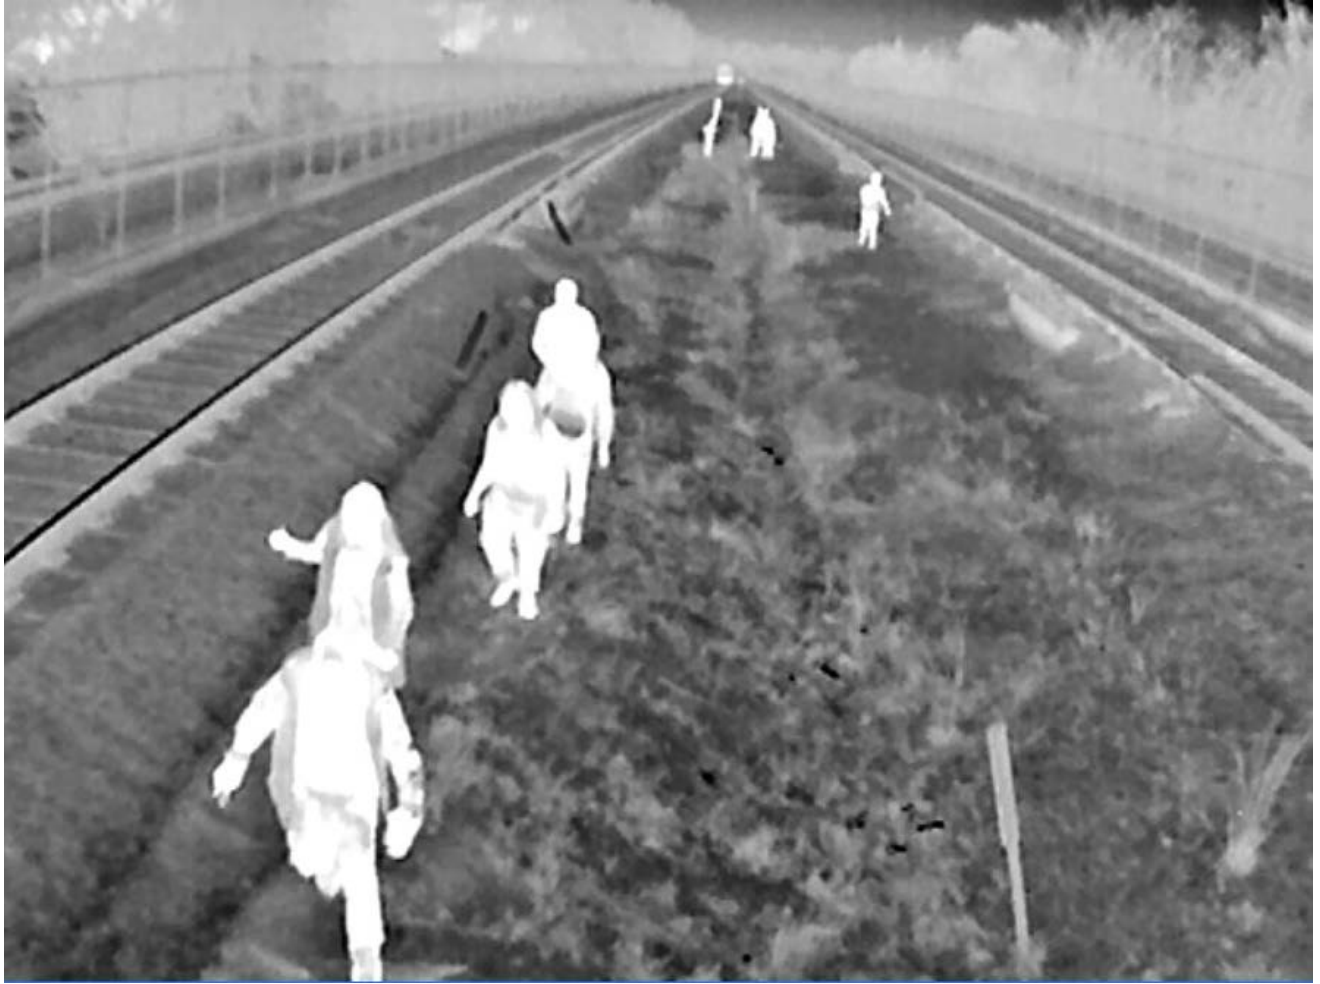
Photo 6 – 14 remaining uncontrolled self-evacuated customers

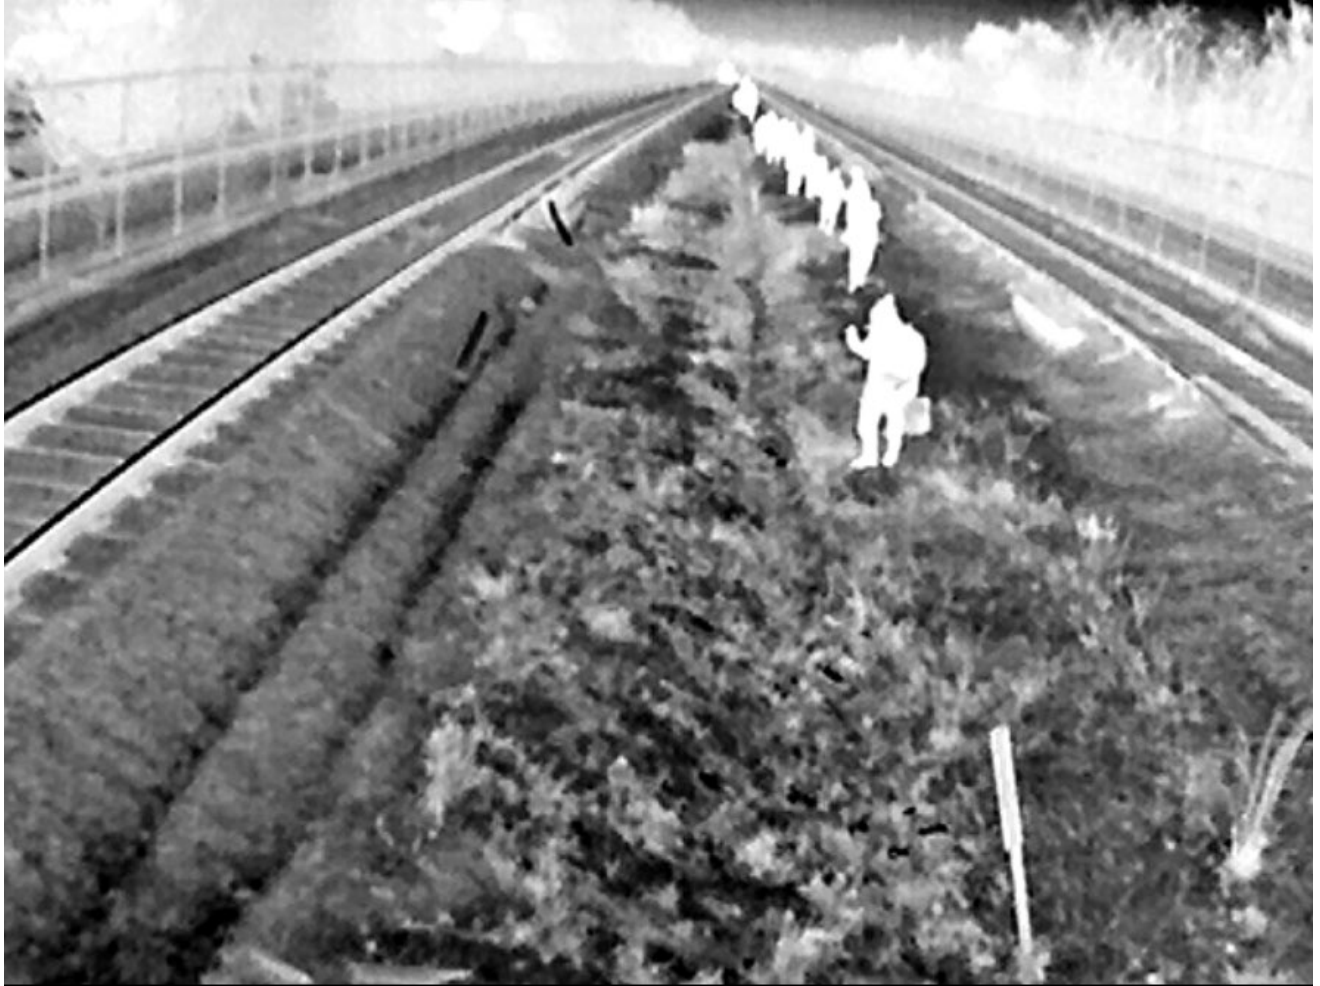
22:58 hrs. – RS 1 reported to ROCC per MTPD report, customers were evacuated from the consist. (Further investigation revealed, one customer reported minor injuries as a result of the evacuation)

Photo 7 – 22:58:00 hrs. Controlled evacuation of 59 customers
