WMSC Commissioner Brief: W-0049 – Fire/Smoke at L’Enfant Plaza Station – February 4, 2020

FINAL REPORT OF INVESTIGATION A&I E20061

SMS 20200204#86294

Final Report – Fire/Smoke resulting non-serious injury
or property damage
E20061

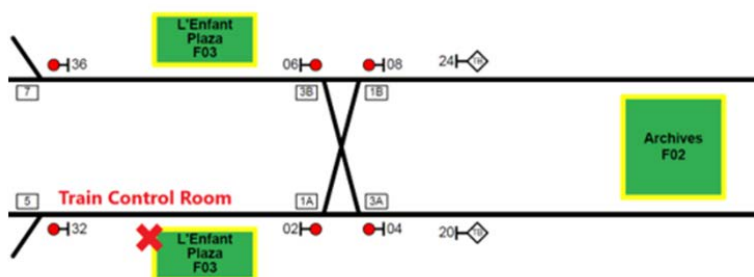
Field Sketch/Schematics

L'Enfant Plaza, Track 1

Lower Platform Level, Train Control Room

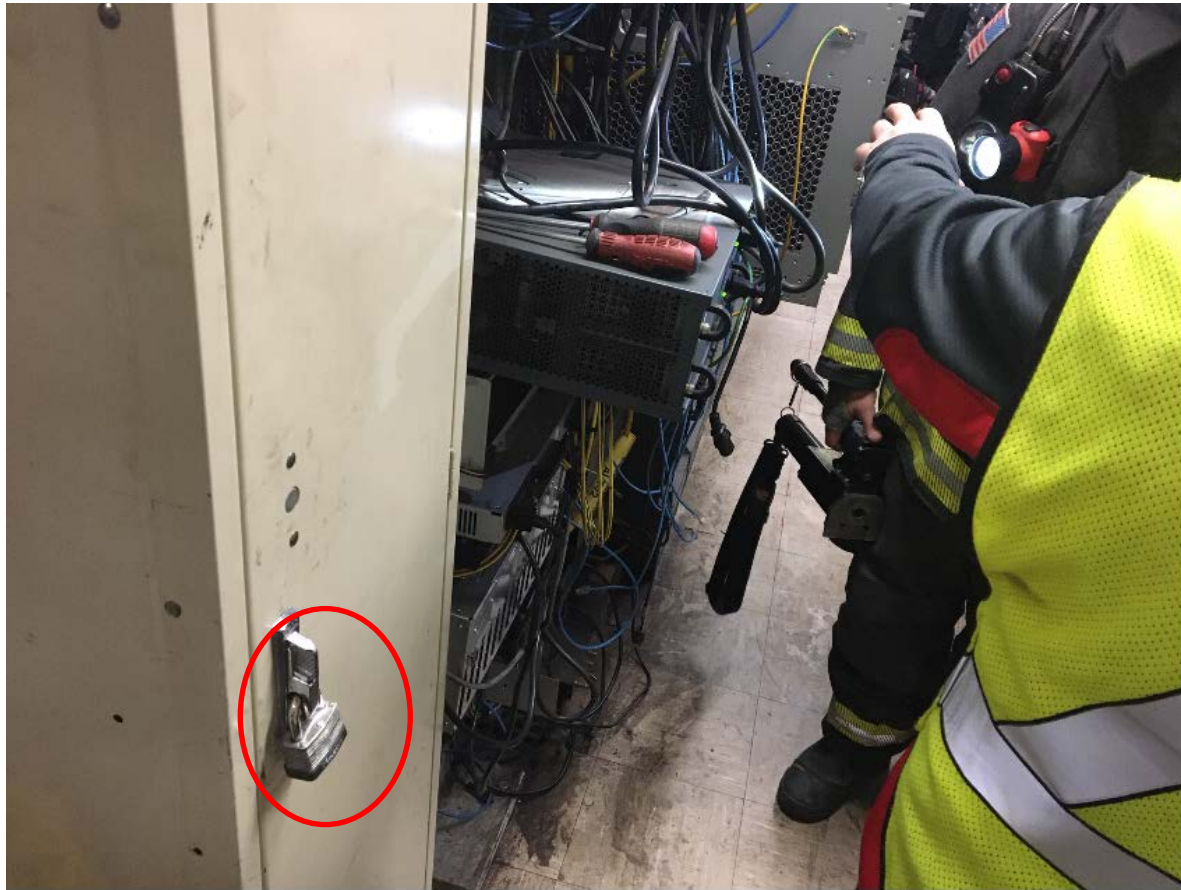
Photo 1 – Lock requiring removal

On Tuesday, approximately noon, ATCM management notified ROCC of a smoke condition at L'Enfant Plaza Station within the TCR. ATCM requested ROCC activate fans to ensure no smoke affected the platform area, as a result of ATCM personnel cutting a lock off a vacant locker **Refer to photo 1**.

After investigation, ATCM management determined, ATCM personnel were tasked with removing belongings from a vacant locker secured closed with a padlock. Personnel proceeded to L'Enfant Plaza TCR to remove a personal lock. Upon arrival, it was determined to utilize a grinder (equipped with cutting wheel) to remove the secured lock. A Bolt cutter was not available at the time of lock removal. ATCM/S began cutting the padlock, and within a second of contact, several sparks traveled to nearby COMM equipment. ATCM/S immediately stopped the work [cutting] mitigate [deflect] sparks away from "IT" equipment.

- ATCM/S used a grinder to cut a padlock off a vacant locker
- ATCM/S did not have Hot-works training
- ATCM did not use bolt cutters to remove installed padlock
- Safety briefing not conducted prior to performing the job
- There are no work instructions available to perform a specific job
- ROCC did not instruct the Train Operator to offload customers before performing a track inspection through a reported smoke-filled area.

1. ATCM shall not perform any work within a TCR resulting in sparks emitting from tool use
2. ATCM will attend Hot-Works Computer Based Training (CBT).
3. ROCC previously issued a directive prohibiting the use of revenue trains to conduct any type of track inspections with Customers Aboard (see attachment 2 pages 1-3).

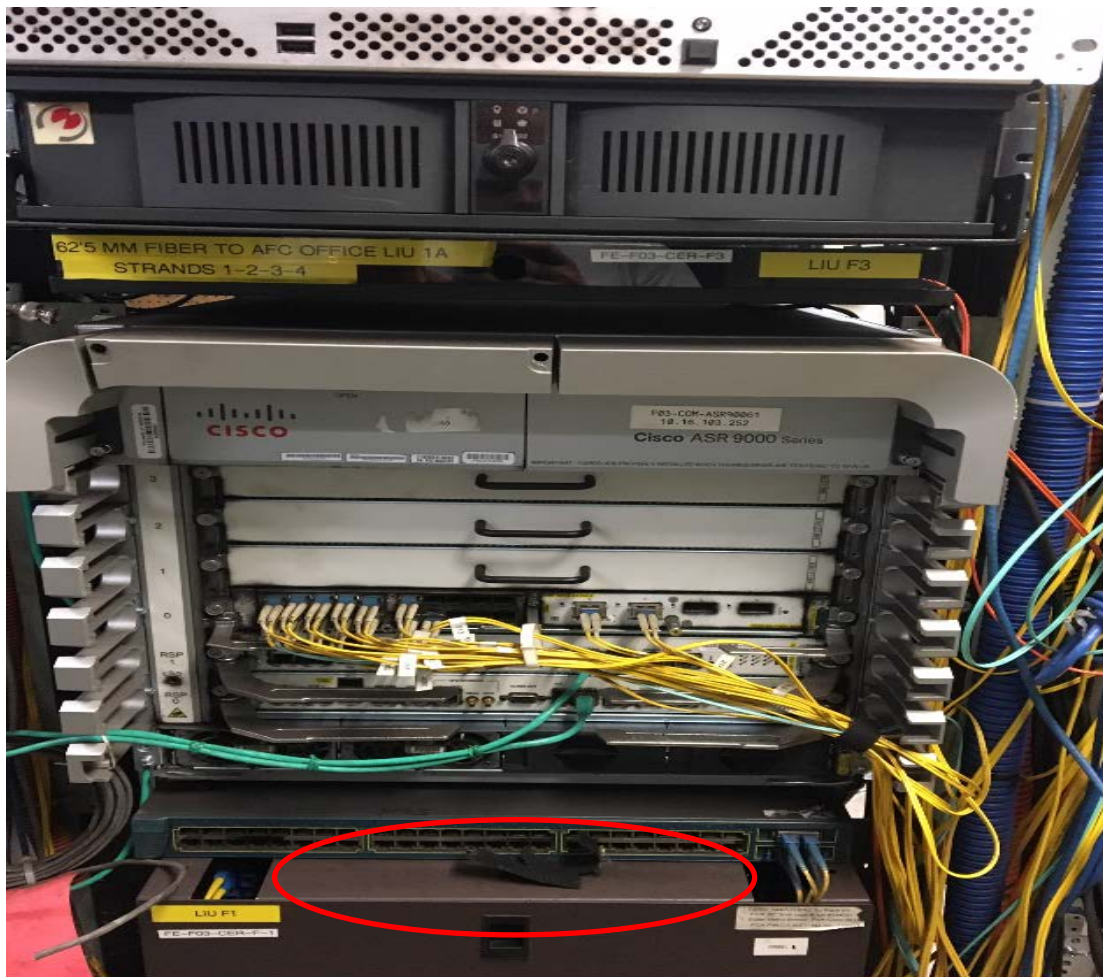
ATC personnel observed a small amount of smoke emitting from a nearby "IT" switch chassis cooling exhaust. The sparks had entered a side vent and ignited the filter inside the chassis. The burning filter was fueled by air being drawn in through a fan and continued to smolder, creating an increasing amount of smoke. Input power was removed

from the chassis to prevent airflow, which stopped the smoke. ATCM personnel extinguished the smoking filter using a Dry-Chemical Fire extinguisher. TCR doors were opened to mitigate smoke condition; however, the smoke that formed within the TCR traveled inside the tunnel area (in the proximity of the platform area). MOC was immediately contacted to report the incident. Upon DCFD arrival, the smoke had dissipated. DCFD personnel performed an inspection and reported no evidence of fire. Thereafter, DCFD deemed the area safe after verifying power was removed, and the burned filter posed no further threat.

Photo 2 – Affected Cisco COMM component

COMM concluded, equipment was not affected and replaced the filter. ATCM Management developed and distributed Lessons Learned (ATCM-LL-#2020-002, attachment 1) to the entire ATCM Compliance team and recommended ATCM employees complete the CBT "Hot Work Operator" class.
