#### WMSC Commissioner Brief: W-0050 - Improper RWP - Rosslyn-Foggy Bottom-GWU stations - July 11, 2020

#### FINAL REPORT OF INVESTIGATION A&I E20249

# Rosslyn – Roadway Worker Protection Violation July 11, 2020

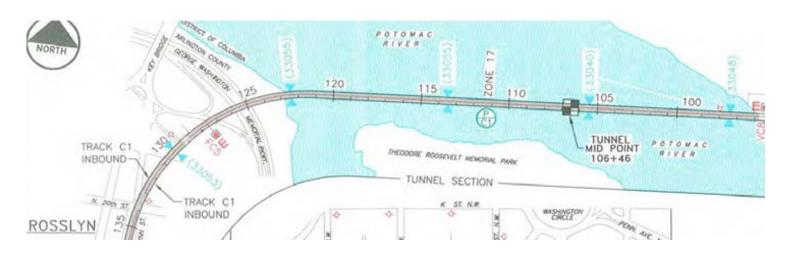
#### Field Sketch/Schematics

Rosslyn Station, Track 2

FT Vortex Location: CM C2-109+00 and CM C2 94+00

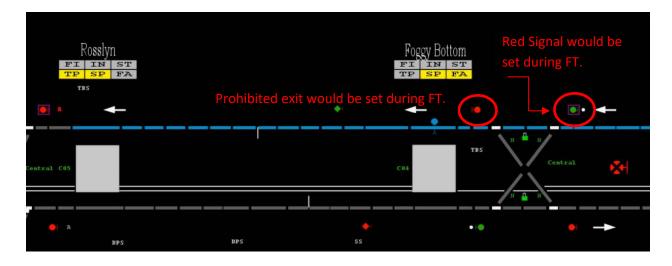
**Photo 1:** AIM shows no indication for FT protection. **Note:** The RWIC did not request FT protection and subsequently did not allow ROCC personnel to adequately provide the proper protection for personnel on the roadway.
