## Inspection Form

Washington Metrorail Safety Commission

<b>Inspection Date</b>	YYYY	MM	DD	<b>Report Number</b>	20200205-WMSC-MAL-1		
	2020	02	05				
<b>Rail Agency Name</b>	Washington Metropolitan Area Transit Authority			<b>Rail Agency Department</b>	CMNT	<b>Sub- Department</b>	Greenbelt MRO Shop
<b>Rail Agency Department Contact Information</b>	<b>Name</b>		<b>Email</b>	<b>Office Phone</b>		<b>Mobile Phone</b>	
	[REDACTED]		[REDACTED]	[REDACTED]		[REDACTED]	
	[REDACTED]		[REDACTED]	[REDACTED]		[REDACTED]	
	[REDACTED]		[REDACTED]	[REDACTED]		[REDACTED]	
	[REDACTED]		[REDACTED]	[REDACTED]		[REDACTED]	
	[REDACTED]		[REDACTED]	[REDACTED]		[REDACTED]	
<b>Inspection Location</b>	Greenbelt MRO Shop - Railyard E99 5801 Sunnyside Ave, College Park, MD 20740

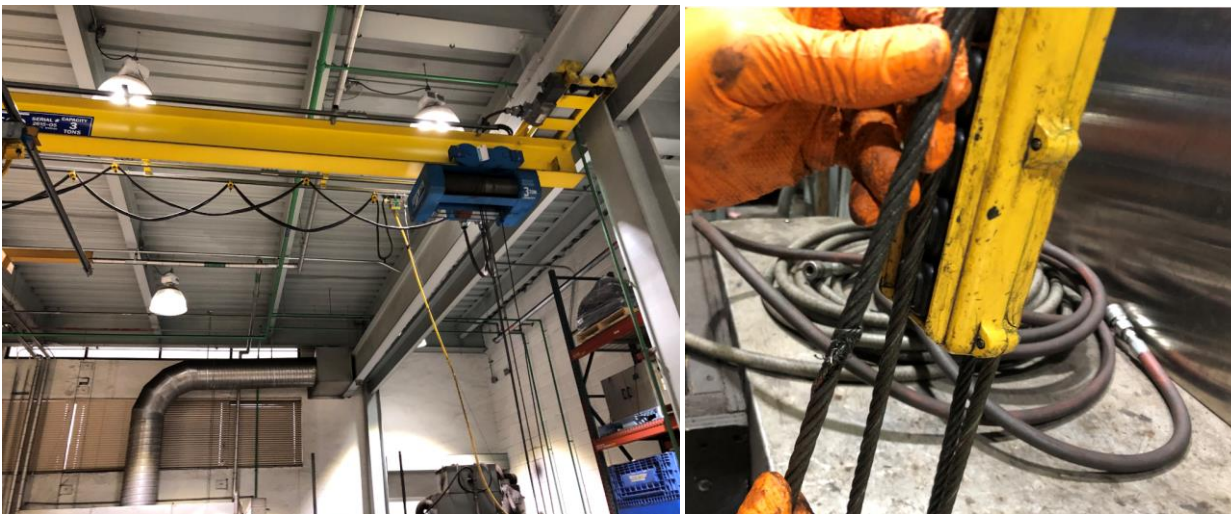
PLNT	Crane #1 cable trans worn and damaged	G117	15527706	HIGH		2/3/2020

Photos 1 and 2– Overhead crane is not safe to operate due to functionality problems, such as gear grinding noises and hoist cable strands are broken or fraying

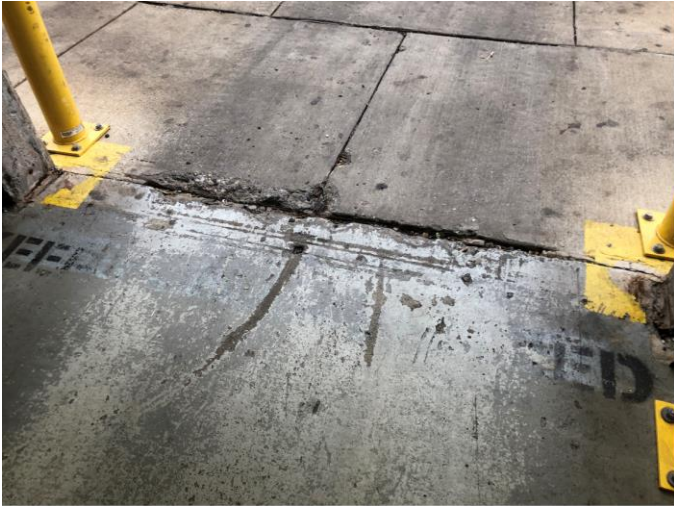
Photo 3 - MRO shop entrance ramp has large sections of concrete missing from the floor, which can cause the forklift to tilt and drop components while they are being transported

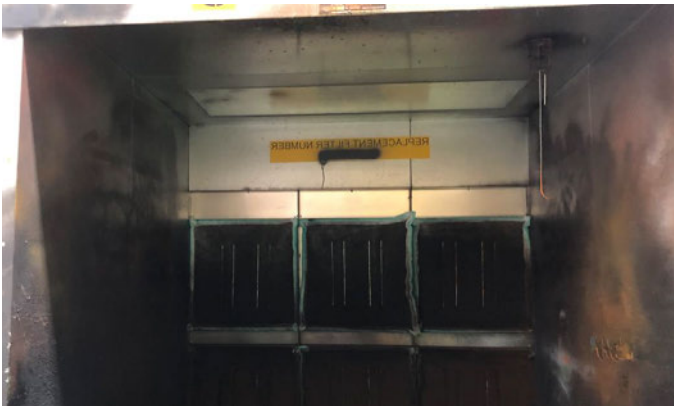
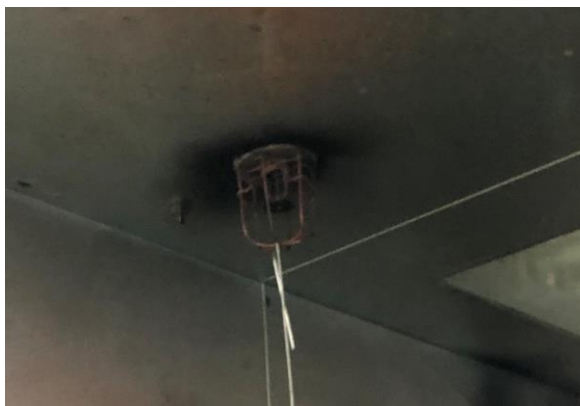
Photos 4 and 5 – The fire sprinkler head in paint booth has been painted

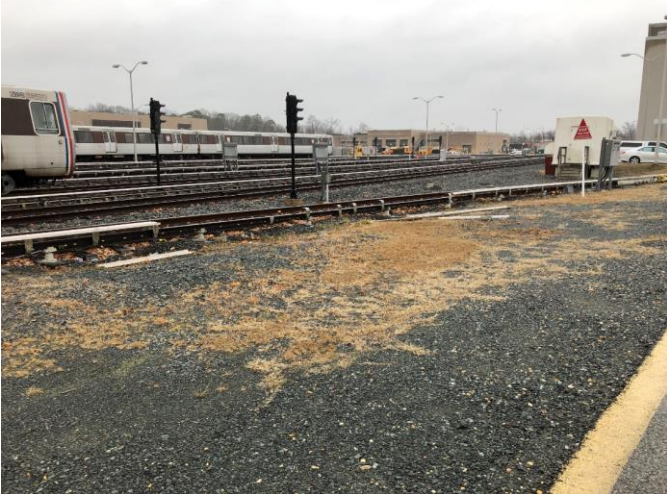
Photo 6 – The railyard had missing third rail covers

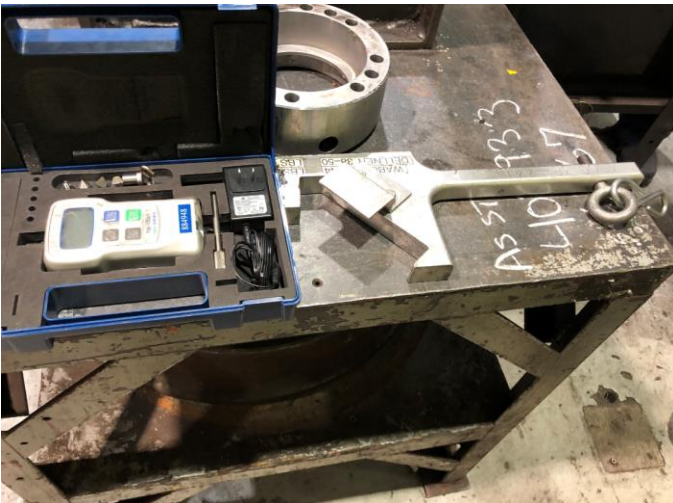
<ul style="list-style-type: none"><li>• <b>Notable/positive.</b> Special tools were organized, calibrated, and properly stored for easy access and use for the task being performed. <b>See attached photo 7.</b></li></ul>		
Remedial Action	N/A		
Effective Practices	<p>Effective Practices</p> <ul style="list-style-type: none"><li>• The MRO shop overhauls both mechanical and electrical components using only "OEM" parts.</li><li>• Special tools were organized, calibrated, and stored for easy access and use for the task being performed.</li><li>• Hazardous material storage included the proper NFPA 704 label for the hazard level and individual material labels for proper storage and separation.</li></ul>

Photo 7 – Special tools were organized, calibrated, and properly stored for easy access and use for the task being performed
