Inspection Form

Washington Metrorail Safety Commission

Inspection Date	YYYY	MM	DD	Report Number	20200205-WMSC-MAL-2		
	2020	02	05				
Rail Agency Name	Washington Metropolitan Area Transit Authority			Rail Agency Department	CMNT	Sub- Department	Greenbelt S&I Shop
Rail Agency Department Contact Information	Name		Email		Office Phone		Mobile Phone
	██████████ ██████████ ██████████		██████████ ██████████ ██████████		██████████ ██████████ ██████████		██████████ ██████████ ██████████
Inspection Location	Greenbelt S&I Shop - Railyard E99 5801 Sunnyside Ave, College Park, MD 20740

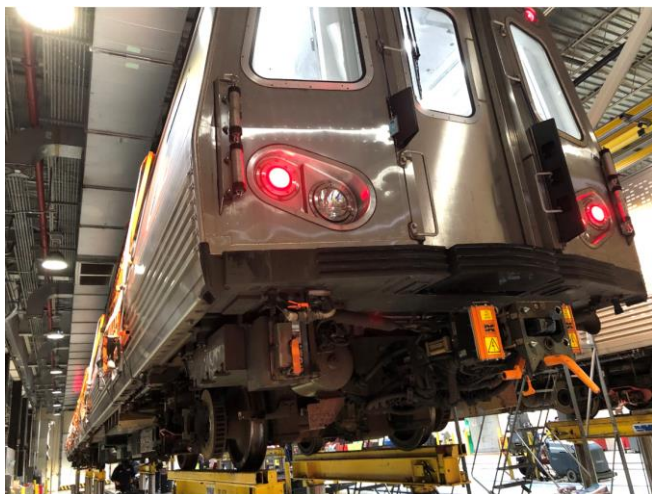
Photo 1 – The S&I Shop does not have a scaffolding structure to reach 7K roof mounted HVAC units

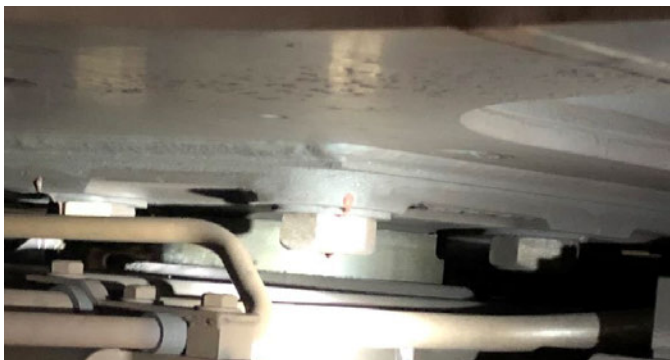
Photo 2 – The truck center pin liner on 7K series railcars is pulling out from its original location

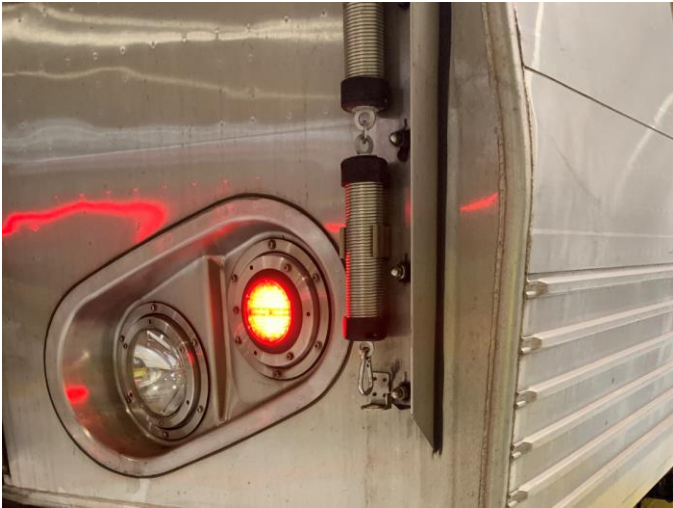
Photo 3 - Inter-car barriers were in the stowed position, but they were not engaged

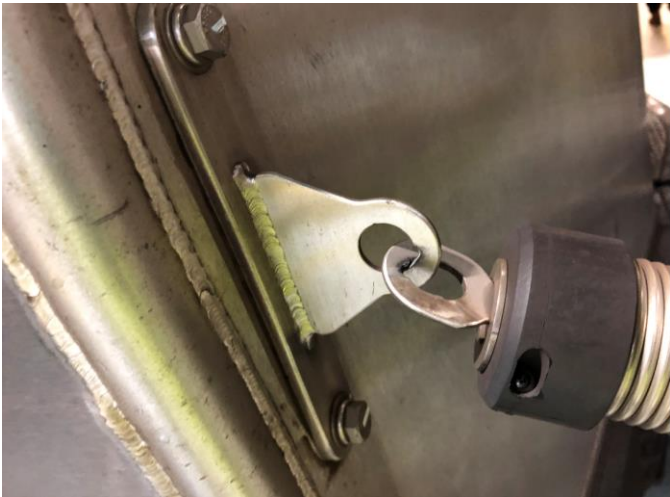
Photo 4 – The original inter-car barriers are showing signs of excessive wear at the connection link

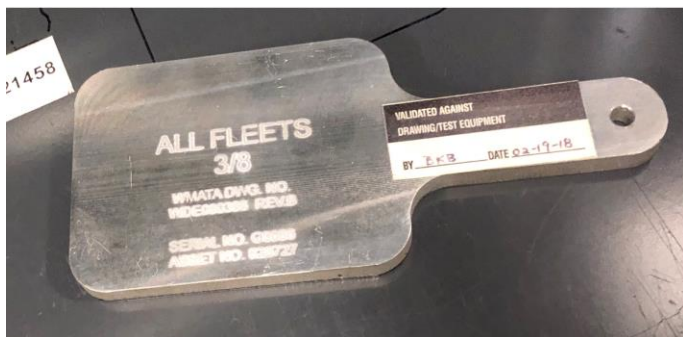
Photo 5 – Special tool was overdue for calibration
