Inspection Form

Washington Metrorail Safety Commission

Inspection Date	YYYY	MM	DD	Report Number	20200214-WMSC-MAL-1		
	2020	02	14				
Rail Agency Name	Washington Metropolitan Area Transit Authority			Rail Agency Department	CMNT	Sub- Department	West Falls Church Yard
Rail Agency Department Contact Information	Name		Email		Office Phone		Mobile Phone
	[REDACTED]		[REDACTED]		[REDACTED]		[REDACTED]
	[REDACTED]		[REDACTED]		[REDACTED]		[REDACTED]
	[REDACTED]		[REDACTED]		[REDACTED]		[REDACTED]
	[REDACTED]		[REDACTED]		[REDACTED]		[REDACTED]
Inspection Location	West Falls Church S&I Shop - Railyard K99 7253 Idylwood Road Falls Church, Virginia 22043

Inspection Activity #	1	Inspection Subject	Shop / Yard Inspection Observation				Activity Code		VM	WI	PI
Job Briefing Employee Name/Title	WMATA Inspection			Accompanied Inspector?	Yes	Out Brief Conducted	Yes	Time	8:00-11:00	Outside Shift	No
Related Reports	N/A			Related CAPS / Findings		TOC-COL-15-003-A					
Related Rules, SOPs, Standards, or Other	Ref		Rule or SOP		Standard		Other / Title		Checklist Reference		
	MetroRail Safety Rules and Procedures Handbook (MSRPH). Section 4-- Safety Rules										
Inspection Location	Main Track	Yard	S

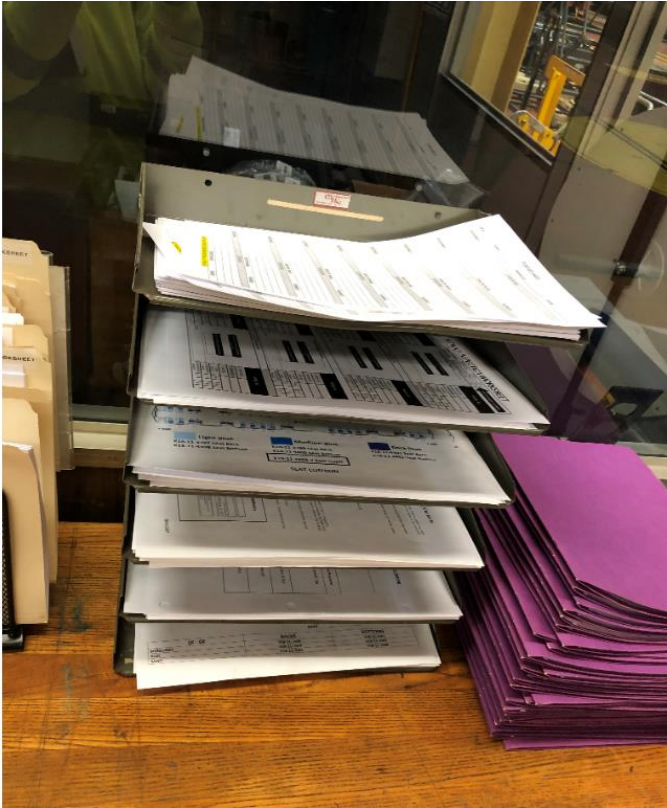
Photo 1 – PI books were properly organized and labeled for the task being performed

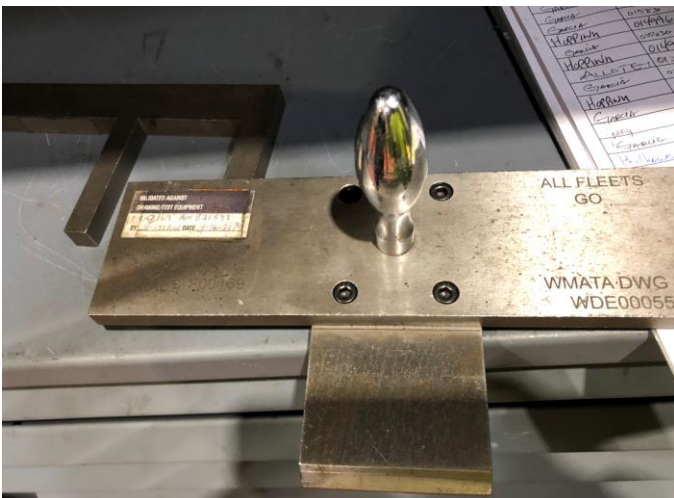
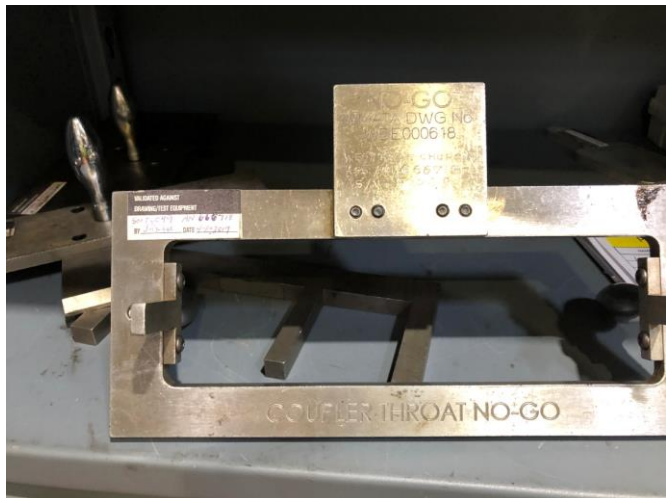
Photos 2 and 3 – Some special tools had an overdue calibration date

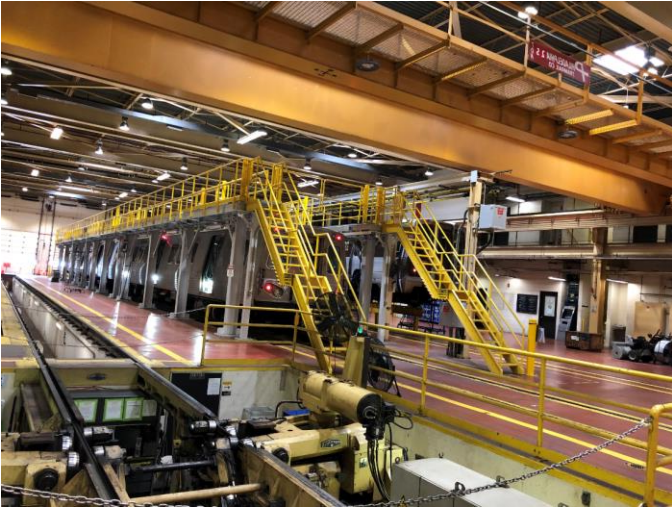
Photo 4 – WFC new compact platform is needed to reach 7000 series roof mounted equipment

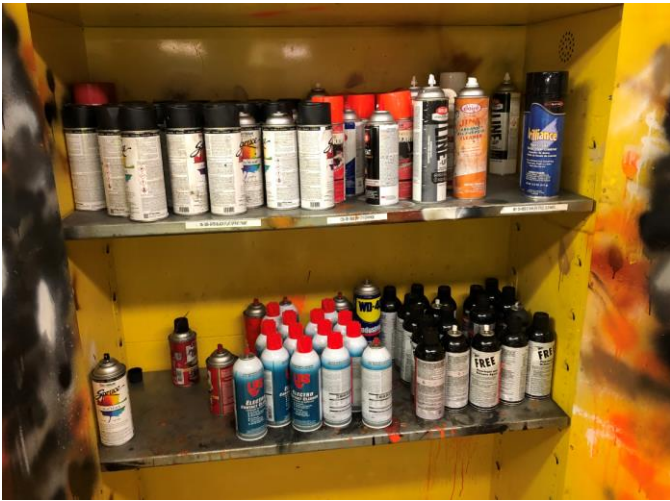
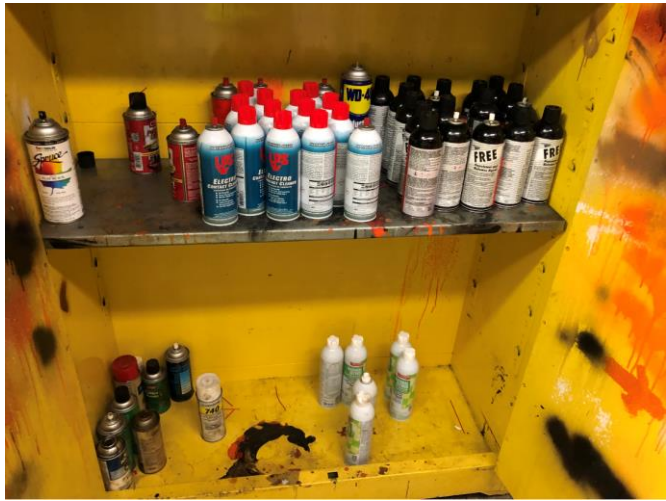
<ul style="list-style-type: none"> <i>Hazardous material storage cabinets did not have individual material labels for proper storage and separation. See attached Photos 6 and 7. Will discuss at the next WMSC-CMNT monthly meeting.</i> <i>Noted missing third rail cover boards adjacent to the S&I Shop. Need to implement daily inspections and maintenance process where third rail covers are reported and replaced regularly. West Falls Church opened a Work Order ticket for replacing the cover boards. See attached photo 8. Will discuss at the next WMSC-CMNT monthly meeting.</i> <i>Noted large sections of concrete are spalling from the shop apron and they are creating trip hazards for personnel working on the apron. See attached photo 9.</i> <p>Railcar Equipment</p> <ul style="list-style-type: none"> <i>Bulkhead doors on 2K/3K series railcars are getting stuck. This is a safety concern. Will discuss at the next WMSC-CMNT monthly meeting.</i> Good initiative to locate broken railcar collector shoes. Collector shoes are being marked with the railcar number in order to locate them on the mainline and identify the railcar number where they are braking off. Locating and identifying collector shoes will allow maintenance personnel to determine the cause of damage by either determining if the third rail height is out of specification or if the railcar collector shoe height needs to be adjusted. <i>See attached Photo 10.</i> <p>Future visits</p> <ul style="list-style-type: none"> WMSC will coordinate effort with WMATA's Fire Marshall to conduct a hazardous material storage and handling observation at selected yards.

Photos 6 and 7 - Hazardous material storage cabinets did not have individual material labels for proper storage and separation

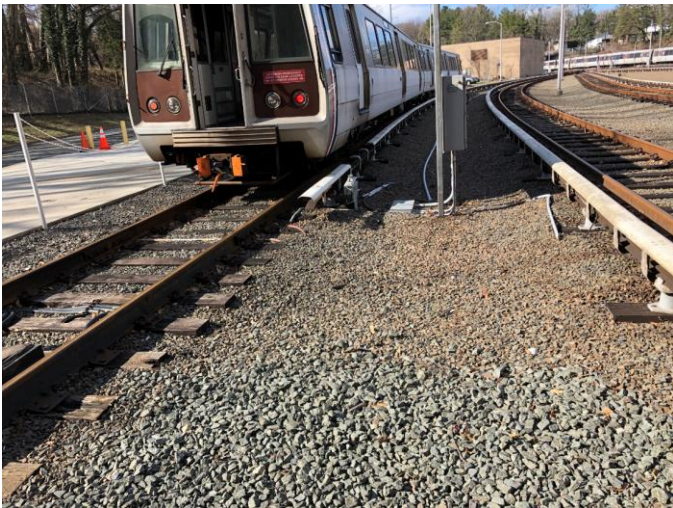
Photo 8 – Missing third rail cover boards adjacent to the S&I Shop

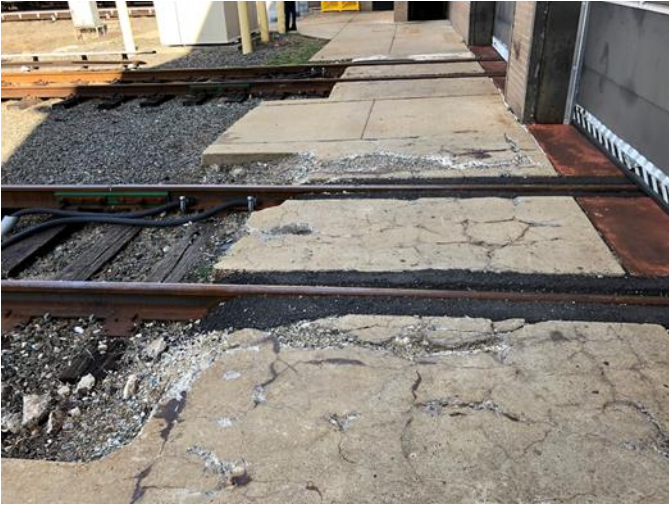
Photo 9 – Large sections of concrete are spalling from the shop apron and they are creating trip hazards for personnel

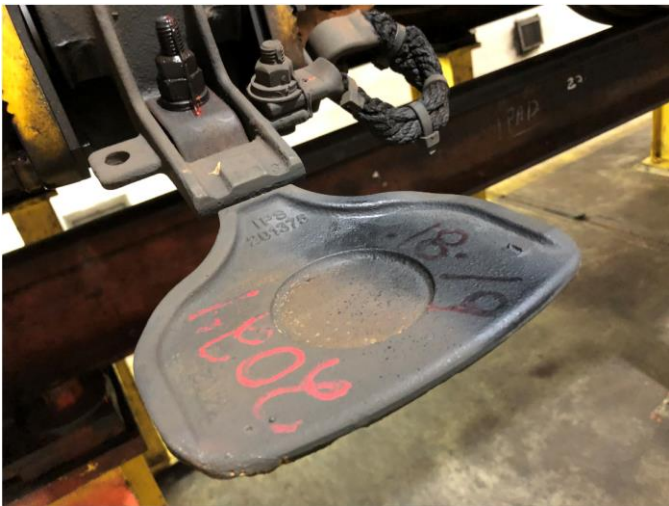
Remedial Action	N/A		
Effective Practices	<p>Effective Practices</p> <ul style="list-style-type: none"> Collector shoes are being marked with the railcar number in order to locate them on the mainline and identify the railcar where they came from. Locating and identifying collector shoes will allow maintenance personnel to determine the cause of damage, by either determining if the third rail height is out of specification or if the railcar collector shoe height needs to be adjusted. West Falls Church received the first of new compact platforms, which are being procured and will be installed throughout S&I shops. This new platform is needed to reach 7000 series roof mounted equipment. PI books were properly organized and labeled for the task being performed. See items listed above under Job well done for WMATA.

Photo 10 – Collector shoes are being marked with the railcar number in order to locate them on the mainline and identify the railcar number where they are braking off
