Inspection Form

Washington Metrorail Safety Commission

Inspection Date	YYYY	MM	DD	Report Number	20200220-WMSC-MAL-1		
	2020	02	20				
Rail Agency Name	Washington Metropolitan Area Transit Authority			Rail Agency Department	CMNT	Sub- Department	Branch Avenue Yard
Rail Agency Department Contact Information	Name		Email		Office Phone		Mobile Phone
	██████████ ██████████ ██████████		██████████ ██████████ ██████████		██████████ ██████████ ██████████		██████████ 8522 N/A
Inspection Location	Branch Avenue S&I Shop - Railyard F99 5700 Capital Gateway Drive Camp Springs, MD 20746

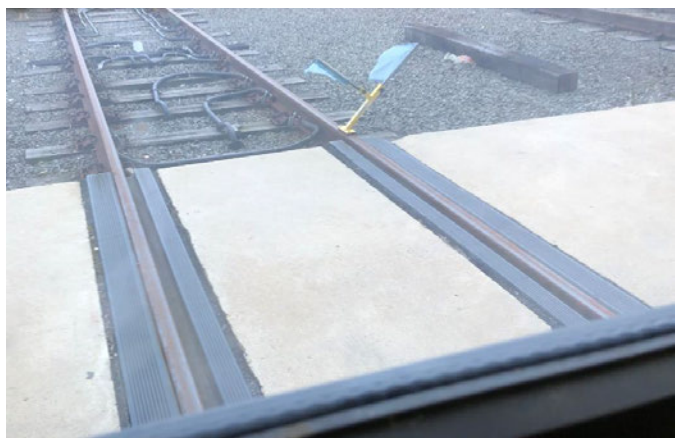
Photo 2 – Yard debris near the shop apron
