Inspection Form

Washington Metrorail Safety Commission

Inspection Date	YYYY	MM	DD	Report Number	20200304-WMSC-MAL-1		
	2020	03	04				
Rail Agency Name	Washington Metropolitan Area Transit Authority			Rail Agency Department	CMNT	Sub- Department	New Carrollton Yard
Rail Agency Department Contact Information	Name		Email		Office Phone		Mobile Phone
	██████████		██████████		██████████		██████████
	██████████		██████████		██████████		██████████
Inspection Location	New Carrollton S & I Shop - Railyard D99 4300 Garden City Dr Hyattsville, MD 20785

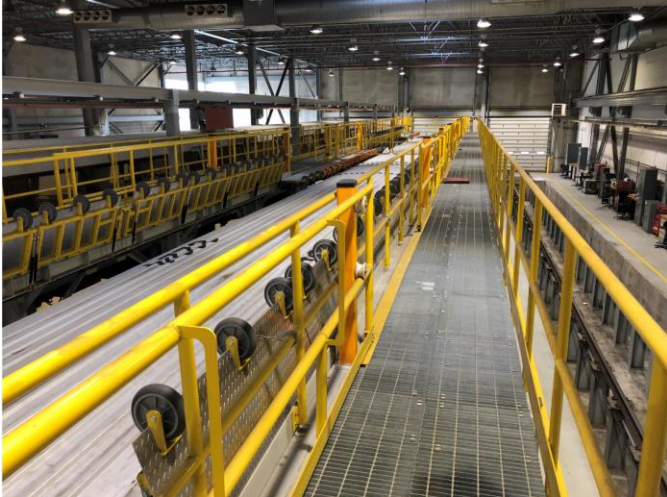
Photo 1 – New compact fixed scaffolding structure to reach railcars roof mounted equipment

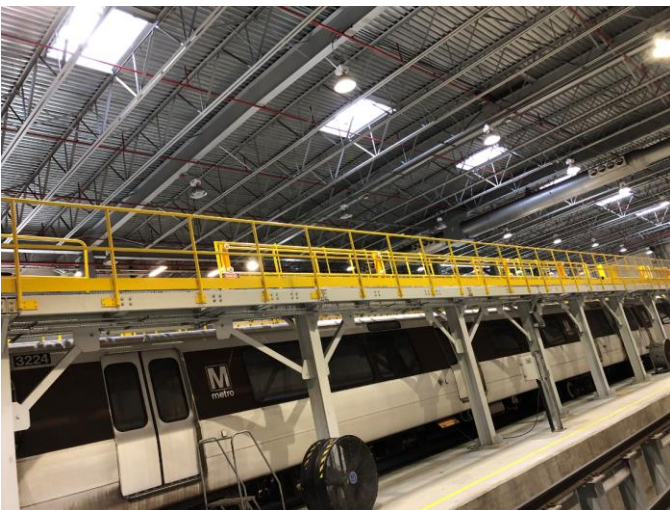
Photo 2 – The new LED lights inside the S&I Shop are flickering

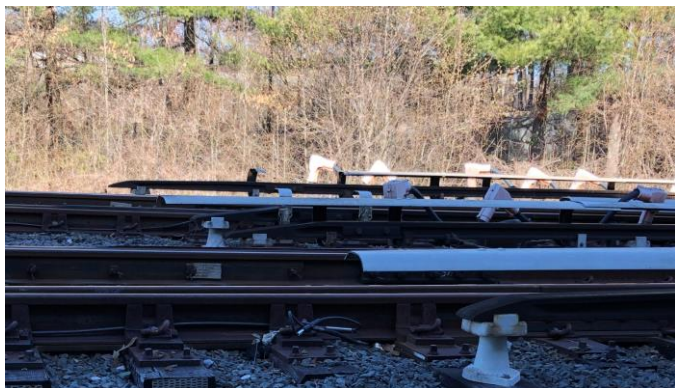
Photo 3 – Some third rail covers were missing

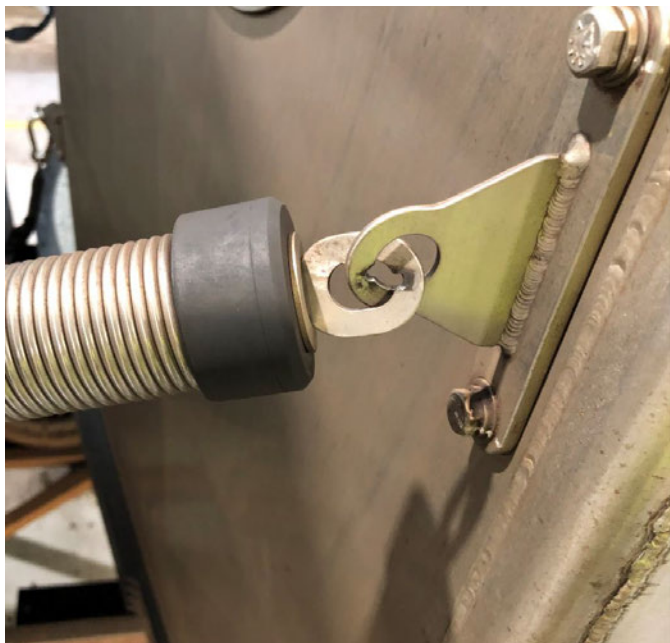
Photo 4 – The original inter-car barriers are showing signs of excessive wear at the connection link
