Inspection Form

Washington Metrorail Safety Commission

Inspection Date	YYYY	MM	DD	Report Number	20200826-WMATA-LBW-1		
	2020	08	26				
Rail Agency Name	Washington Metropolitan Area Transit Authority			Rail Agency Department	Operations	Sub-Department	Stations
Rail Agency Department Contact Information	Name		Email		Office Phone		Mobile Phone
	[REDACTED]		[REDACTED]		[REDACTED]		[REDACTED]
	[REDACTED]		[REDACTED]		[REDACTED]		[REDACTED]
	[REDACTED]		[REDACTED]		[REDACTED]		[REDACTED]
Inspection Location	Mt. Vernon Sq. (E01)

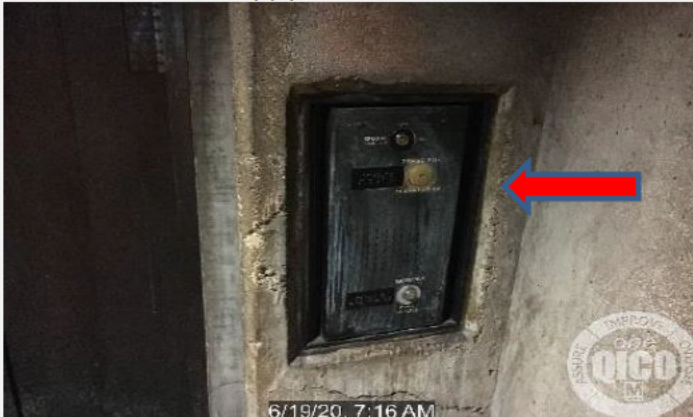
<p>Due to COVID-19 and social distancing, this inspection was completed without entering Mt. Vernon Sq. (E01) and without interacting with any Metrorail personnel.</p> <p>Discrepancies Identified for further review and follow up:</p> <ol style="list-style-type: none"> Water Damage on elevator control panel (E01X03) Risk – Elevated (4,2) – TRST and ELES

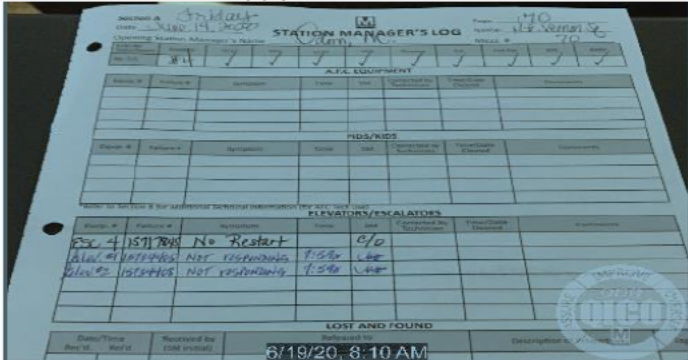
<ol style="list-style-type: none"> Elevators out of service (E01X01 and E01X02) Risk – Elevated (4,3) – ELES

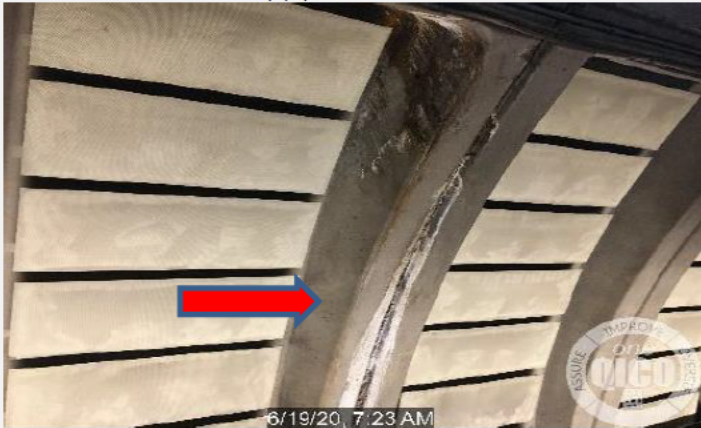
<ol style="list-style-type: none"> Ceiling is leaking water from coffer in Multiple locations Risk – Moderate (3,3) – TRST

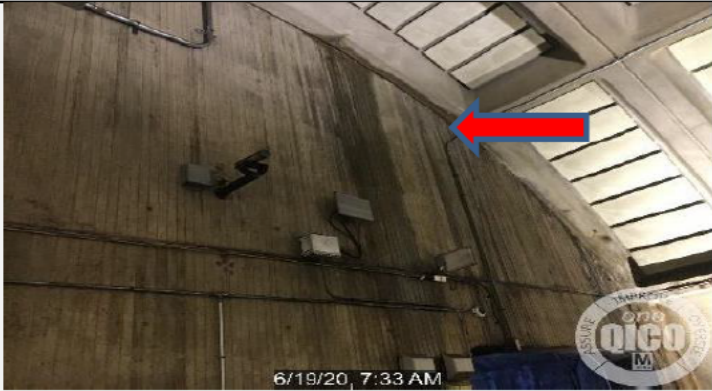
<ol style="list-style-type: none"> Water leak from station bulkhead at each end of the platform Risk – Moderate (3,3) – TRST 	<p>Remedial Action Required?</p> <p>Recommended Reinspection?</p>	<p>No</p> <p>Yes</p>
--	---	---	----------------------

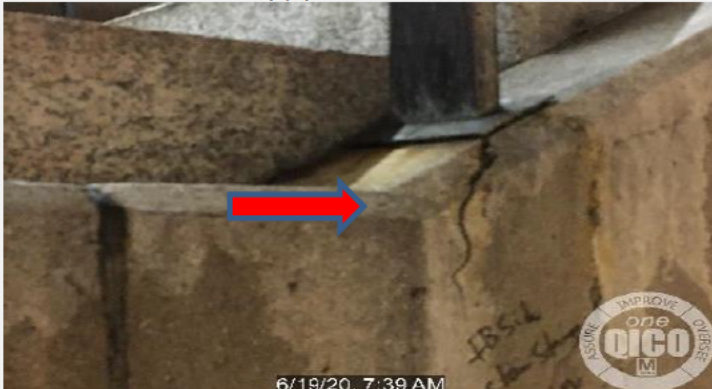
<p>6/19/20, 7:33 AM</p> <p>5. Handrail concrete mounting cracked and broken (stairway from Mezzanine) Risk – Moderate (3,3) – TRST and PLNT</p>

<p>6/19/20, 7:39 AM</p> <p>The Inspector recommends reinspection of Mt. Vernon Sq. (E01) to reassess the discrepancies identified in this report and open work orders.</p>		
Remedial Action	N/A
