Inspection Form

Washington Metrorail Safety Commission

Inspection Date	YYYY	MM	DD	Report Number	20200827-WMATA-LBW-1		
	2020	08	27				
Rail Agency Name	Washington Metropolitan Area Transit Authority			Rail Agency Department	Operations	Sub-Department	Stations
Rail Agency Department Contact Information	Name		Email		Office Phone		Mobile Phone
	[REDACTED]		[REDACTED]		[REDACTED]		[REDACTED]
	[REDACTED]		[REDACTED]		[REDACTED]		[REDACTED]
	[REDACTED]		[REDACTED]		[REDACTED]		[REDACTED]
Inspection Location	Clarendon (K02)

Inspection Activity #	1	Inspection Subject	Station Assessment – Clarendon (K02)				Activity Code	RTRA	GEN	RR	
Job Briefing Employee Name/Title	NA		Accompanied Inspector?	NA	Out Brief Conducted	NA	Time	NA	Outside Shift	NA	
Related Reports	N/A		Related CAPS / Findings		NA						
Related Rules, SOPs, Standards, or Other	Ref		Rule or SOP		Standard		Other / Title		Checklist Reference		
Inspection Location	Main Track	Yard	Station	OCC	RTA Facility	WMSC Office	Track Type	At-grade	Tunnel	Elevated	N/A
			X			X			X		
Line(s)	Kilo	Track Number		Chain Marker and/or Station(s)			From		To		
Vehicles	Head Car Number		Number of Cars		Equipment						
Description	The WMSC Inspector cond

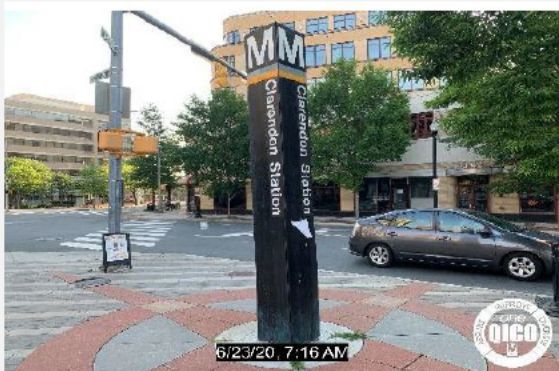
1. Station pylon loose/damaged/leaning – entrance Highland St. and Clarendon Blvd.
Risk – Moderate (4,2) – PLNT

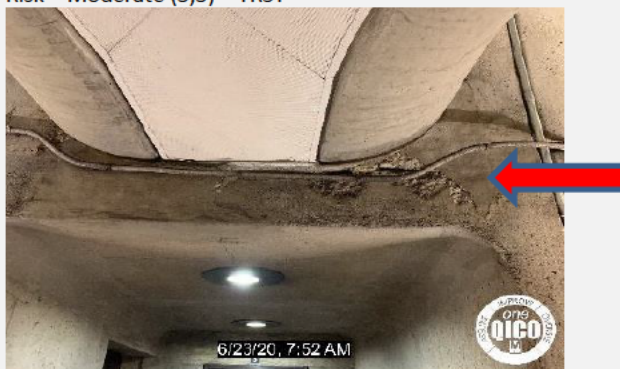
2. Deteriorating concrete (spalling)
Platform over entrance to elevator K02E03
Risk – Moderate (3,3) – TRST

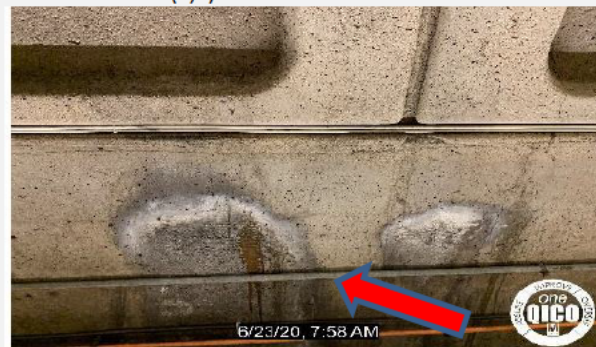
3. Mineral deposits from water leak on coffer panel
Platform track 1 panel #66
Risk – Moderate (3,3) – TRST

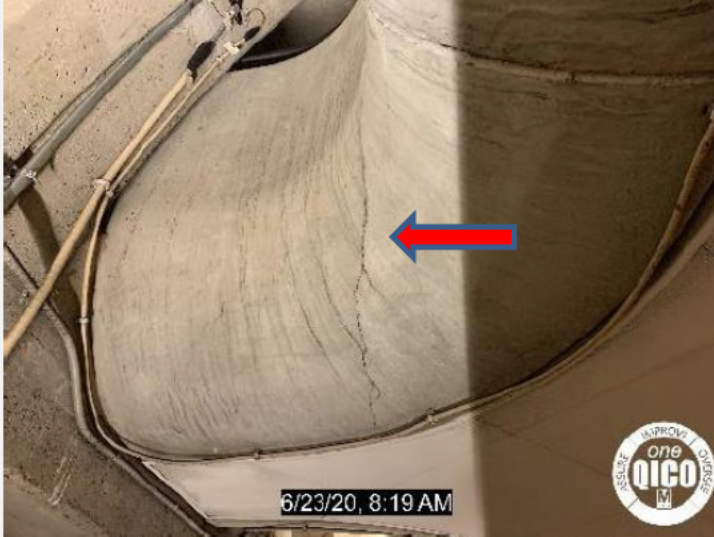
<p>5. Crack in mezzanine parapet wall Platform above entrance to elevator K02E02 Risk – Elevated (4,2) – TRST</p>

<p>The Inspector recommends reinspection of Clarendon (K02) to reassess the discrepancies identified in this report and open work orders.</p>			
Remedial Action	N/A
