Inspection Form

Washington Metrorail Safety Commission

Inspection Date	YYYY	MM	DD	Report Number	20200916-WMATA-LBW-1		
	2020	09	16				
Rail Agency Name	Washington Metropolitan Area Transit Authority			Rail Agency Department	Operations	Sub-Department	Stations
Rail Agency Department Contact Information	Name		Email		Office Phone		Mobile Phone
	[REDACTED]		[REDACTED]		[REDACTED]		[REDACTED]
	[REDACTED]		[REDACTED]		[REDACTED]		[REDACTED]
	[REDACTED]		[REDACTED]		[REDACTED]		[REDACTED]
Inspection Location	Tysons Corner (N02)

Inspection Activity #	1	Inspection Subject	Station Assessment – Tysons Corner (N02)				Activity Code	RTRA	GEN	RR	
Job Briefing Employee Name/Title	NA		Accompanied Inspector?	NA	Out Brief Conducted	NA	Time	NA	Outside Shift	NA	
Related Reports	N/A		Related CAPS / Findings		NA						
Related Rules, SOPs, Standards, or Other	Ref		Rule or SOP		Standard		Other / Title		Checklist Reference		
Inspection Location	Main Track	Yard	Station	OCC	RTA Facility	WMSC Office	Track Type	At-grade	Tunnel	Elevated	N/A
			X			X			X		
Line(s)	November	Track Number		Chain Marker and/or Station(s)			From		To		
Vehicles	Head Car Number		Number of Cars		Equipment						
Description	The WMSC In

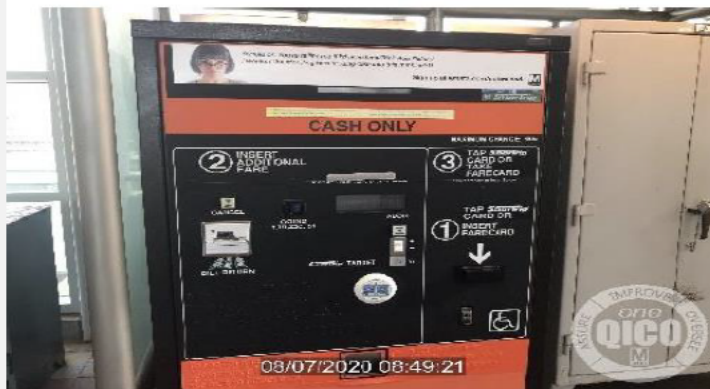
- Exit fare machine not working – AM2901
Risk – Moderate (3,3) – AFCS

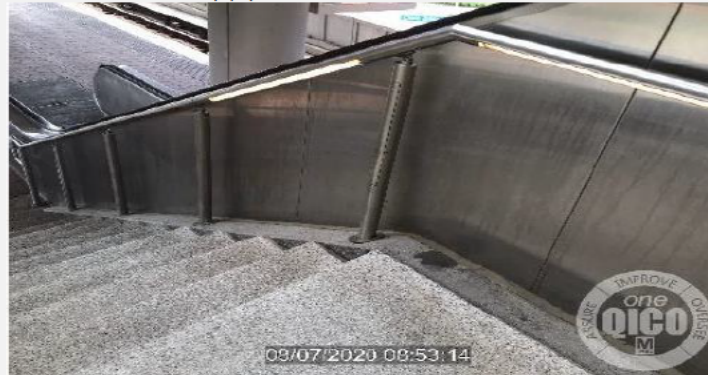
- Stairway handrail lights out – adjacent to escalator N02X07
Risk – Low (1,3) – LVEM

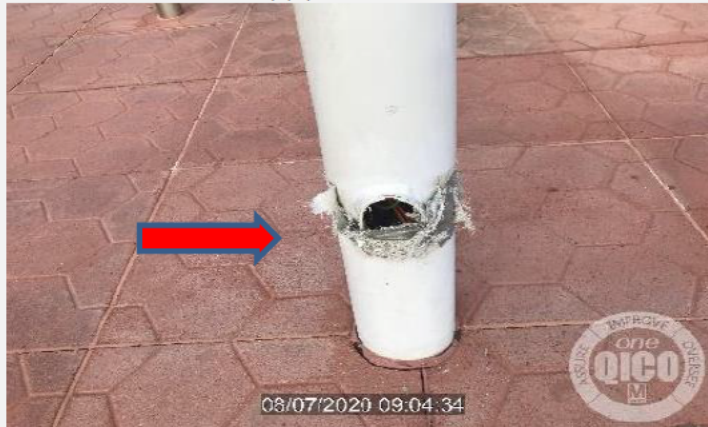
- Wire cover missing at base of post – platform center
Risk – Moderate (4,3) – LVEM

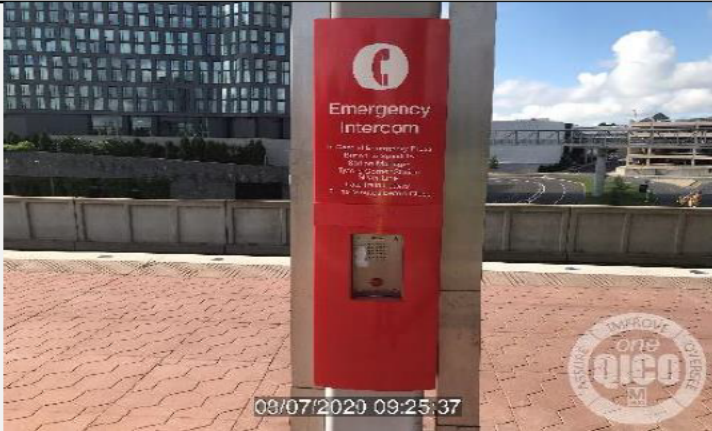
- Emergency intercom not functional – Platform center
Risk – Moderate (5,2) – COMM

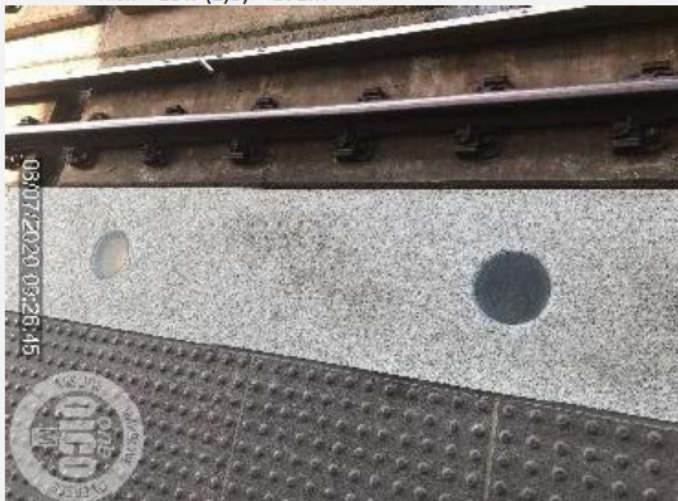
<p>5. Train Approach Warning (TAW) lights out (Platform multiple locations track 1 and track 2) Risk – Low (2,3) – LVEM</p>

<p>The Inspector recommends reinspection of Tysons Corner (N02) to reassess the discrepancies identified in this report and open work orders.</p>		
<p>Remedial Action</p>	<p>N/A</p>
