WMSC Commissioner Brief: W-0052 – Improper Roadway Worker Protection at East Falls Church Station – August 19, 2020

FINAL REPORT OF INVESTIGATION A&I E20307

Date of Event:	8/19/2020
Type of Event:	Improper Roadway Worker Protection
Incident Time:	12:15 hrs.
Location:	East Falls Church Station, Track 2
Time and How received by SAFE:	12:25 hrs., On-Call SAFE Phone
WMSC Notification Time:	14:11 hrs.
Rail Vehicle:	Train ID 611, 7K 8-Car Consist Lead Car 7078
Injuries:	No
Damage:	No

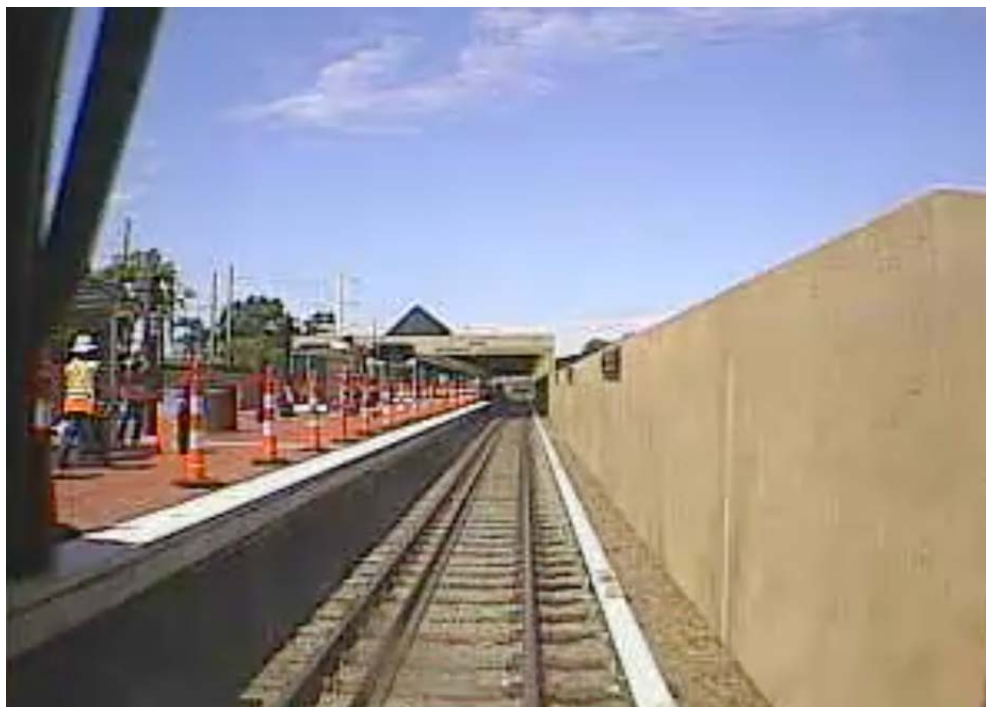
Train ID 611 entering platform limits currently under Platform Improvement Project with construction personnel and equipment on the platform.

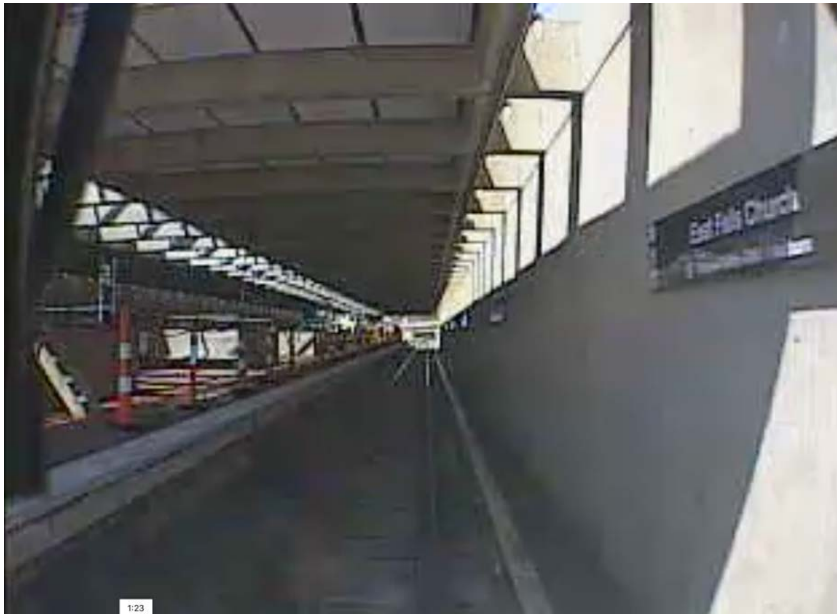
Forward-Facing video shows limited lighting through the platform limits.

Additionally, due to the East Falls Church Platform Improvement Project, CCTV was inoperative and not available. Additionally, environmental conditions of the platform, i.e., construction cones, construction workers with comparable safety vest as the AMF, and poor platform lighting indirectly contributed to this event.

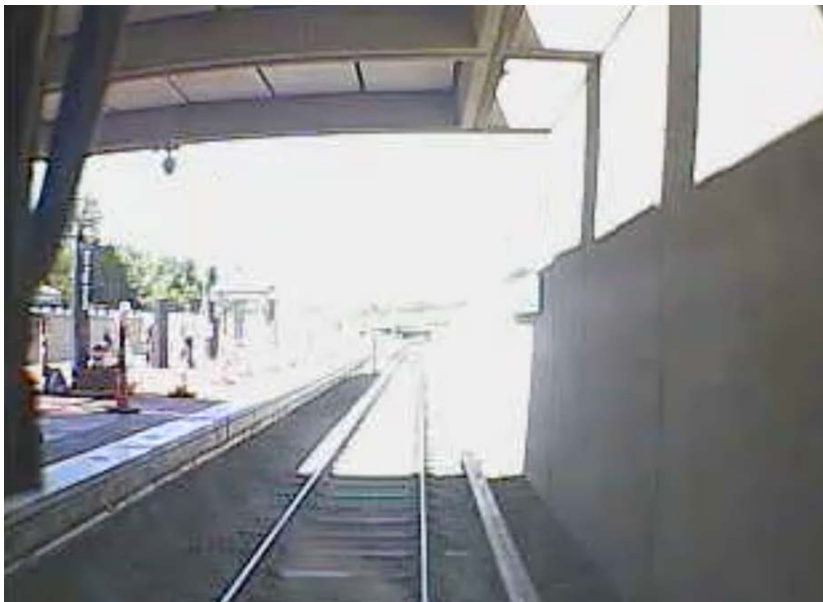
Approximately 125 feet away from the end of the platform limits, Forward-Facing video shows an increase in lighting conditions [sun glare] with no visible person at the 8-car marker.

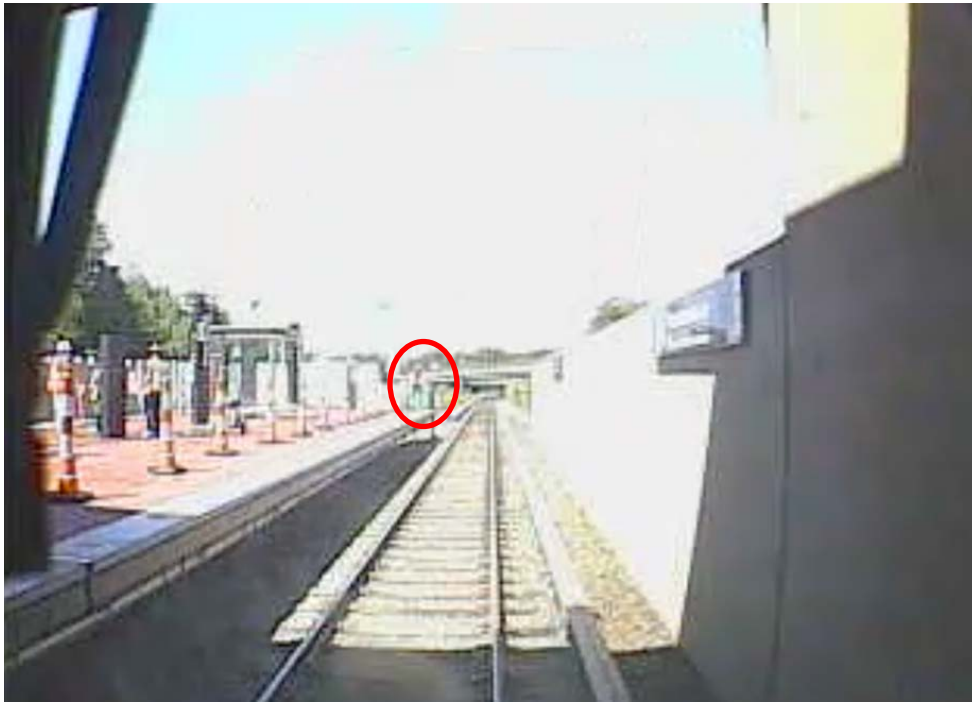
Approximately 80 feet from the 8-car marker, the AMF appears in the line of sight of the Forward-Facing video. Note: At this time, the train is traveling at approximately 31.78 mph.

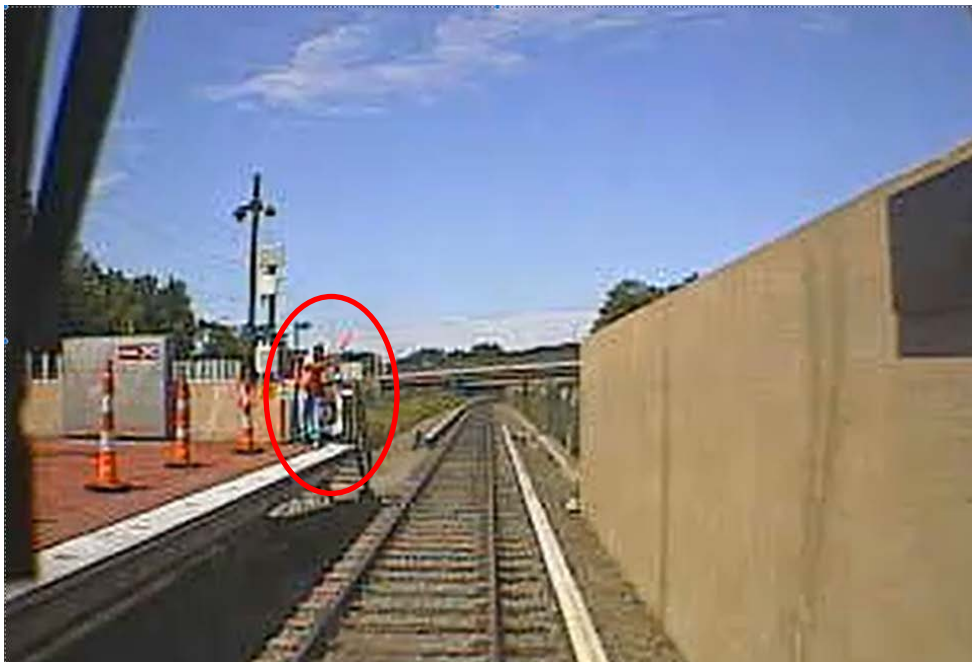
The AMF positioned at the 8-car marker with designated safety equipment and devices set up waving a rolled-up orange flag as the consist passed.

- Based on the ARS, the AMF reported the RWP violation to the ROCC immediately after Train ID 611 passed the 8-car marker.
- The AMF was positioned properly at the 8-car marker at East Falls Church Station, Track 2 platform with a flashing amber lantern positioned at the 8-car marker and a rolled-up orange warning flag in their hand as the consist passed.

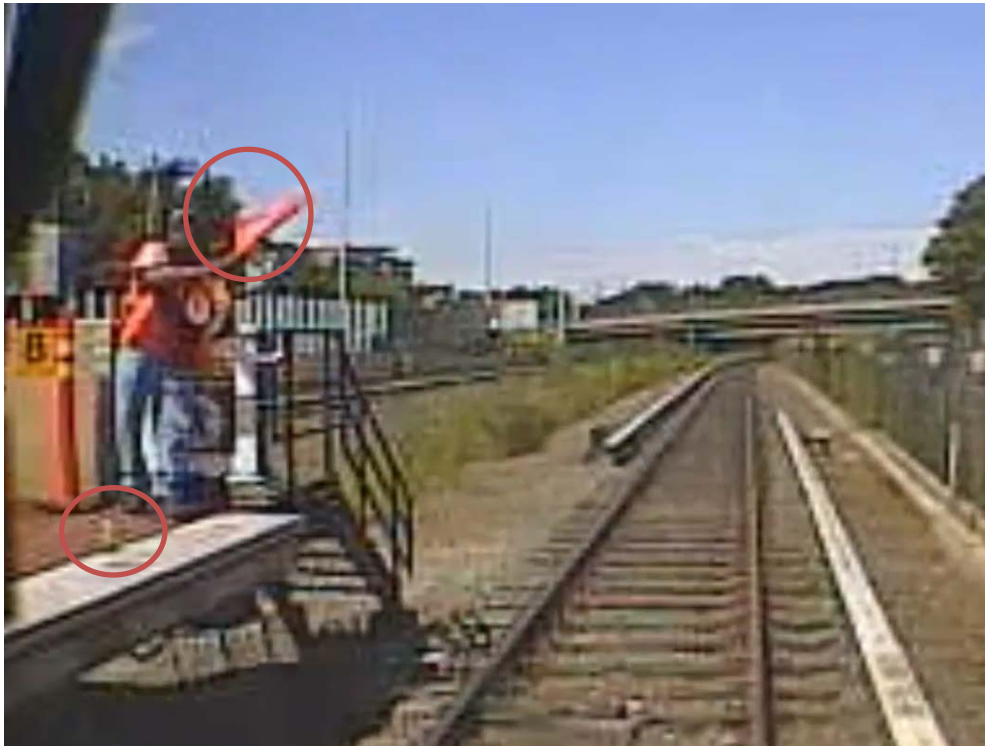
Safety equipment highlighted below:

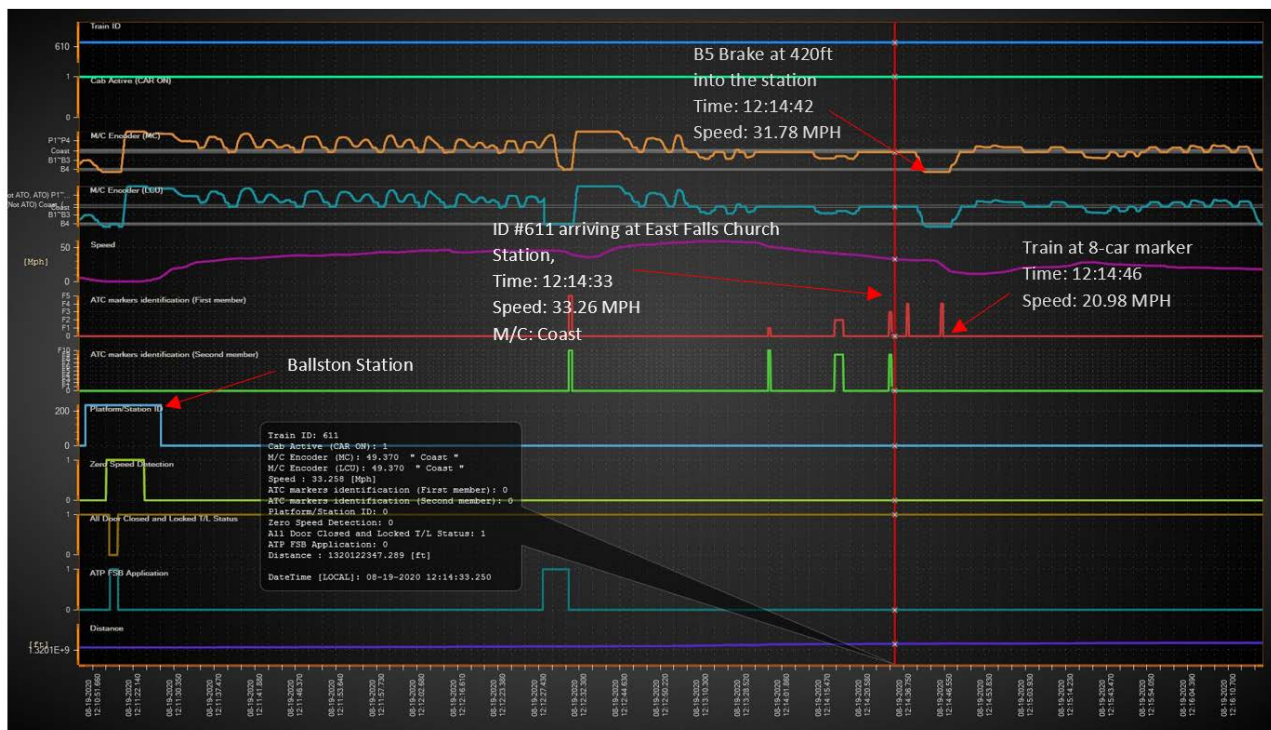
Diagram 1- Event Recorder Graphical Analysis

B5 and the train speed was 31.78 mph. At 12:14:46 hrs., the consist reached the end of the Station's platform with a speed of 20.98 mph, with the master controller in B5. At 12:16:22 hrs., the consist came to a stop 2,919 feet beyond the 8-car marker of East Falls Church Station. At 12:16:25 hrs., the consist began to move again towards McLean Station. At 12:17:02 hrs., the consist horn was activated 417.11 feet after beginning to move and continued doing so up to 11,902.4 feet beyond East Falls Church Station's platform. At 12:18:10 hrs., the consist speed reached 30.91 mph after starting to move from a complete stop and before reaching the Mobile Work Crew. At 12:21:30 hrs., Forward-Facing video showed Lead Car 7078 passed roadway workers at a speed of 15.73 mph, 12,985.39 feet beyond East Falls Church Station platform.

NOTE: Per data evidence from CENV, at no time did the consist come to a complete stop within the limits of the platform. Additionally, the Forward-Facing video showed the AMF in position properly at the 8-car marker on the platform as the consist passed. Below is a snapshot of the Vehicle Monitor System (VMS) at the time of the reported incident.

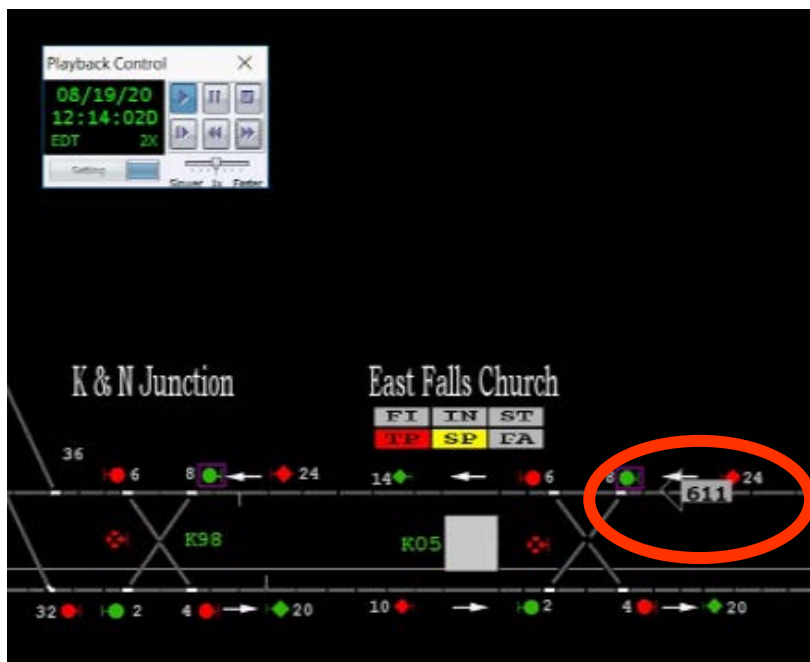
At 12:14:02 hrs., Train ID 611 on approach to East Falls Church Station, Track 2.

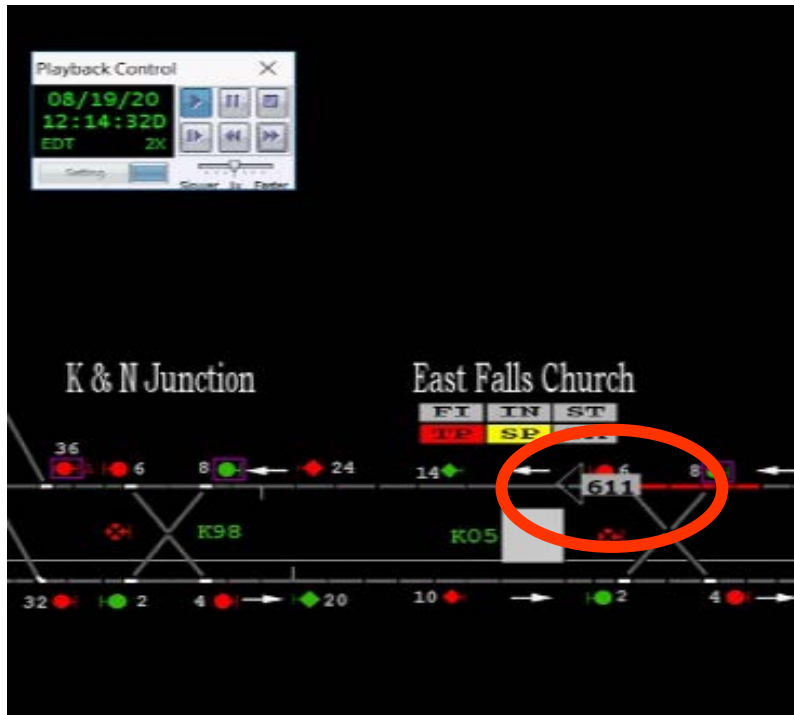
At 12:14:32 hrs., Train ID 611 entering East Falls Church, Track 2.

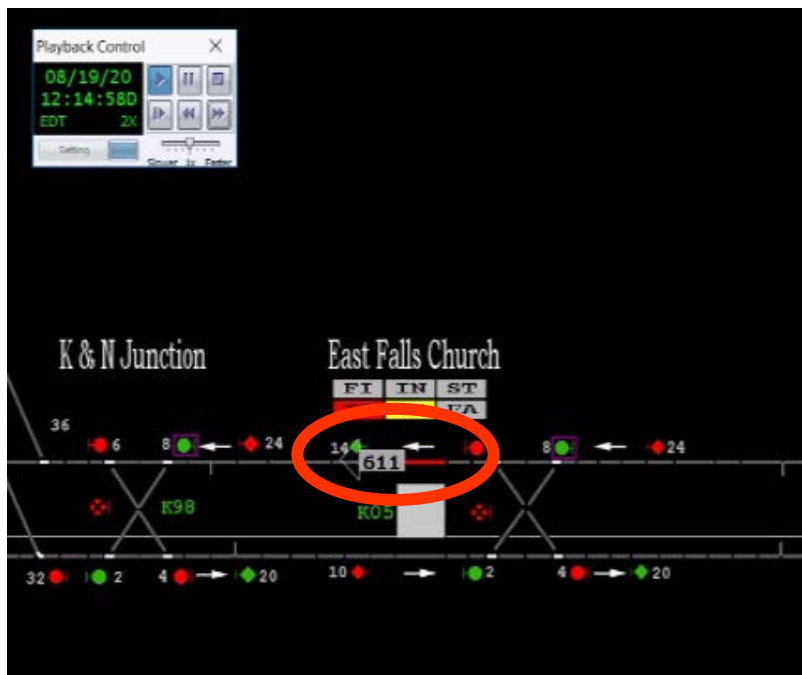
At 12:14:58 hrs., Train ID 611 passed East Falls Church Station, Track 2.
