WMSC Commissioner Brief: W-0053 – Improper Door Operation at Largo Town Center – August 25, 2020

FINAL REPORT OF INVESTIGATION A&I E20313

**Largo Town Center Station, Track 1
Improper Door Operation
August 25, 2020**

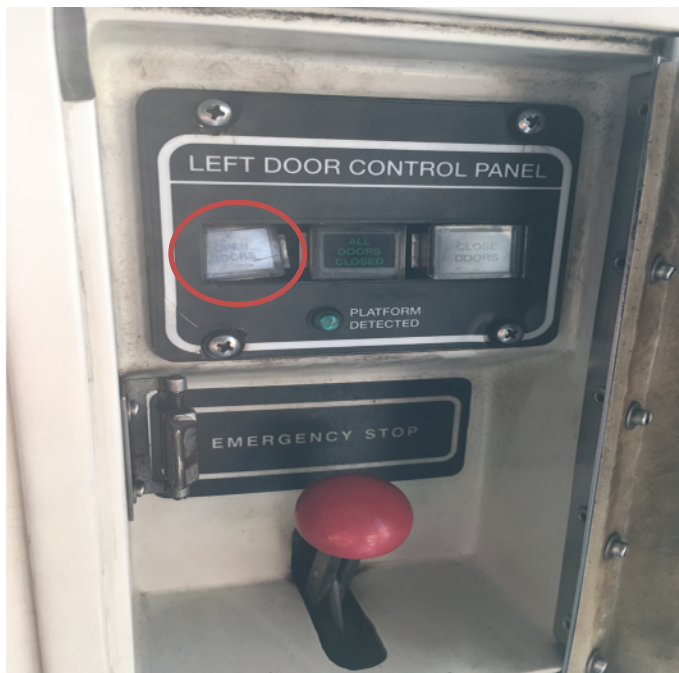
Photo 1 - Broken control panel switch barriers.

NOTE: The consist door open pushbutton on the left was stuck in the ON position. This pushbutton is energized from the operator's cab, which means when the consist was keyed up from car 3135, the door open signal was sent to the door open train lines on the left side. This caused the doors to open on the opposite side of the platform.

Car 3135 – Left side door operation control panel switch barriers were broken. See photo 1. CMNT personnel made the necessary repairs and changed out the side barriers to keep the buttons in place. CMNT checked the functionality of the door open/close pushbuttons by cycling the doors multiple times.

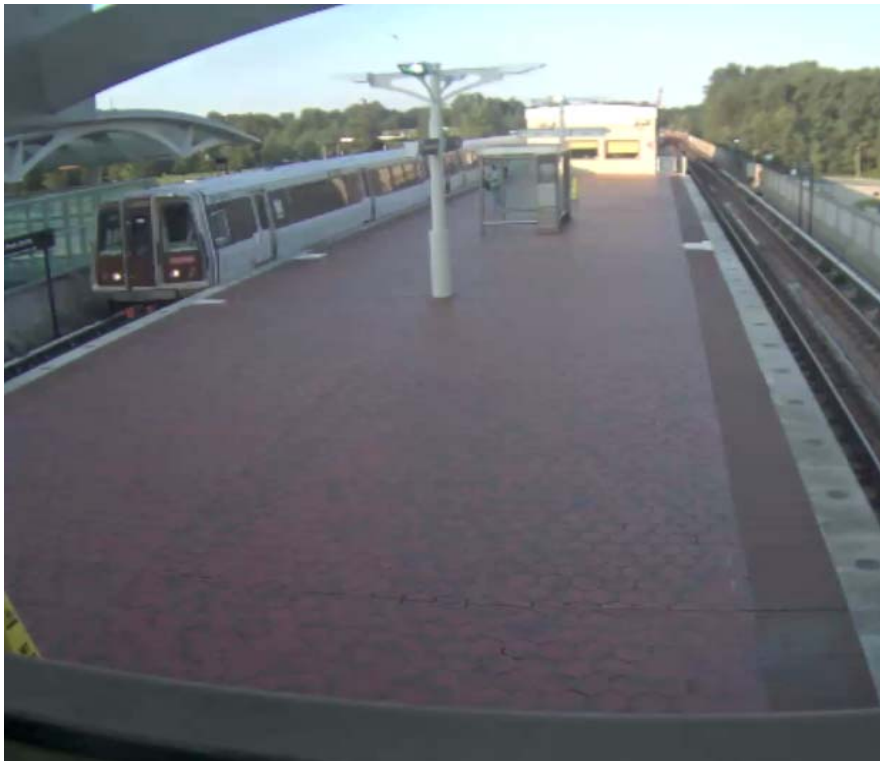
Photo 2 - The consist entering Largo Town Center Station 07:41:29 hrs.

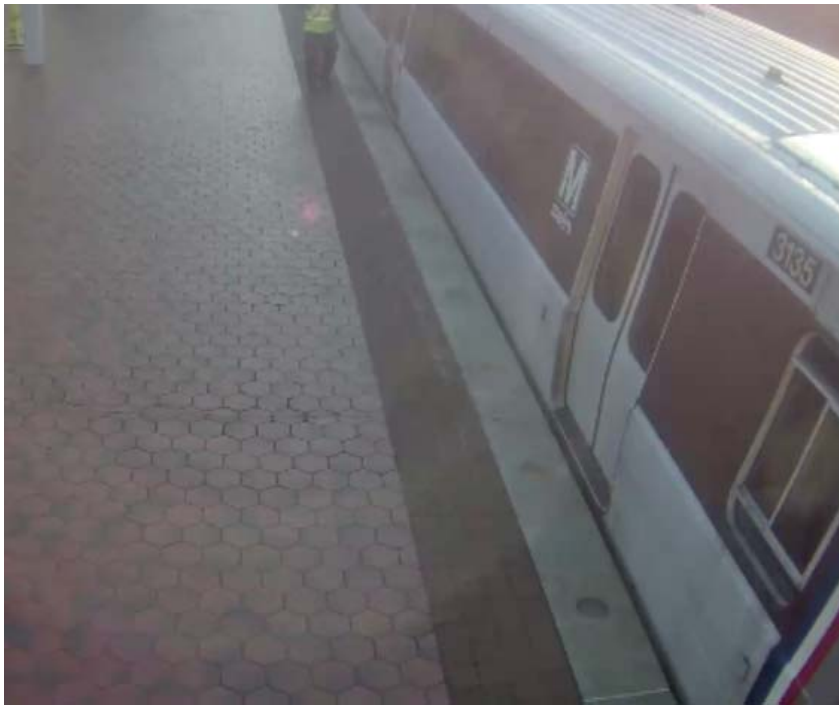
Photo 3 - The consist berthed at the 8-car marker at 07:41:52 hrs., and then the customers exited the consist shortly after.

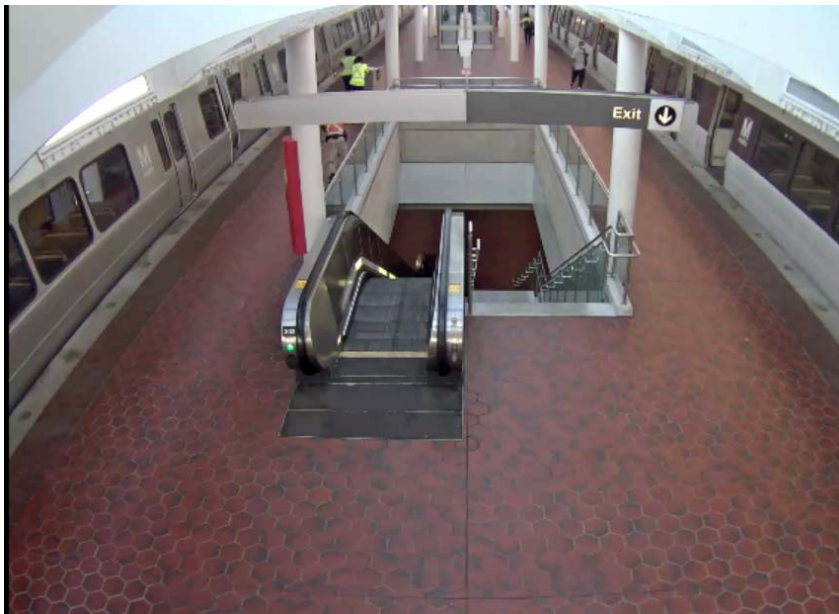
Photo 4 - The consist doors opened on the opposite side of the platform at 07:44:53 hrs. At this point, per CCTV, the customers had already exited the consist and the platform side doors were closed. Additionally, the yard operator had already walked through the entire consist to confirm the consist was clear of customers.

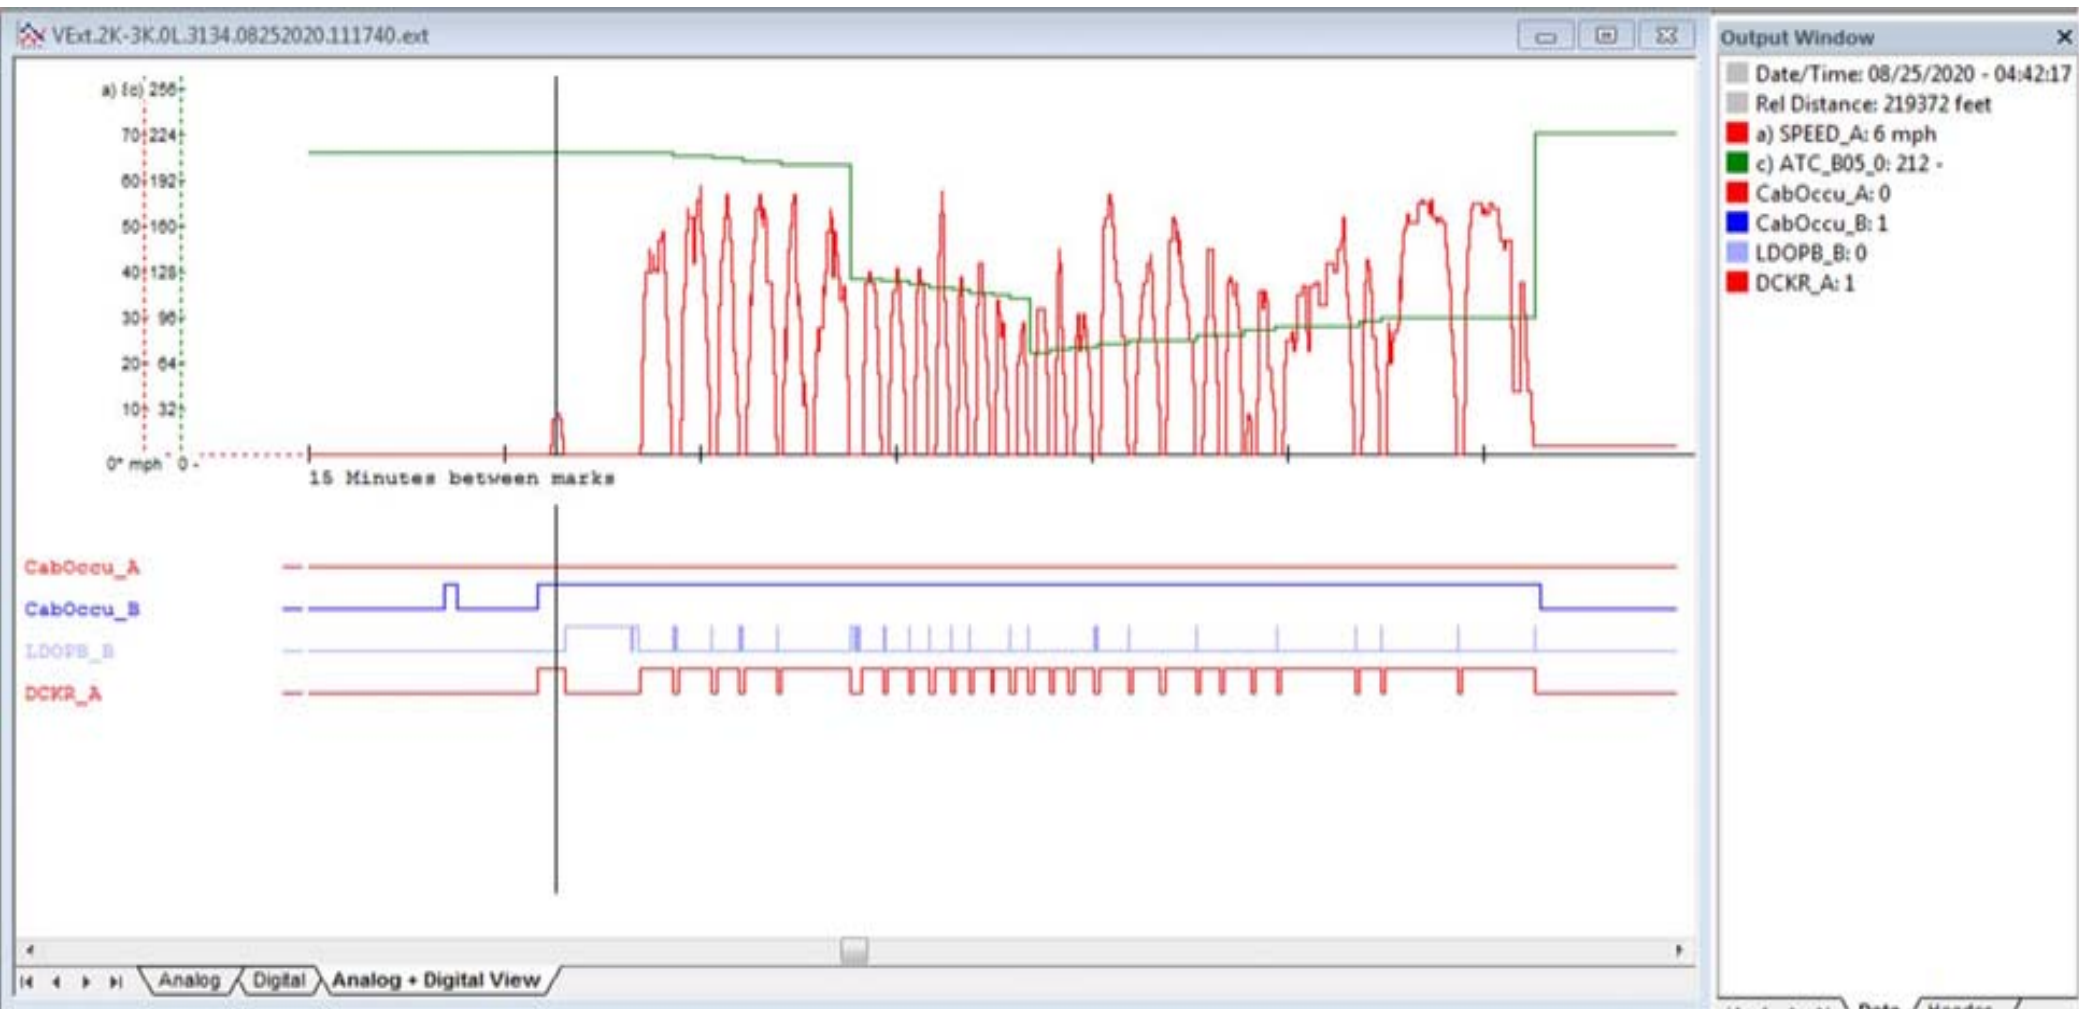
Diagram 1- Event Recorder Graphical Analysis

At 04:48:48 hrs., the consist started moving in the direction towards Franconia-Springfield Station, Track 2. During the time from Largo Town Center Station to Franconia-Springfield Station, Track 2 the LDOPB was erratic (activated/deactivated) in 5 stations. At 05:56:29 hrs., the consist arrived in Franconia-Springfield Station, Track 2 and keyed down from car #3135 at 05:57:05 hrs. CENV personnel performed an analysis of the affected consist when the consist went back to Largo Town Center Station. The detailed times of events and the screenshot in diagram 2 for the lead car data showed at 07:35:57 hrs., the consist arrived in Largo Town Center Station with car 3099 leading. At 07:36:02 hrs., the doors open on the left side from car 3099 and on the right side from car 3134. At 07:36:10 hrs., the - doors close on the left side from car 3099 and on the right side from car 3134. At 07:36:25 hrs., the consist was keyed down from car 3099. At 07:38:58 hrs., the consist was keyed up from car 3135. At 07:38:58 hrs., the left door pushbutton was activated. Line 3 and 4 were energized and doors opened on the opposite side of the platform.
