WMSC Commissioner Brief: W-0054 – Derailment in Greenbelt Yard – July 30, 2020

FINAL REPORT OF INVESTIGATION A&I E20280

Date of Event:	7/30/2020
Type of Event:	Derailment
Incident Time:	23:12 hrs.
Location:	Greenbelt Yard Storage Tracks, Switch 407
Time and How received by SAFE:	23:39 hrs., On-Call Phone
WMSC Notification Time:	01:14 hrs.
Rail Vehicle:	Flatcar (F) 452-Prime Mover (PM) 58
Injuries:	No
Damage:	No

Greenbelt Yard – Derailment

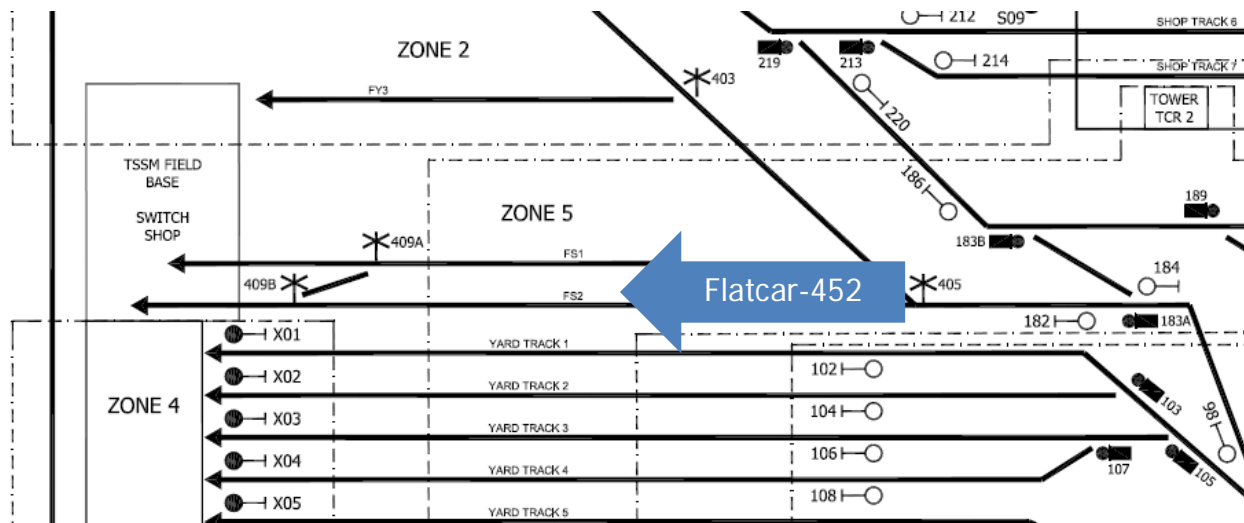
Field Sketch/Schematics

The incident area was located at Greenbelt Yard, Switch 407 on a Ballast Track.

The above illustrates the area of the derailment.

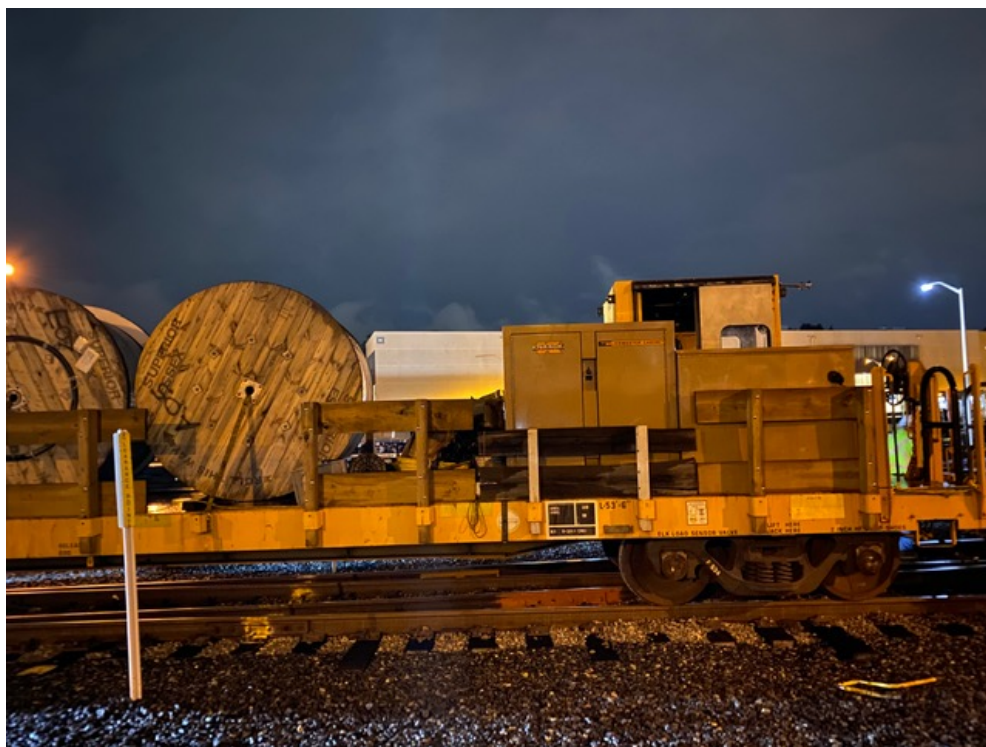
Photo 2 – Flatcar 452

- CTEM personnel performed a post-incident inspection of the affected Flatcar (F) 452 and found no anomalies.

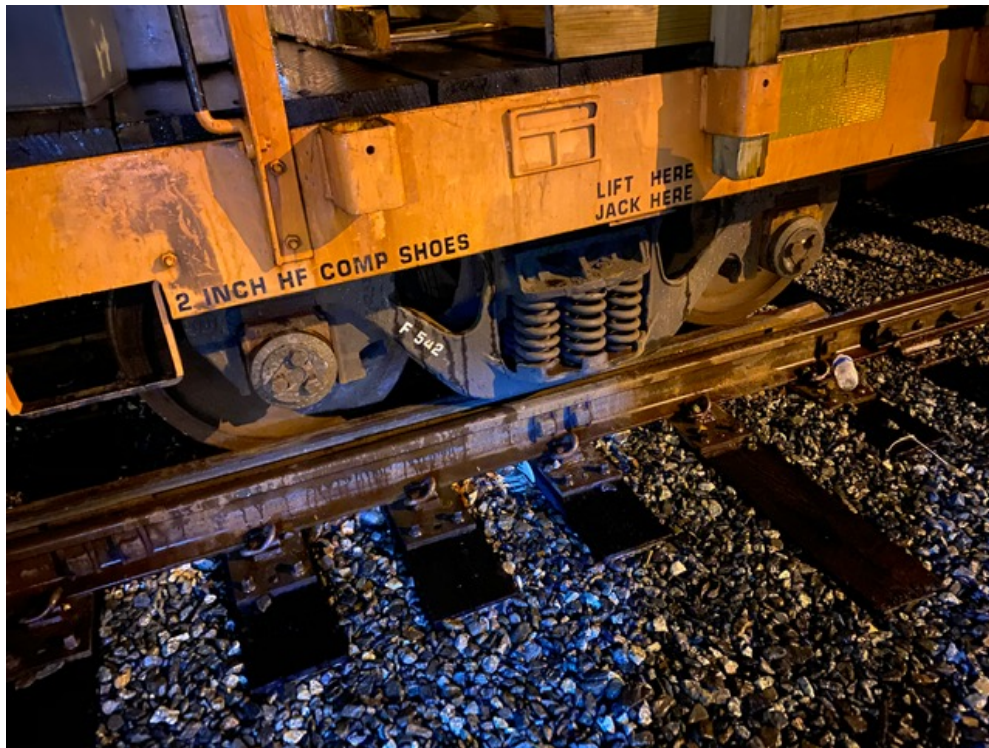
Photo 3 – The front truck of the Flatcar derailed

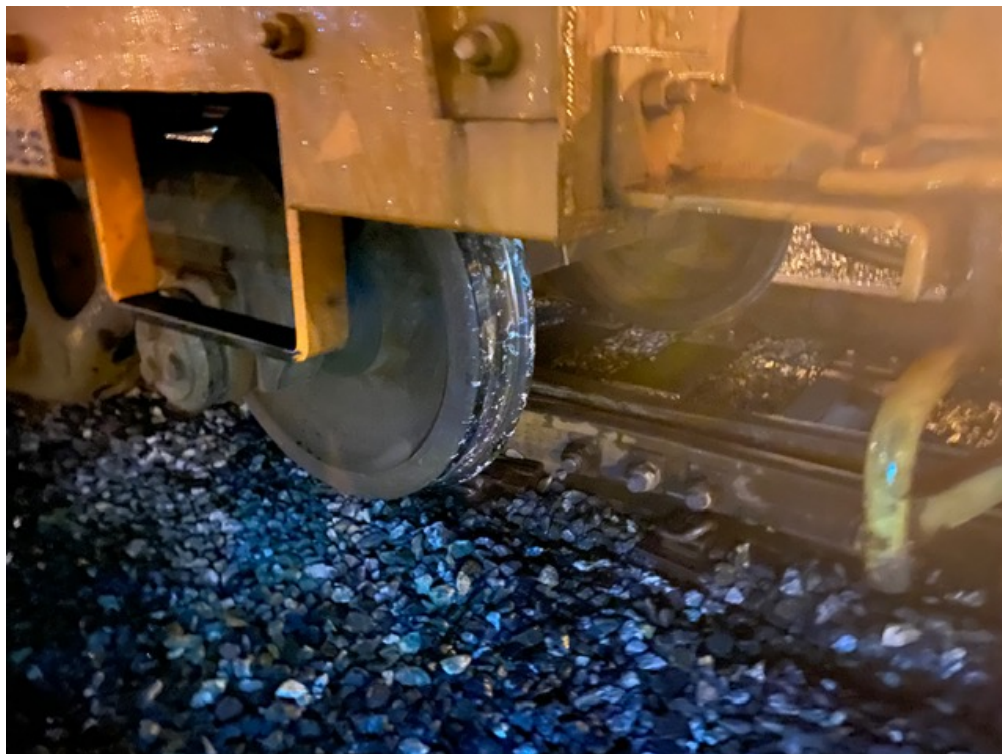
Photo 4 – The front truck of the Flatcar derailed. The Point of Rest (POR) was approximately 3-6 inches away from the derailment location.

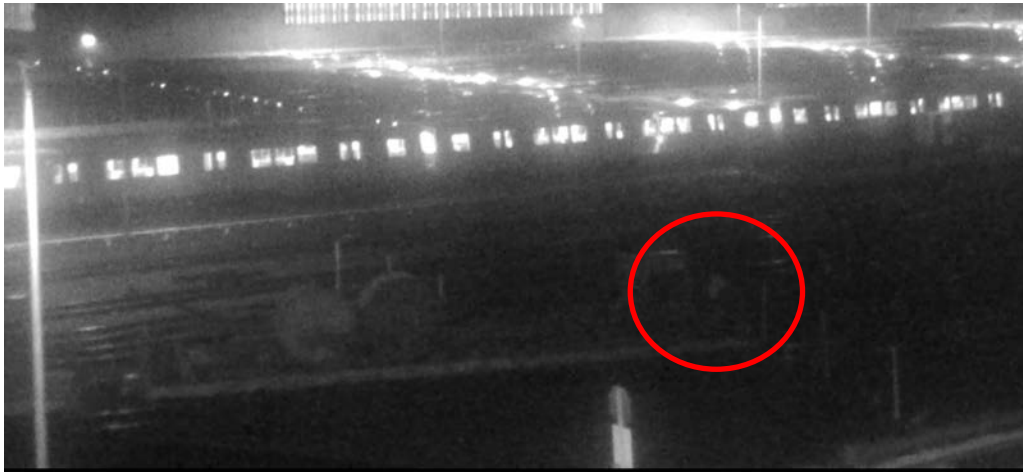
The Equipment Operator and Flagman operated the Class II Vehicle without placing two white lights on the lead flat car and two red lights on the rear flat car, while it was being pulled per MSRPH 23.5.4.2.1.

Photo 5 - The Equipment Operator and Flagman were operating Class II Vehicle back and forth without placing two white lights on the lead Flatcar and two red lights on the rear Flatcar. This violates MSRP 23.5.4.2.1.

IRPG has performed a safety stand-down to discuss the derailment, the associated hazards, the task of hand cranking and clamping in accordance with SOP 35, placing lights on the flatcars per MSRPH 23.5.4.2.1, and familiarization with the locations of new hand-thrown switch stands.

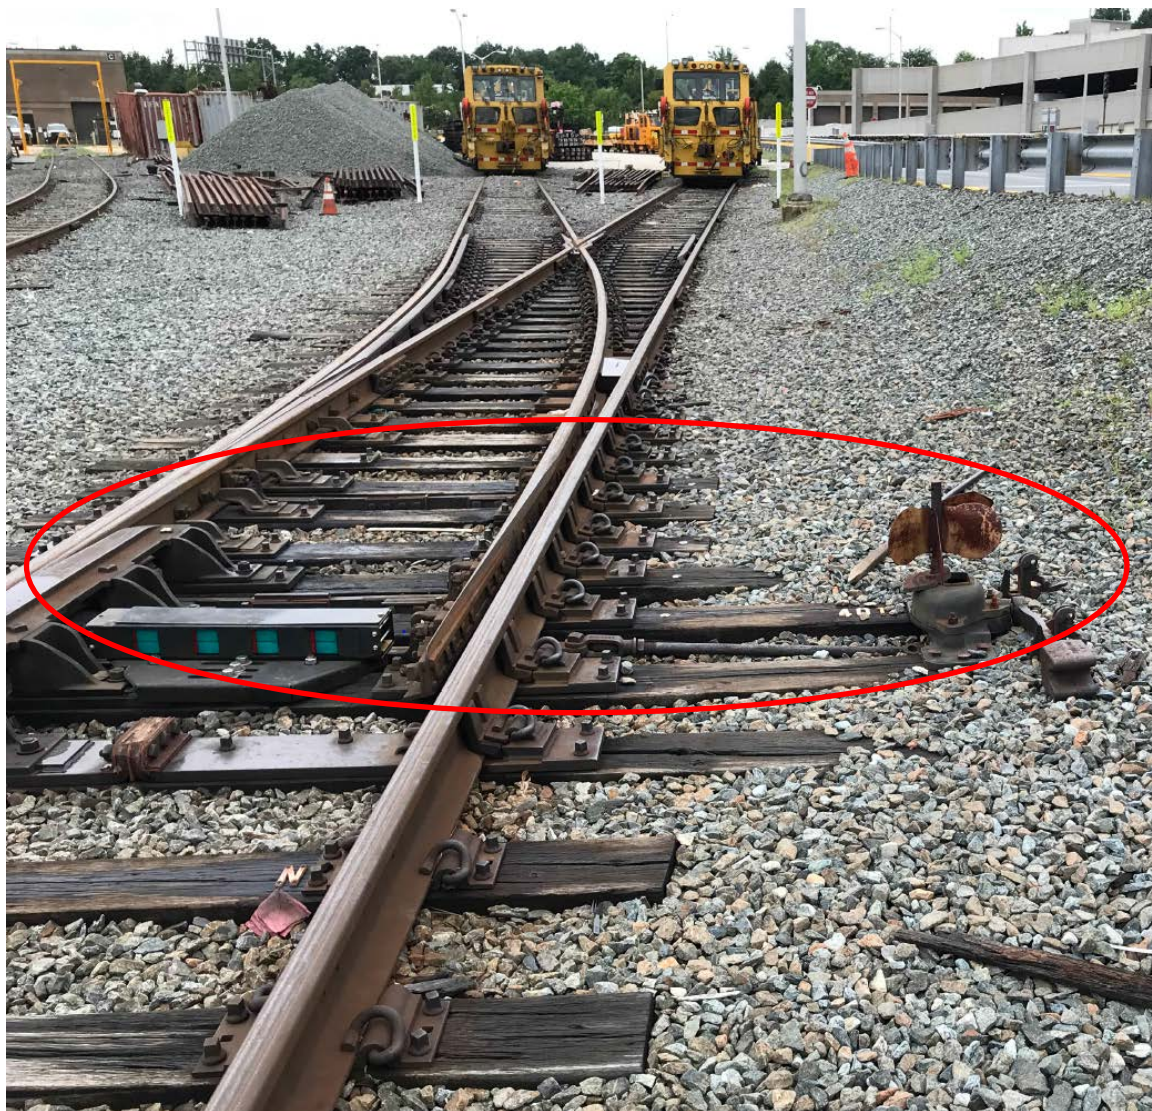
The hand-thrown switches in this area of the Greenbelt Yard were approximately four years old, and did not have appropriate switch stands. Metrorail had not identified this switch stand problem prior to this derailment. The involved switches had also not been included in regular preventive maintenance or inspections and were not shown on yard maps. These switches are used to create additional storage space for Roadway Maintenance Machines (RMM).

Photo 6 – Old Hand-thrown Switch

For three switches identified in the Greenbelt Yard, Metrorail installed the appropriate switch stands.

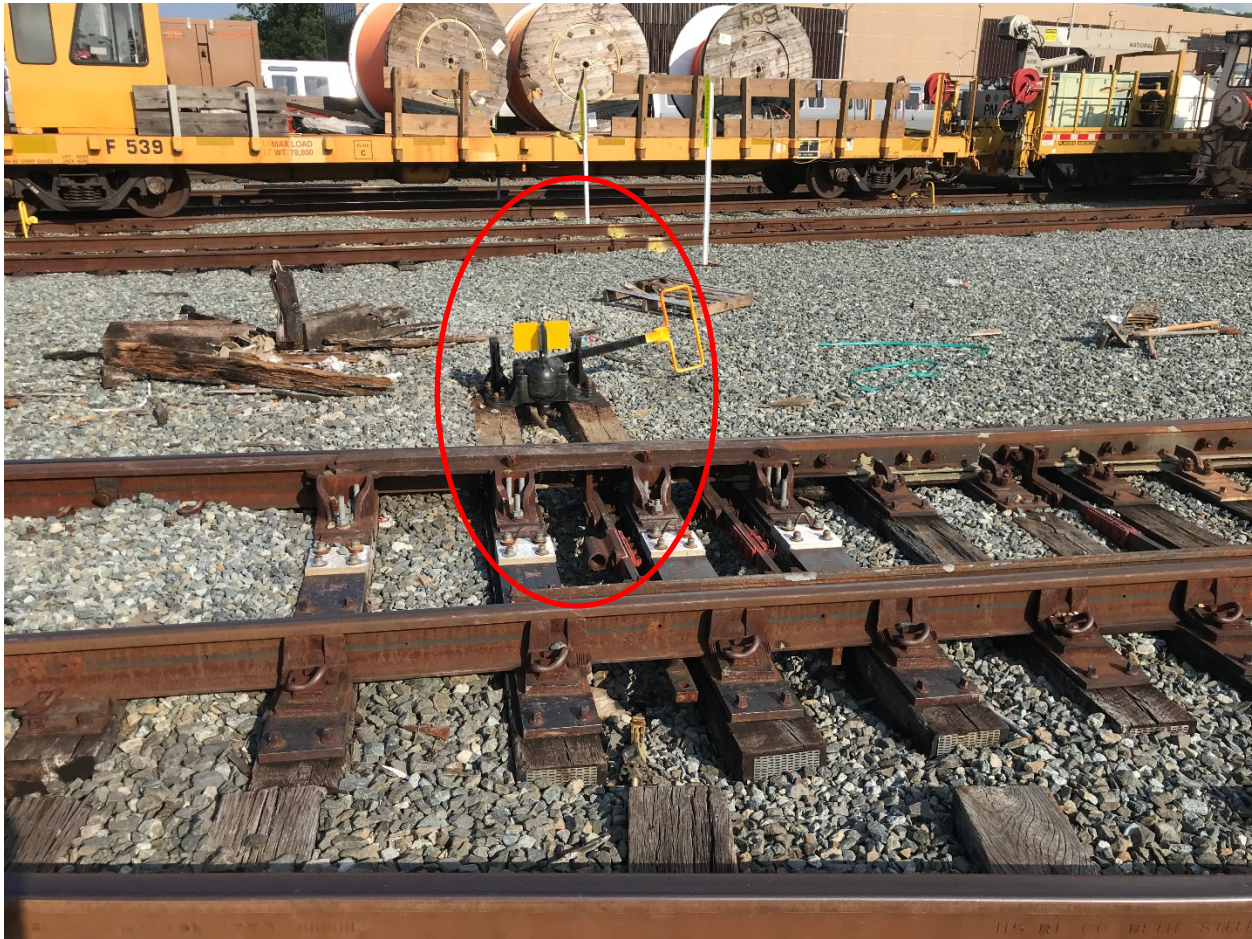
Photo 7 – New Manual Hand-thrown Switch Replacement

TRST has since placed the appropriate switch stand in this location to eliminate this event from occurring again. Please become familiar with the location of these switch stands.

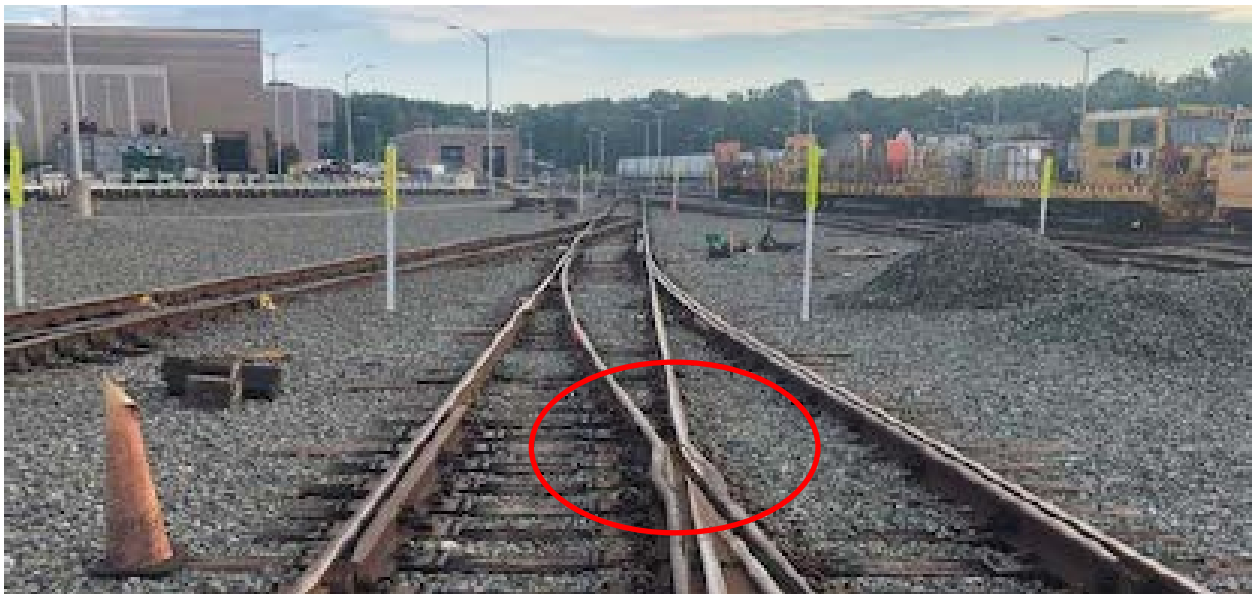
- (1) Pin missing on the right side of the heel block.
 - This would not be considered a defect condition.
- (1) Deteriorated special tie 1 foot in front of the frog.

- In this situation, TRST would pay attention to the gauge and also comments stating lateral movement (there are none), the current gauge is 56 ½" which is as built for a turnout within the yard or on the mainline. This condition would not be addressed until the ties surrounding fail. This would be subjective because, in this location, the ties are still performing their primary function; maintain gauge and distribute the load of vehicle movement.

- (3) Bolt missing at the heel block.
 - Not alarming and will be addressed by a maintenance team at a later date.
- (1) Loose joint bar bolt to the 6-hole joint at frog heel.

Photo 8 – Photo of the frog where the derailment occurred.

- This item will be addressed by a maintenance team.
