WMSC Commissioner Brief: W-0055 – Improper Operation in New Carrollton Yard – August 11, 2020

FINAL REPORT OF INVESTIGATION A&I E20297

New Carrollton Yard – Unintended Movement Undesired Coupling August 11, 2020

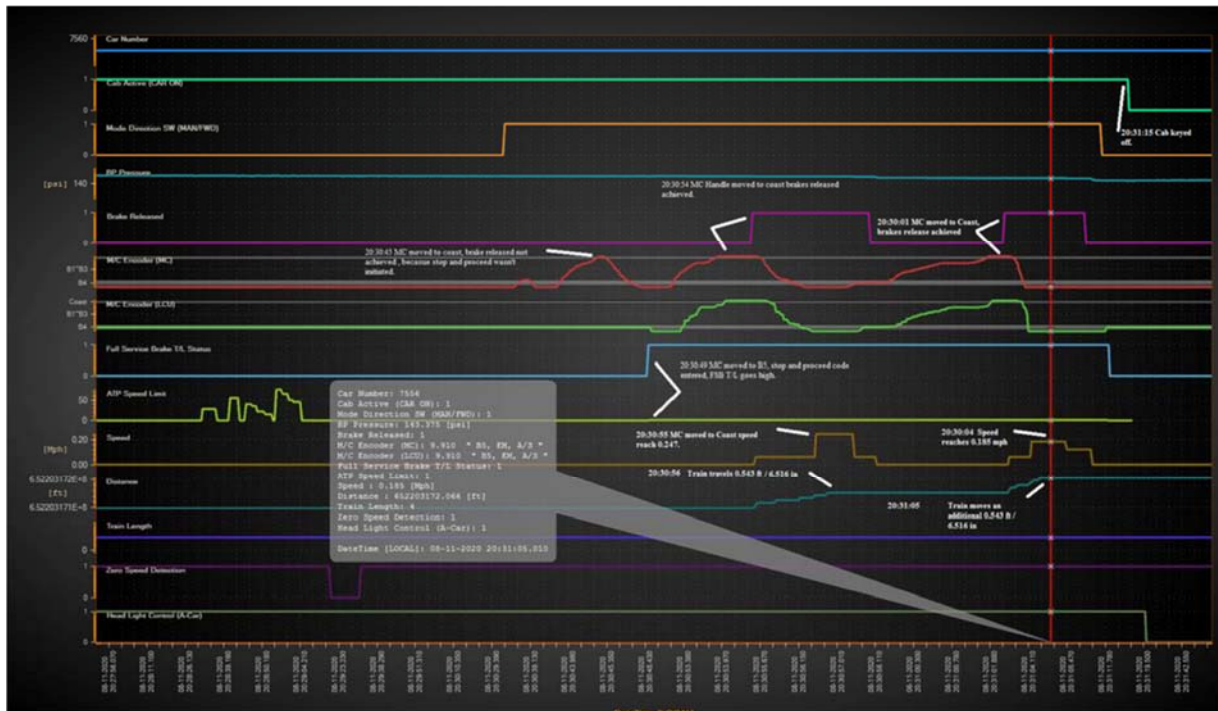
Figure 1: ER Data Graph

CENV reviewed Car 7668-69 and 7556-57 ER, Brake, Propulsion, and VMDS logs. There were no train failures that could have contributed to the coupling event. Based on NVR and ER data, when the individual moved the MC handle to coast, it allowed the consist to drift backward toward 3280 and couple.

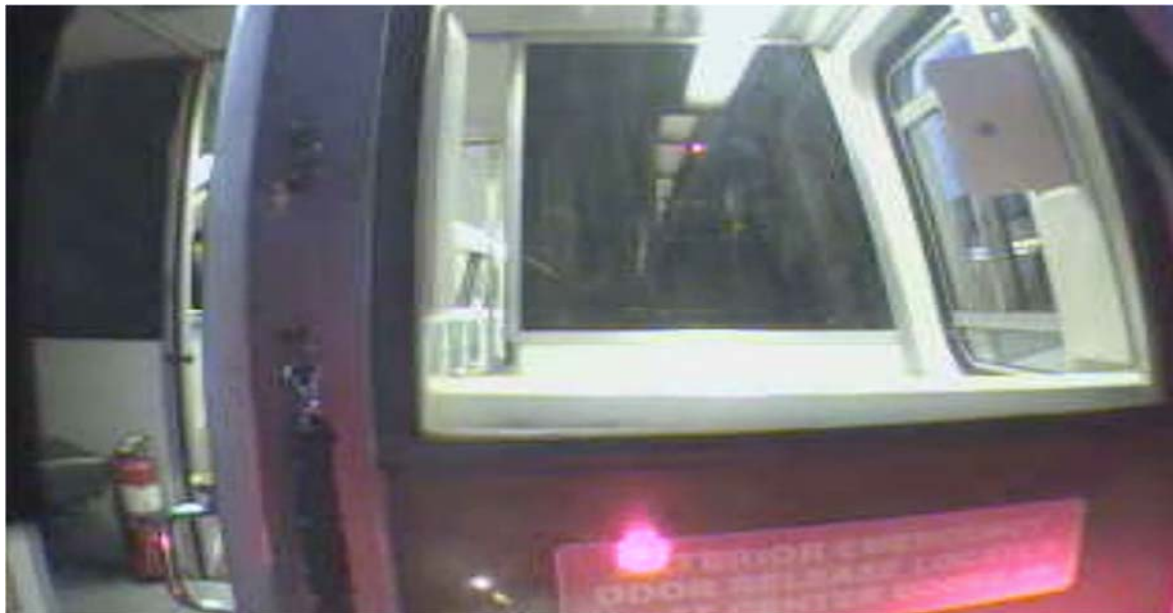
The Train Operator stored the 4-car consist approximately one foot away from the 8-car consist stored at the Track 9 bumper post, directly violating MSRPH 3.126, which states, *“When storing Class 1 Rail Vehicles, operators shall: Secure cars being stored a minimum distance of two (2) feet apart at all storage locations, yards and/or tail track.”*

Photo 2: Based on a review of NVR car-borne forward-facing and console footage, the Train Operator secured consist T7556-7557x7669-7668L one foot away from the stored cars 3280x3281 on Track 9.

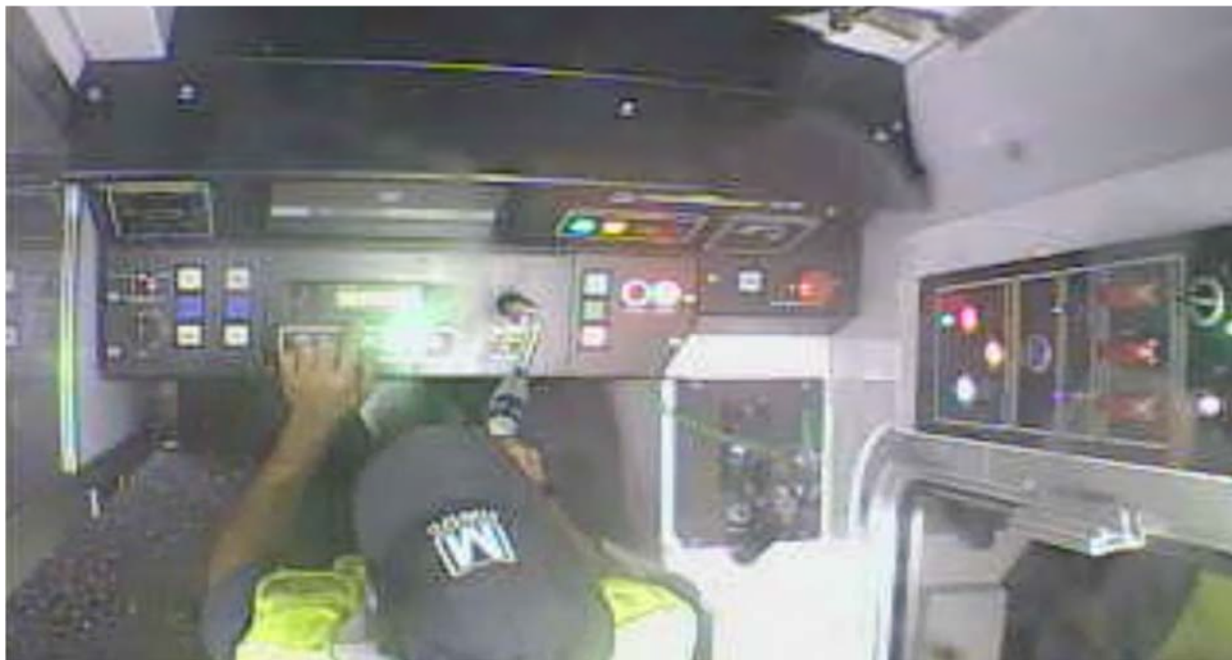
Photo 3: A CMNT Technician is later observed on lead Car 7556, keyed up performing DI Procedure.

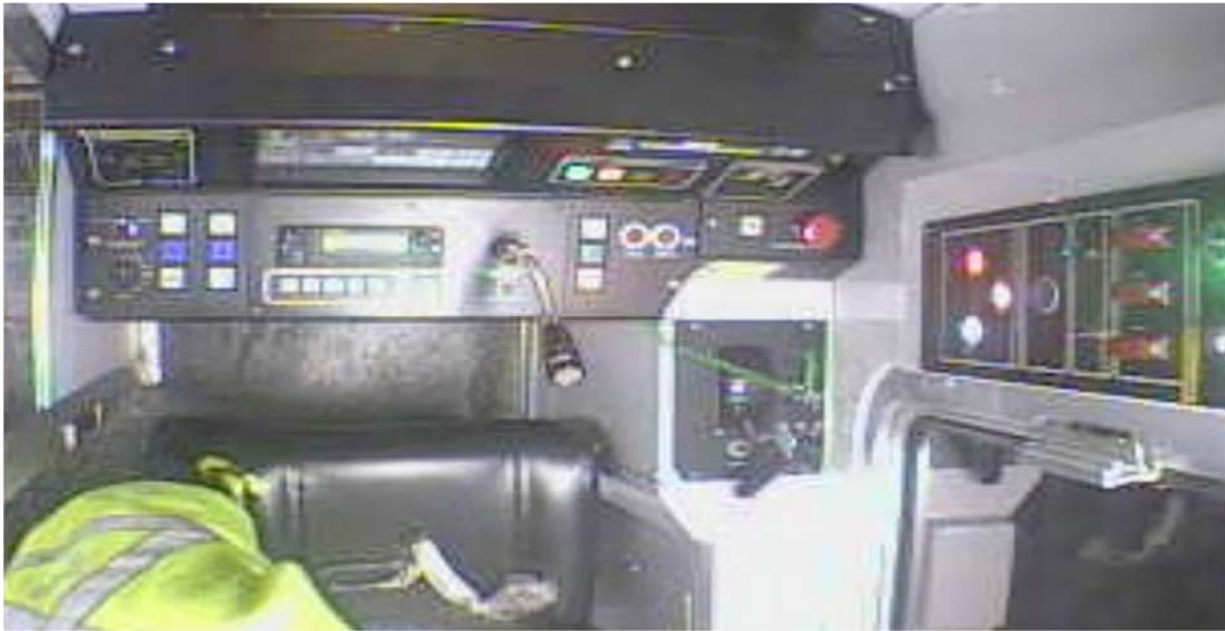
Photo 4: The CMNT Technician is observed shortly after keyed up in car 7668 installing seals on the K and L panel behind the Train Operator seat.

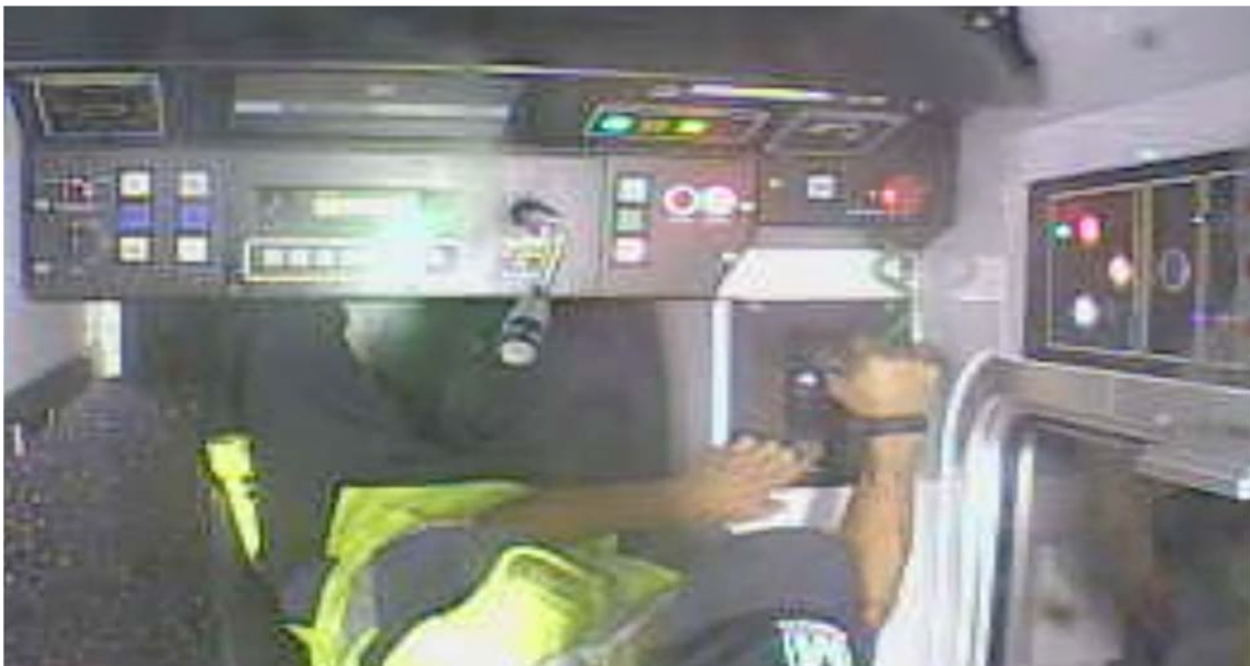
The CMNT Technician performed two brakes off tests on the 7K consist by placing the MC in coast without applying the holding brake, consequently causing a rollback condition and subsequent undesired coupling violating *“CMNT DI 3.6 Brake procedures, which states, “Manually apply holding brake using Manual Holding Brake Apply/Release switch on Auxiliary Control Panel. Verify Red Apply Indicator is On.”*

Photo 5: After that, the CMNT Technician went back in the lead car, keyed up, continued DI check, then depressed the overtravel button and moved the MC to the coast position three times, subsequently achieving a brakes off indication on the console.

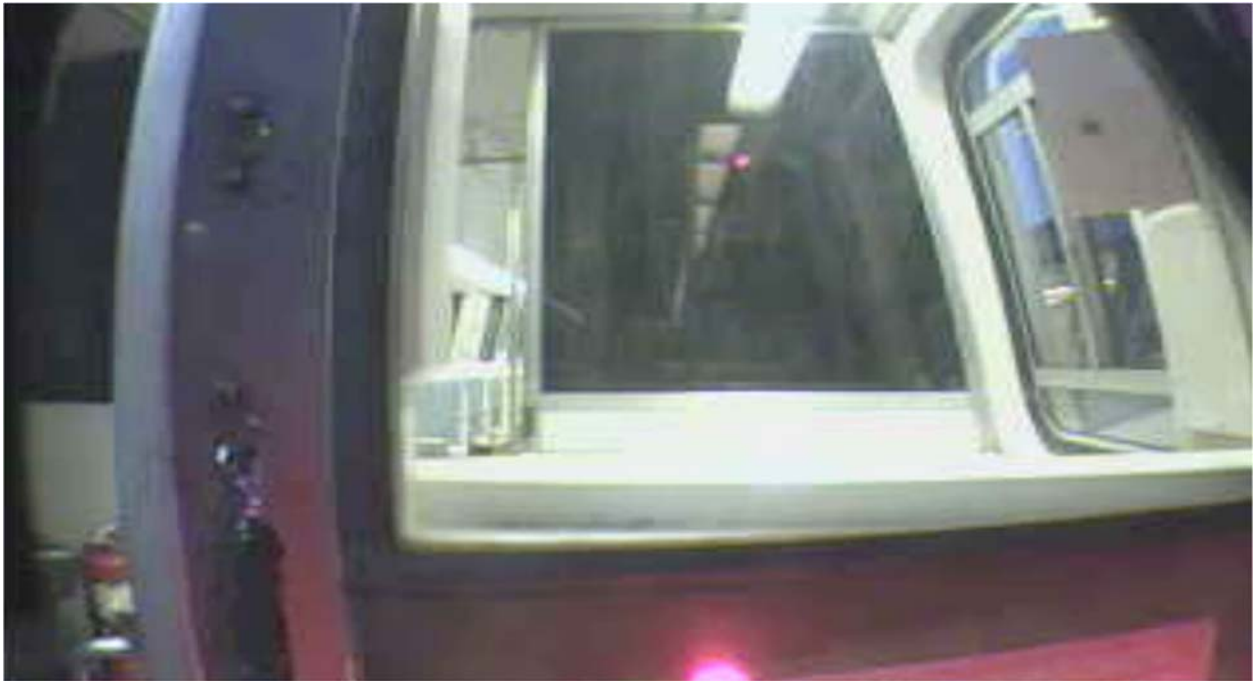
Photo 6: Forward-facing footage on Car 7668 shows the consist drift back twice and coupled to legacy car 3280 as the train was moved into the coast position the second time. The CMNT Technician then keys down the lead car 7556.

Based on a New Carrollton Yard track schematics review, SAFE determined Track 9 is a Tangent track with a 0.1 percent grade. The slight grade contributed to the drift back condition when the CMNT Technician moved the MC to coast.

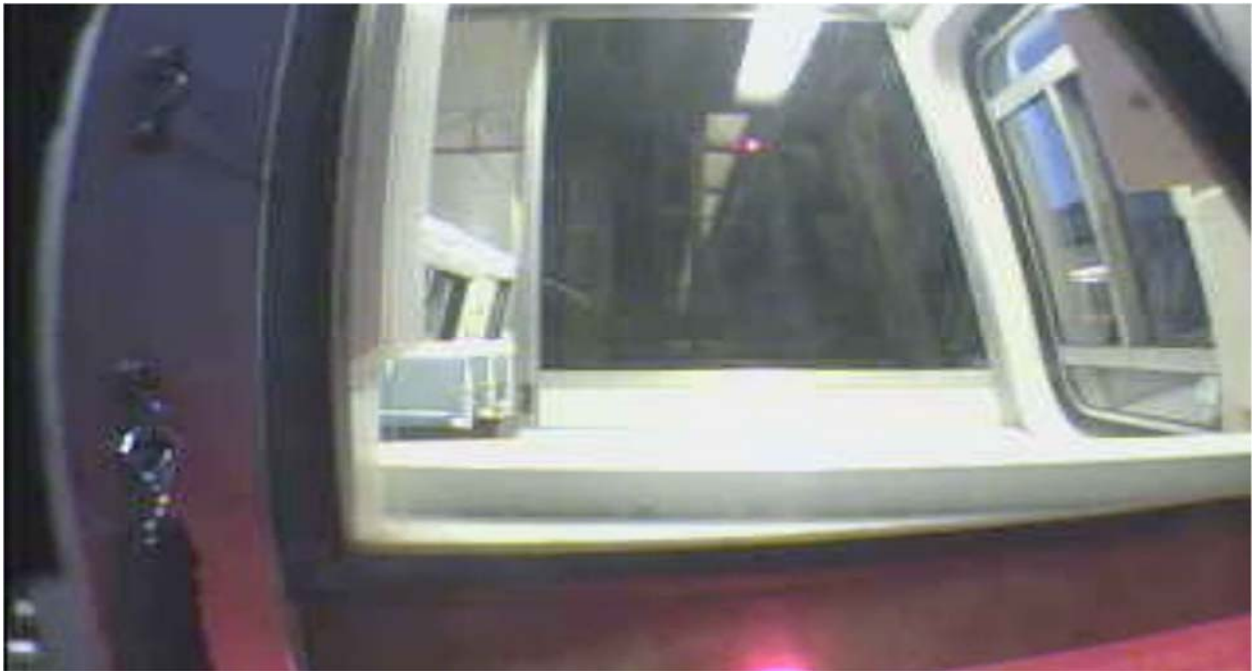
Photo 7: Train couples to legacy car 3280.

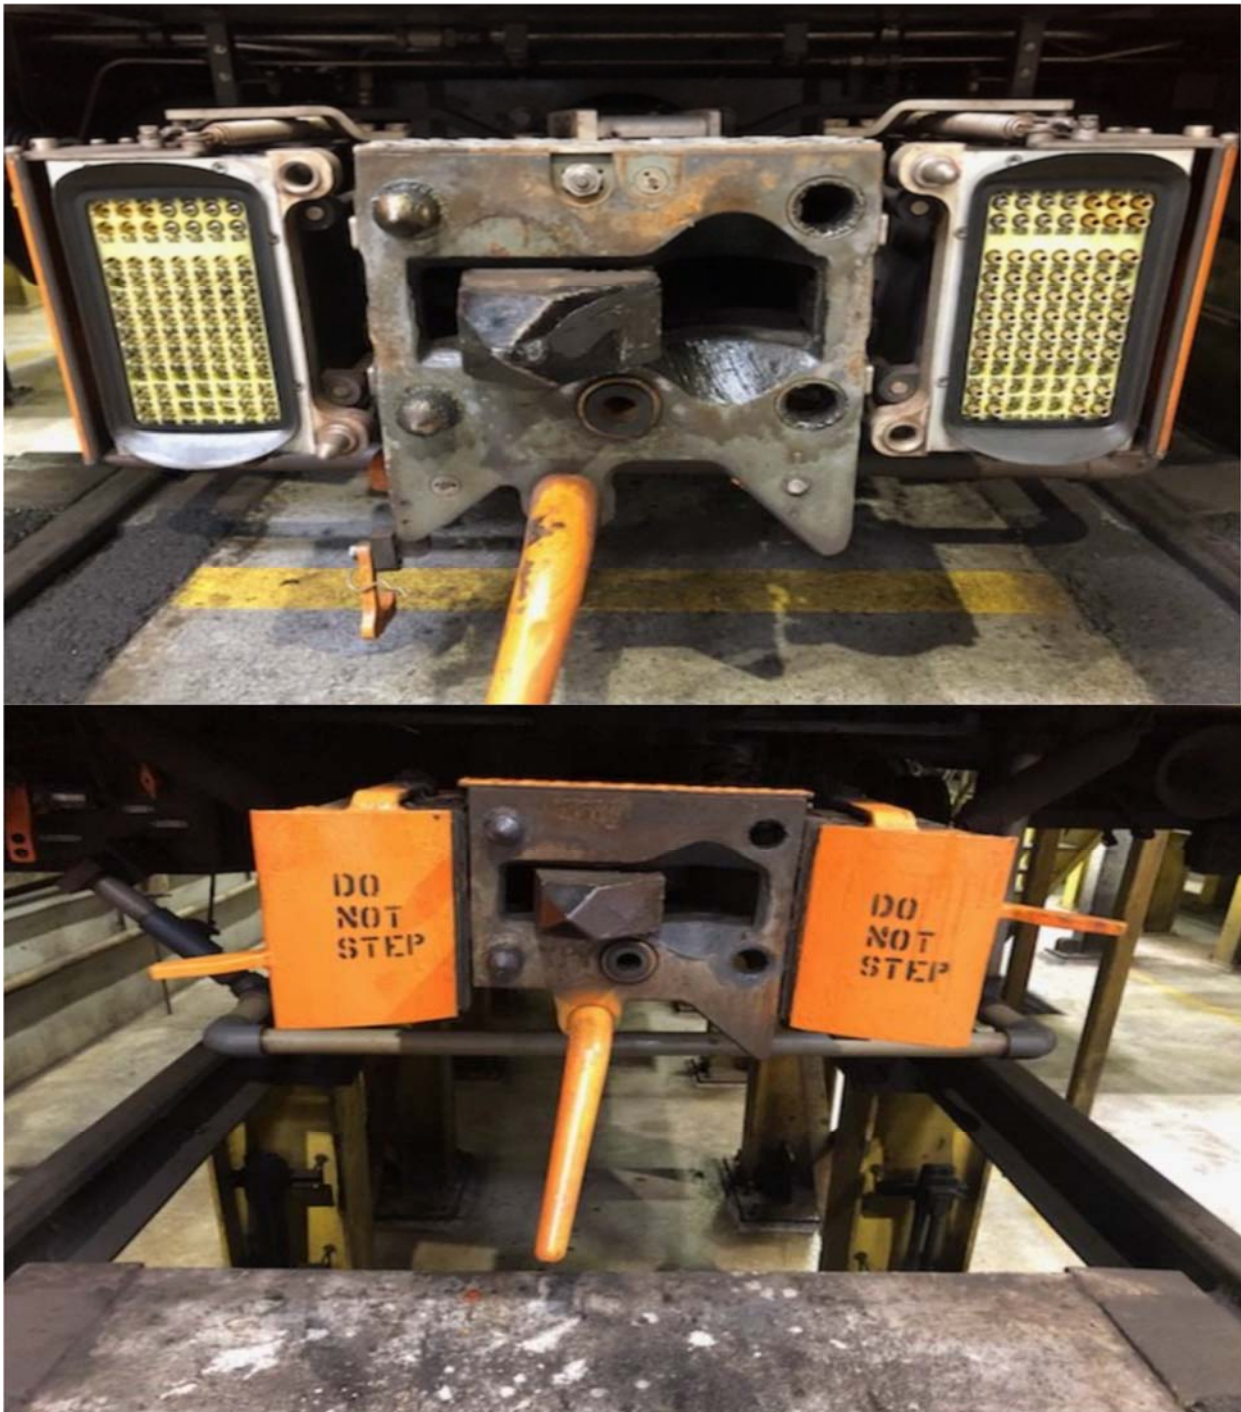
Based on the post-incident inspection, CMNT did not find any discrepancies on Cars 7668 and car 3280. CMNT performed an inspection on front and rear electrical couplers, sheer bolts, and coupler face. A DI was completed on both cars and released for revenue service.

Photo 8: Couplers involved.
