WMSC Commissioner Brief: W-0056 – Improper RWP near Fort Totten Station – August 22, 2020

FINAL REPORT OF INVESTIGATION A&I E20310

**Fort Totten Station – Improper RWP
August 22, 2020**

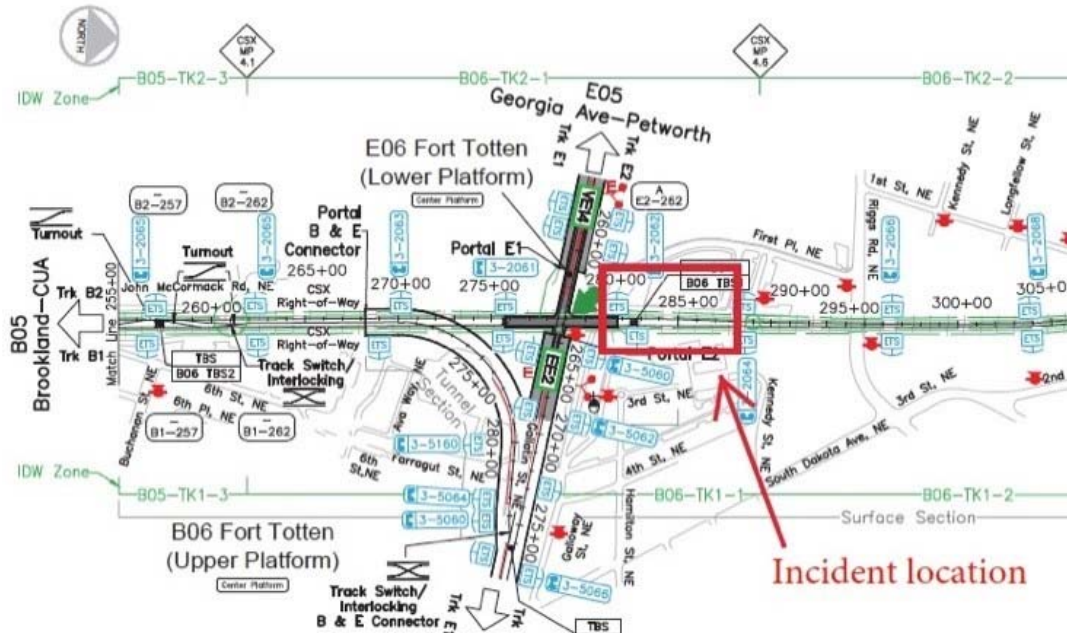
Figure 1: Fort Totten Station, Track #1, Chain Marker (CM) B1-284+00

Fort Totten Station, Track #1, Chain Marker (CM) B1-284+00
Transfer station for Green and Red Line Trains
